Summary sheet of FCG inspector's report

SHEFFIELD WEDNESDAY FOOTBALL CLUB

Condition of outer perimeter brick walls

Date of report 19 May 1989

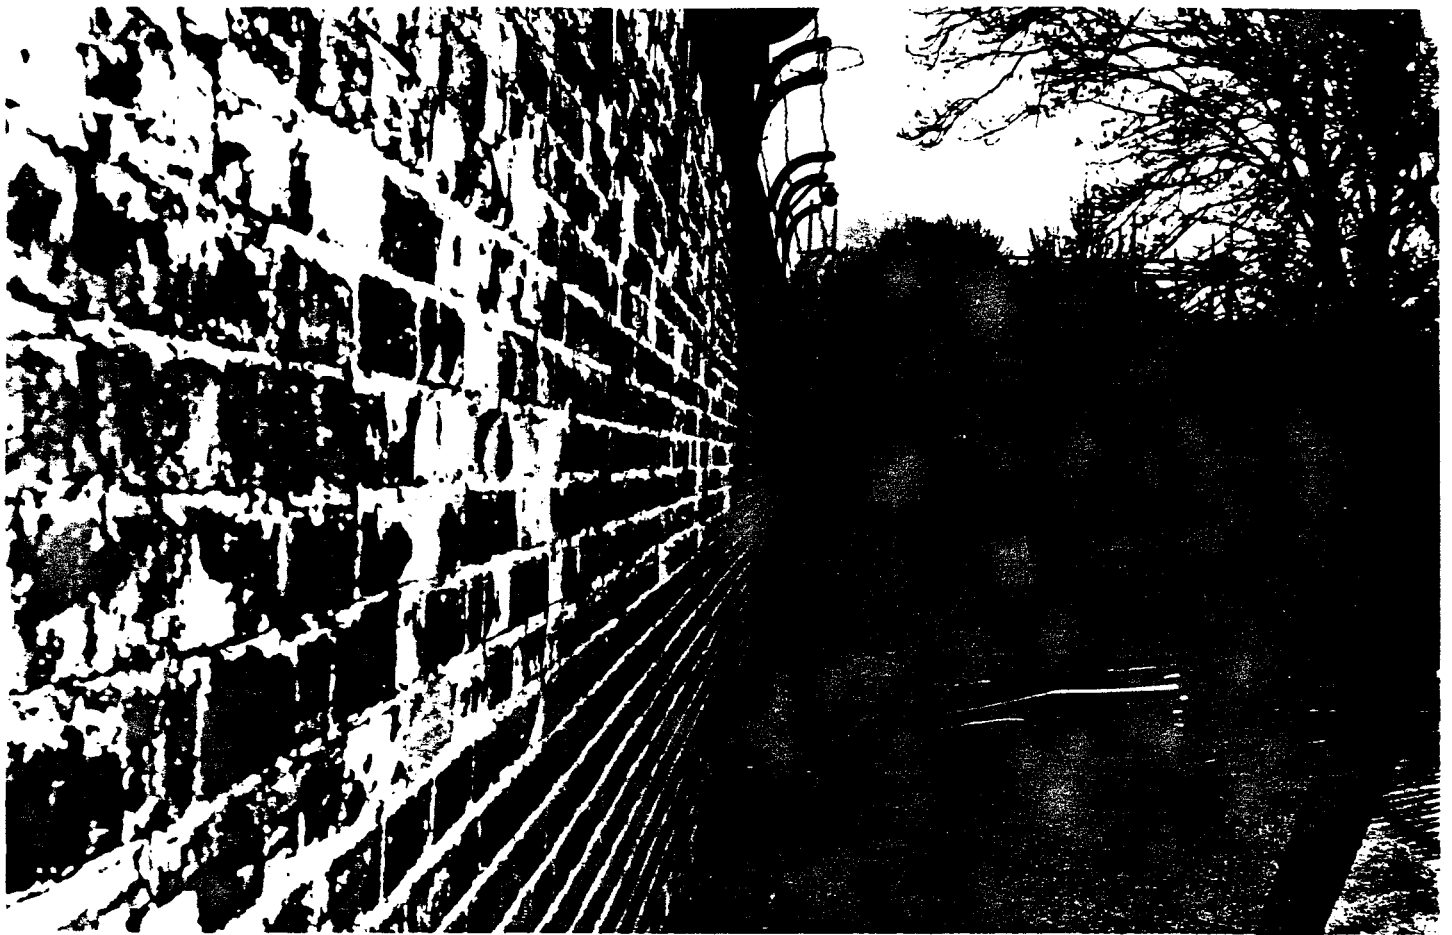
PHOTOGRAPH 1

1.4 The wall is distorted and bowed along its length and is also out of plumb, leaning inwards over parts of its length and outwards over other parts (see Table 1, Photographs 1-4). The **maximum** deflection out of plumb is 100 mm (4 inches) leaning outwards. No damp-proof course appears to have been provided when the wall was constructed and the mortar near the base has eroded and weathered due to damp and frost action. Both faces have been repointed in cement mortar in the past but the original black mortar can be seen where the pointing has deteriorated. It is not known upon what type of foundation the wall is constructed. However, the base of the stretch between the corner and Gate 'D' shows stepped brickwork at the base and it is possible that this is the top of a stepped brick foundation.

1.7 Advice was given that the wall was significantly distorted, had failed **as** a structure and was unsafe. It was considered to **be** liable to topple during high winds, or if set oscillating by crowd pressure. Consequently it was considered that it should **be** either taken down and reconstructed or stabilized by buttressing or other equally effective means.

VIEW OF SW PERIMETER WALL FROM GATE 'C' TO CORNER

5.2 The freestanding wall at the South West corner, between Gate 'C' and turnstiles 19-22 is distorted, has inadequate lateral stability for its height and is unsafe and liable to topple if subjected to wind or crowd pressure. As recommended earlier it should be taken down and reconstructed, suitably buttressed or stabilized by other equally effective measures. Whatever course is adopted the wall should be upgraded to meet modern design loading criteria for sportsgrounds.

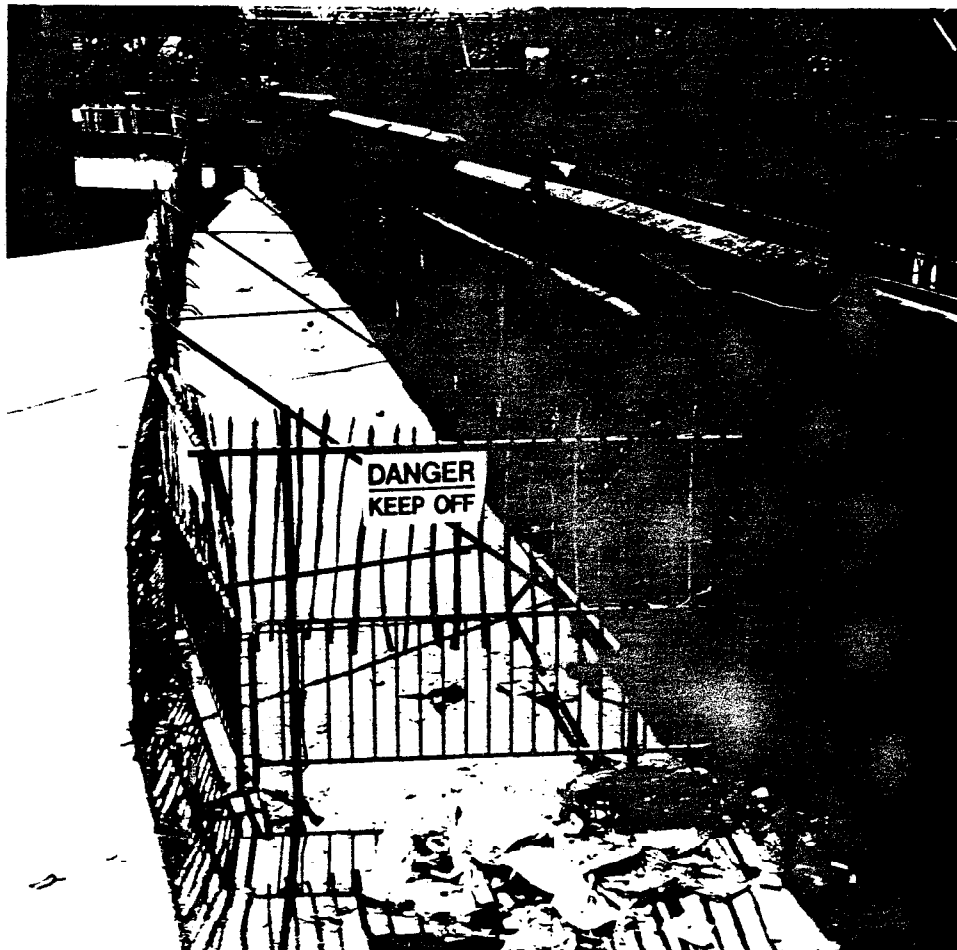
PHOTOGRAPH 2

INTERNAL VIEW OF SW PERIMETER WALL FROM GATE 'C' TO CORNER

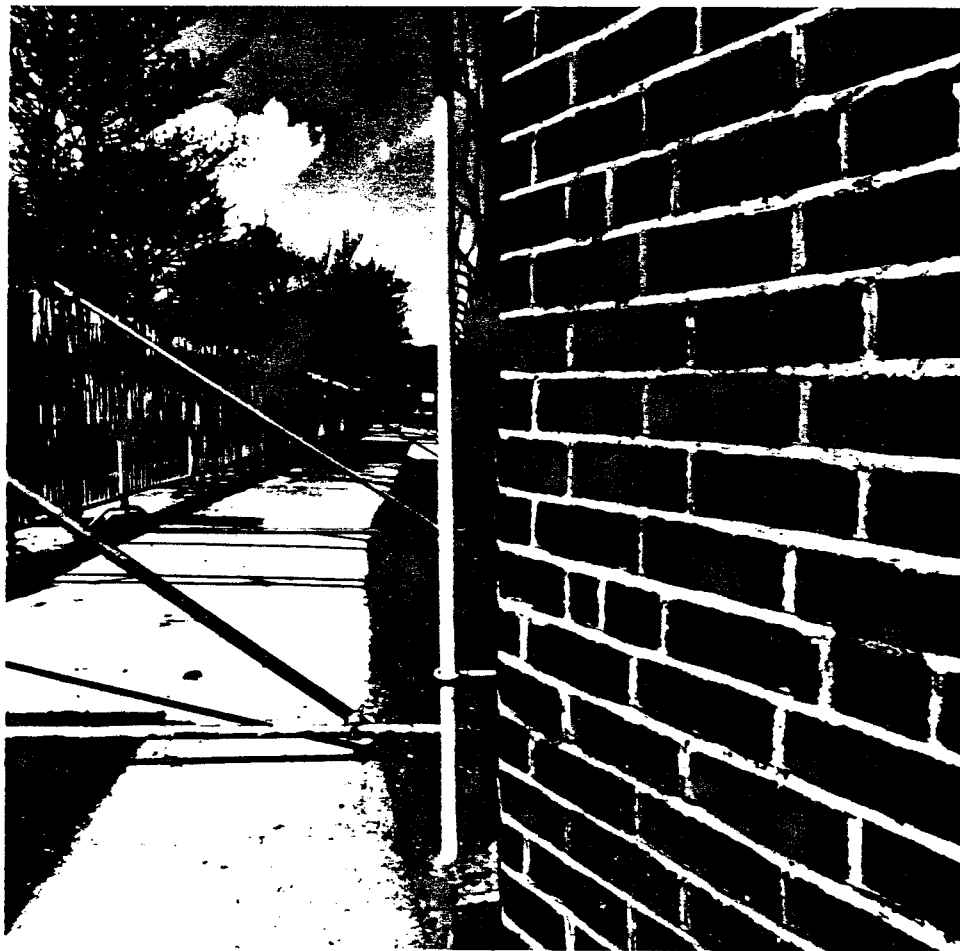
PHOTOGRAPH 3

SW PERIMETER WALL FROM CORNER TO GATE 'C'

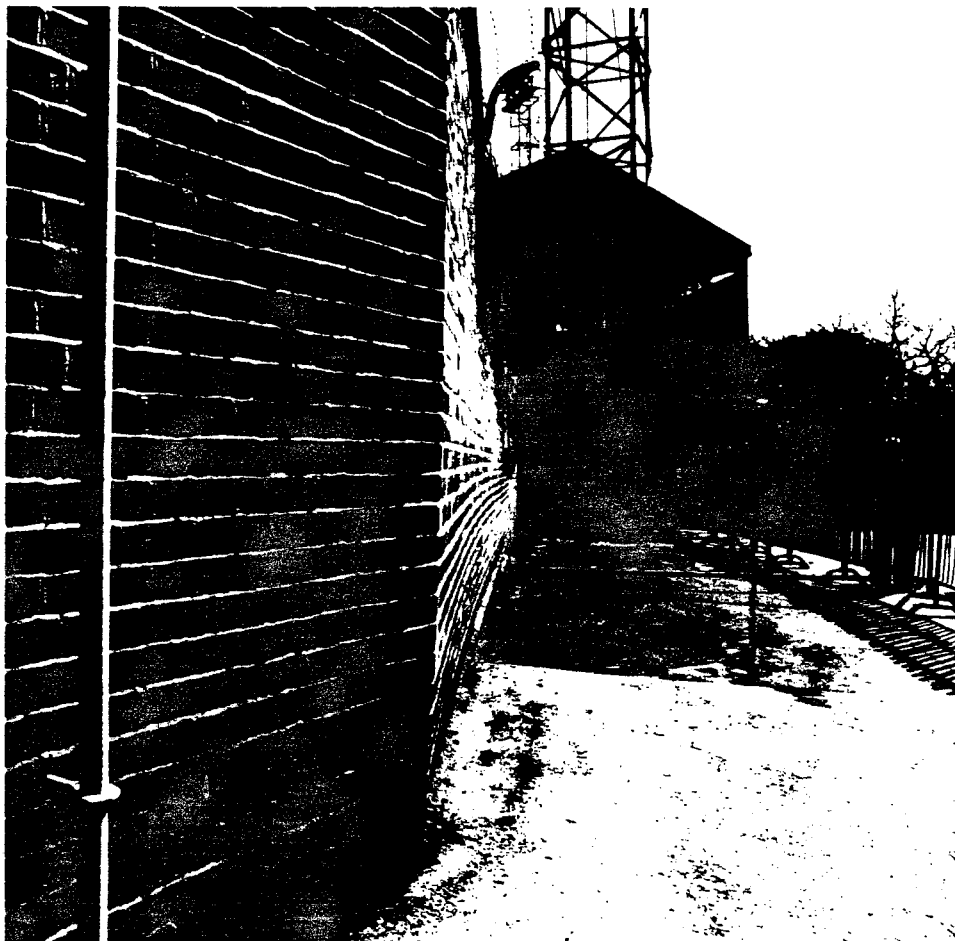
PHOTOGRAPH 4

SW PERIMETER WALL FROM CORNER TO SOUTH STAND

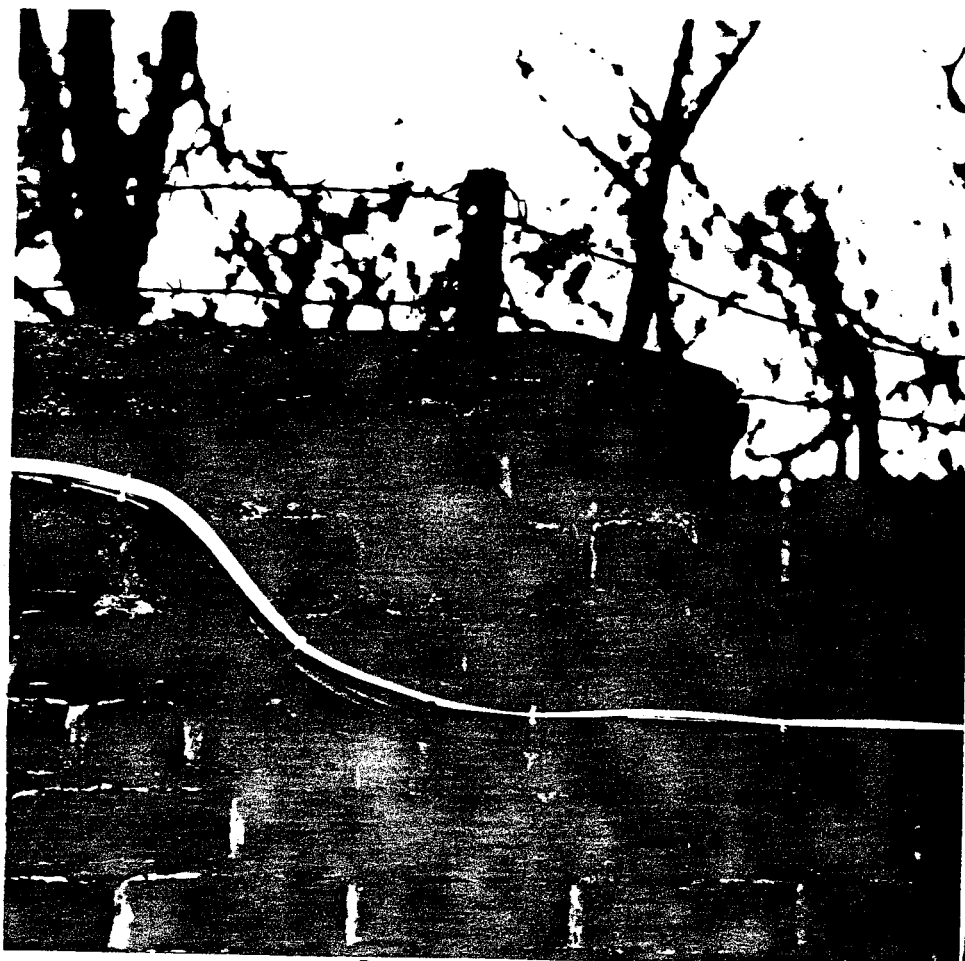
PHOTOGRAPH 6

1.5 There was some diagonal cracking in the wall at a distance of 40 m from Gate 'C' and again at 50 m, the latter extending for the full height of the wall. In addition there were areas of loose brickwork at the top of the wall, and in places the concrete coping was weathered and cracked, particularly where the top of the wall was stepped (see Photographs 5-8).

SW PERIMETER WALL LOOSE & DISPLACED AT
STEP IN WALL HEIGHT ~ INNER FACE

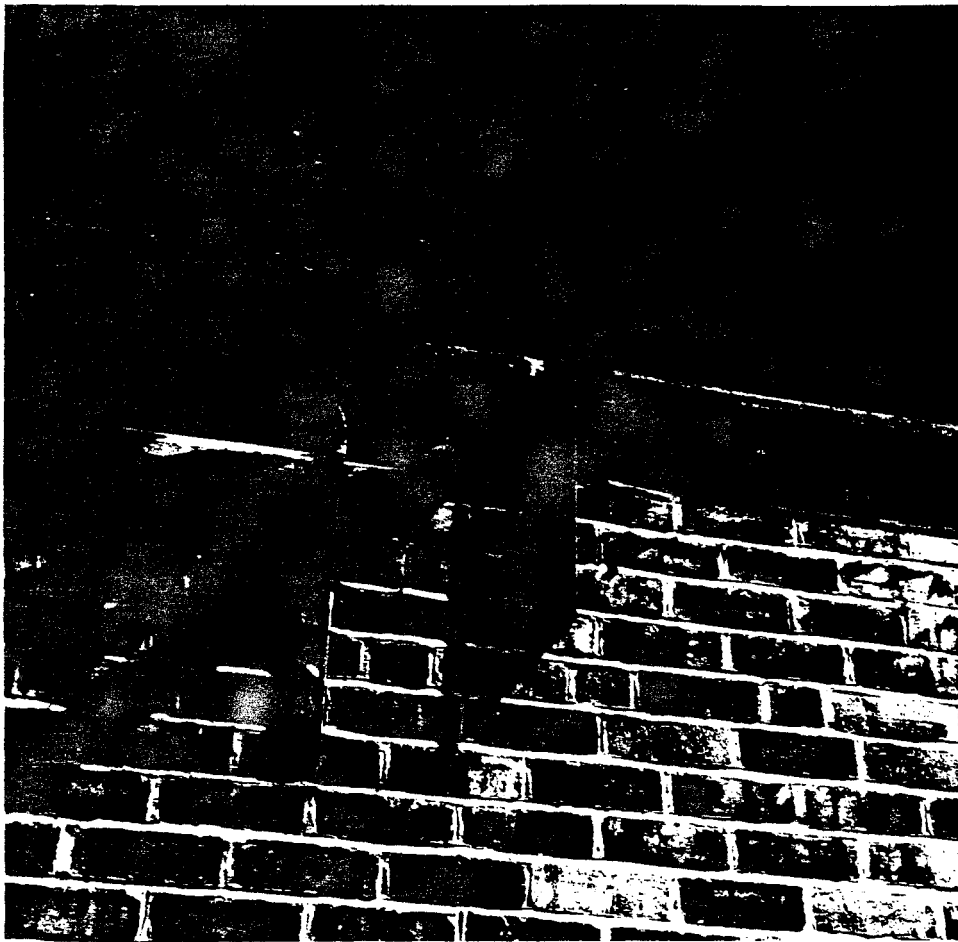
PHOTOGRAPH 7

DETERIORATION OF BRICKWORK AT STEP IN
WALL HEIGHT ~ OUTSIDE FACE OF WALL

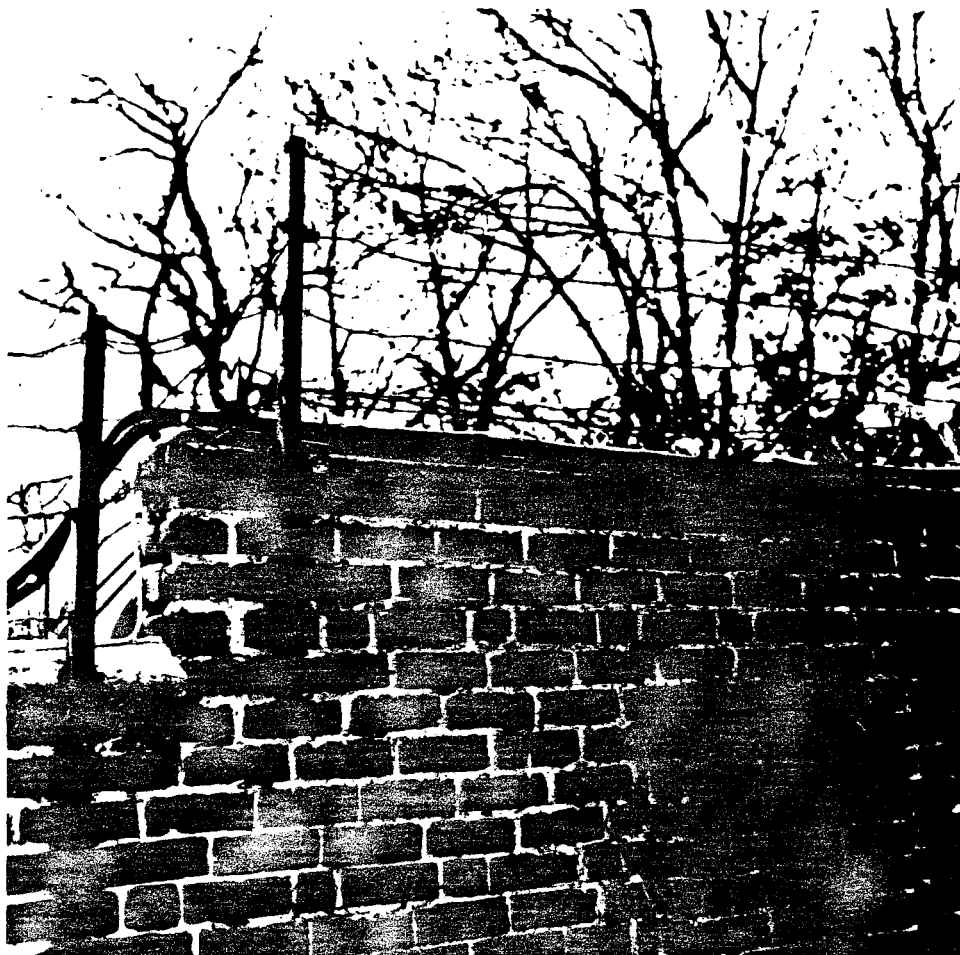
PHOTOGRAPH 8

SKY PERIMETER WALL LOOSE BRICKWORK AT STEP IN
WALL HEIGHT ~ INTERNAL FACE

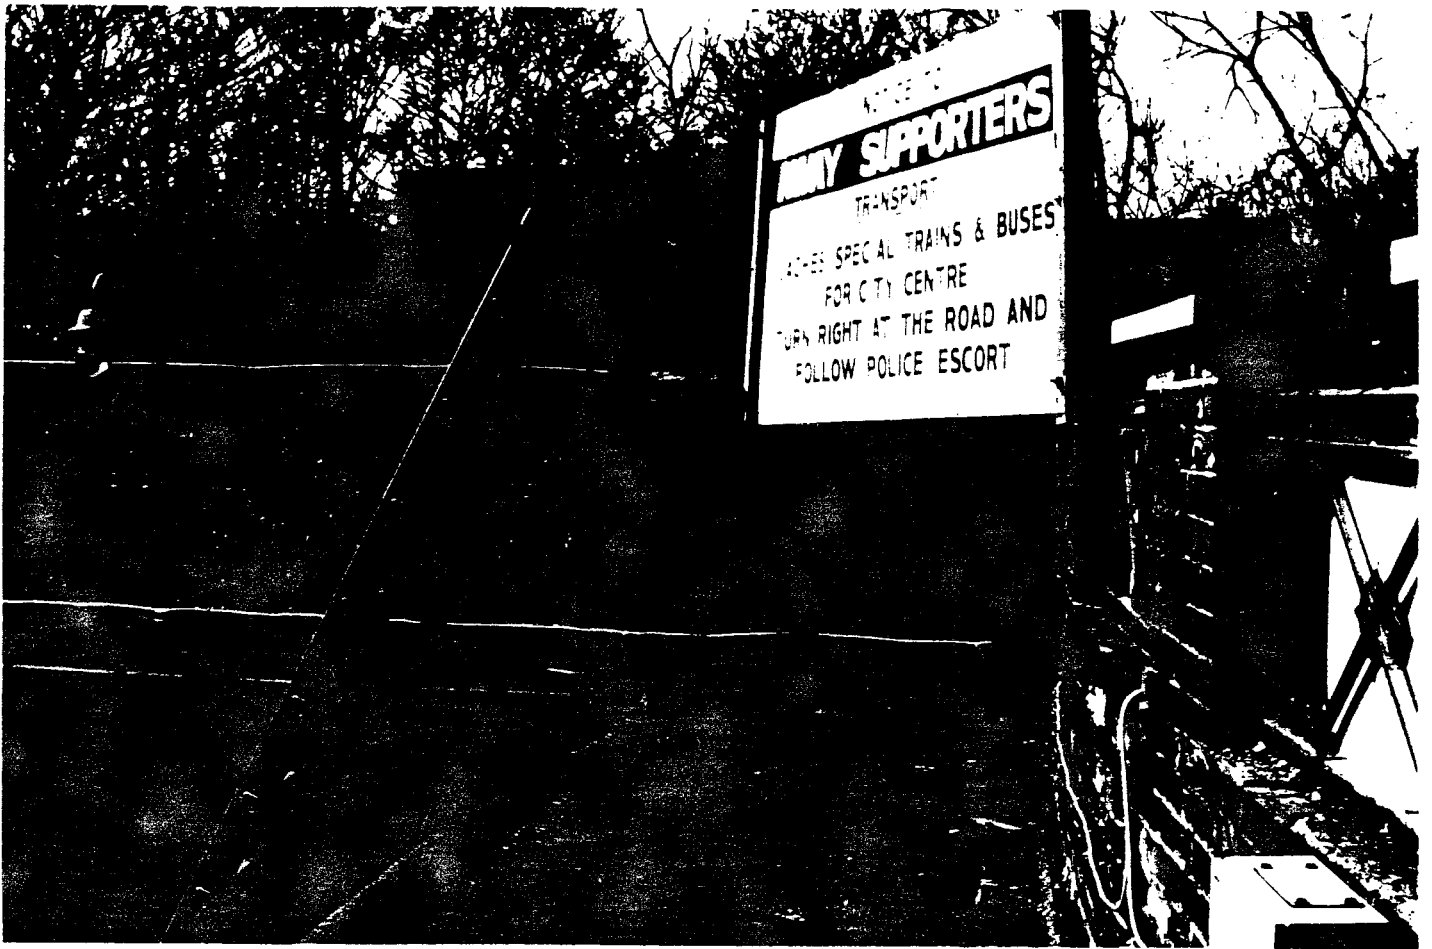
PHOTOGRAPH 9

PARAPET WALL ABOVE TURNSTILE BUILDING A-G ADJACENT TO GATE 'C'

2.4 In view of the general condition of the parapet wall, brick piers and railings, and their failure to provide an effective barrier, it is recommended that consideration be given to dismantling and reconstruction of the parapet as a solid barrier of sufficient height to deter climbers.

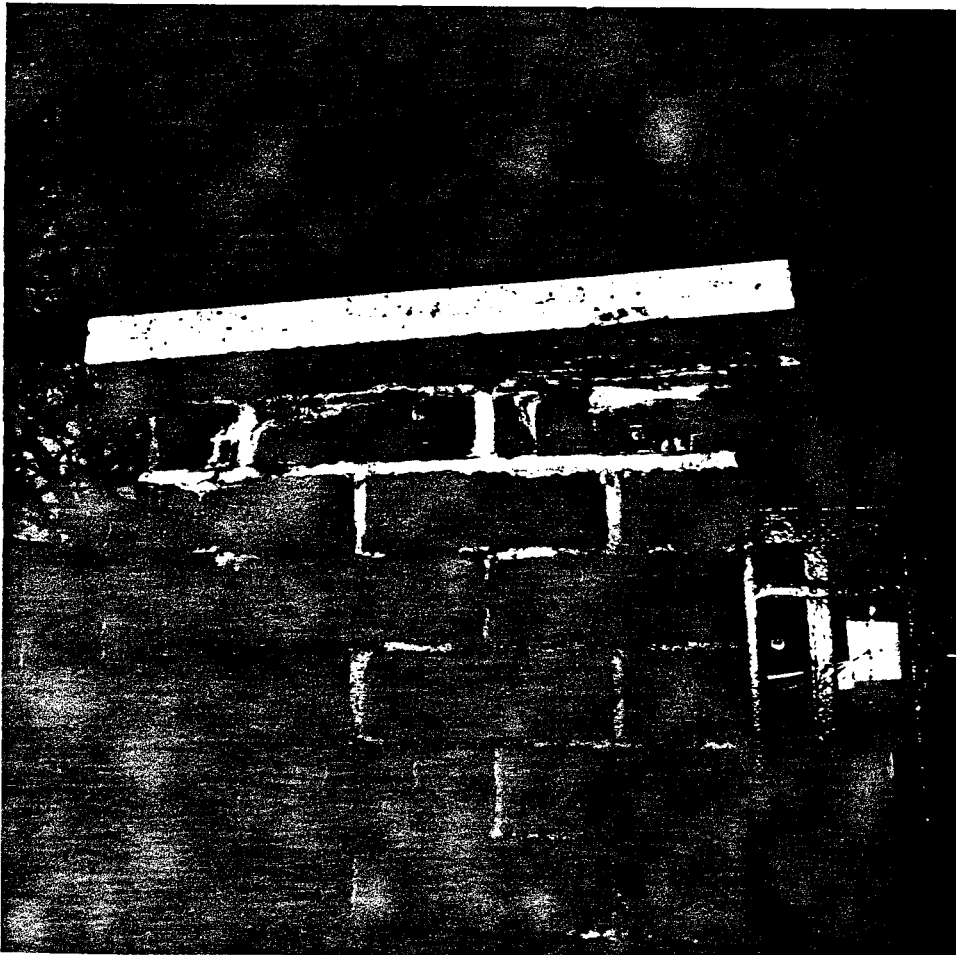
PHOTOGRAPH 12

2.2 The parapet walls, piers and railings are generally dilapidated with loose and spalling brickwork in places, loose and broken sections of railing and loose coping stones on top of the brick piers (see Photographs 10-16). The 230 mm x 345 mm (9 inches x 13 1/2 inches) brick pier adjacent to Gate 'C' has become detached from the wall and is displaced (Photographs 9 and 10). The end of the infill railing is fixed to the pier but the opposite end of the railing is only loosely held by the next pier (Photograph 11). As a result the pier and attached railing are loose and can easily be rocked by hand. They are held in position by the wooden post of a large notice board which is positioned diagonally across the corner of the turnstile building (see Photograph 9). However, the effect of a number of people using the railing as a hand-hold to climb over the wall could be sufficient to pull the railings and pier over onto the crowd below. The coping belonging to the brick pier above turnstile 16, adjacent to Gate 'B' was lying on the ground adjacent to the exit from the turnstiles (Photograph 20).

TOP OF ABOVE BRICK PIER OVER TURNSTILE'S'
SHOWING LOOSE COPING

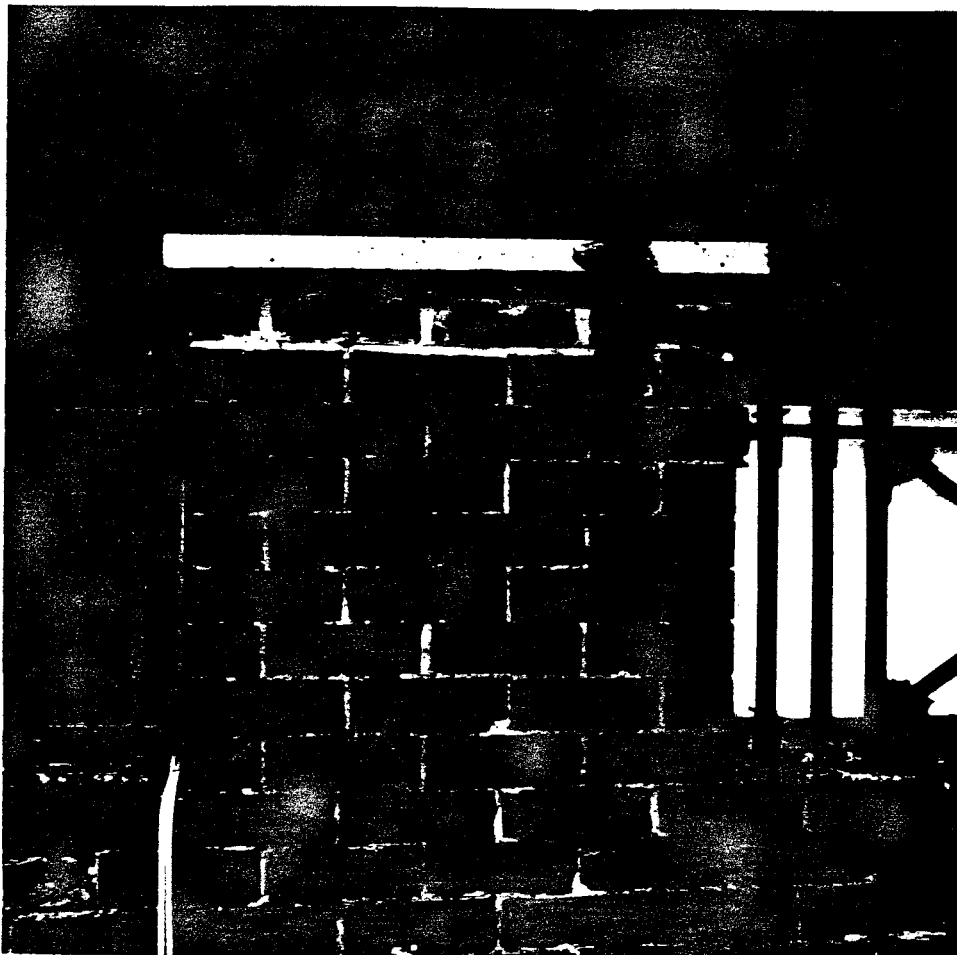
PHOTOGRAPH 13

BRICK PIER IN PARAPET OVER TURNSTILES A-G
SHOWING LOOSE COPING

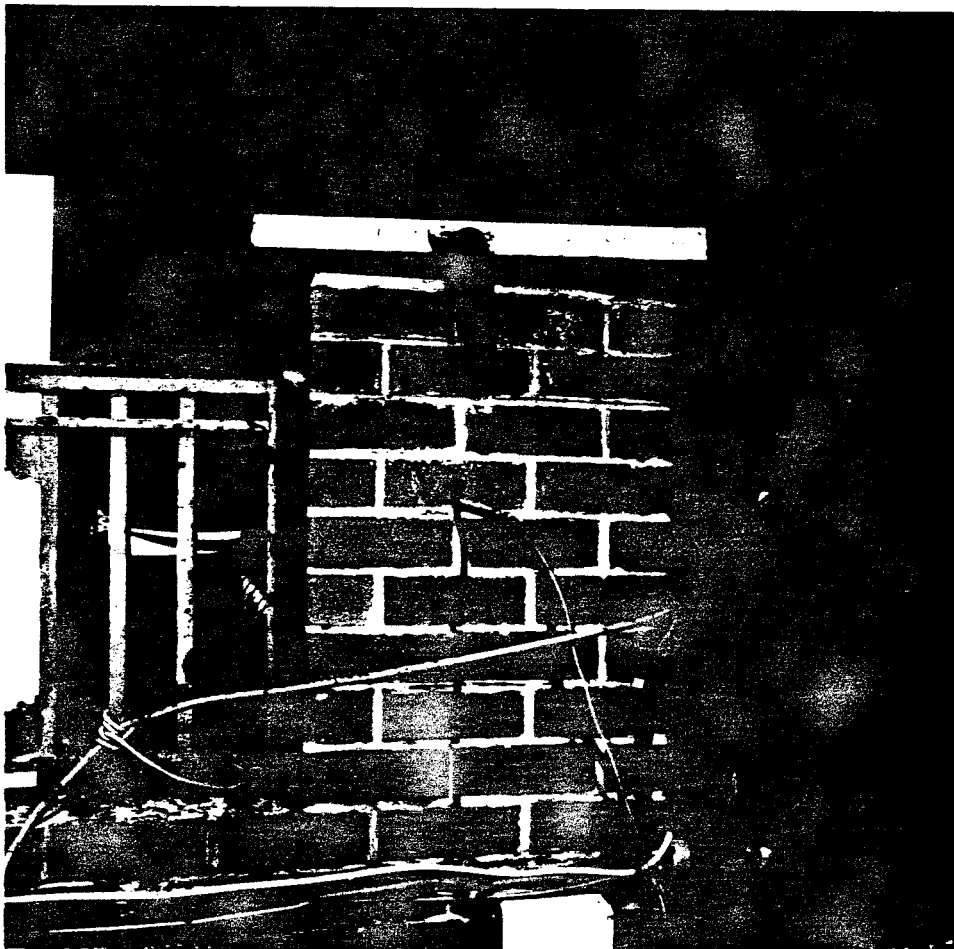
PHOTOGRAPH 14

AS ABOVE

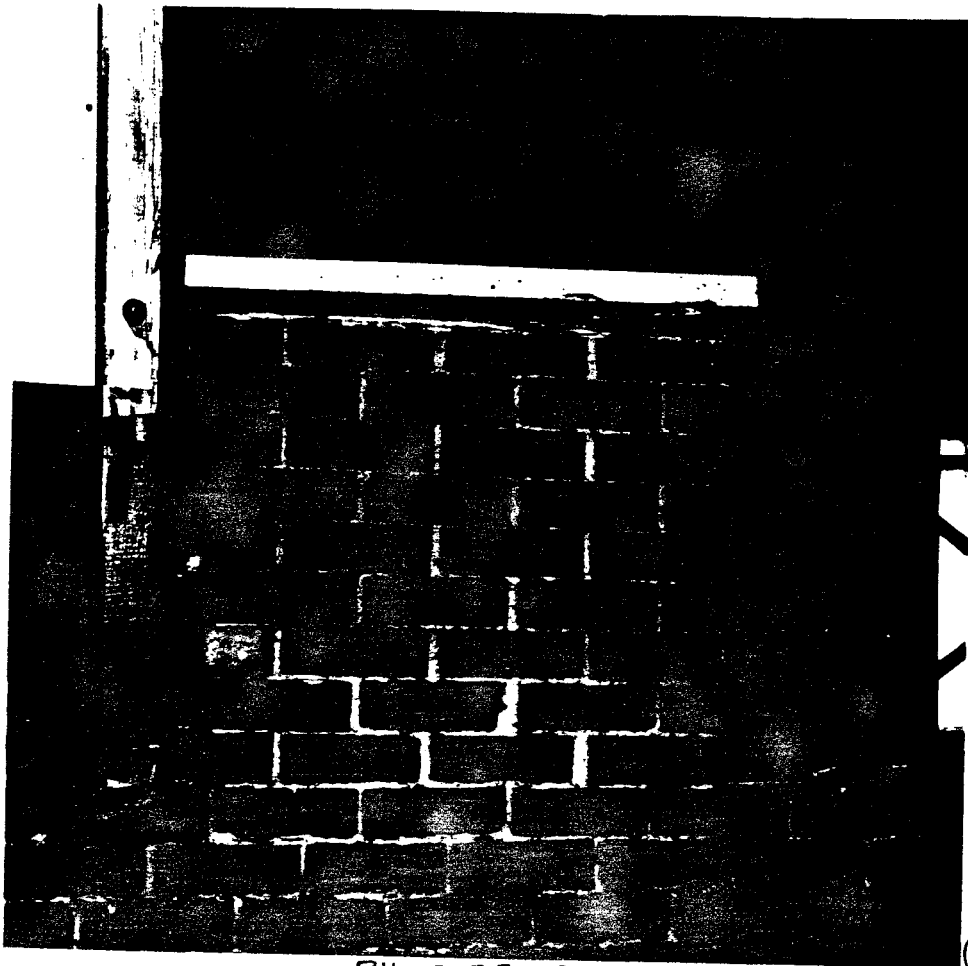
PHOTOGRAPH 15

BRICK PIER IN PARAPET OVER TURNSTILES A-G'
SHOWING LOOSE COPING

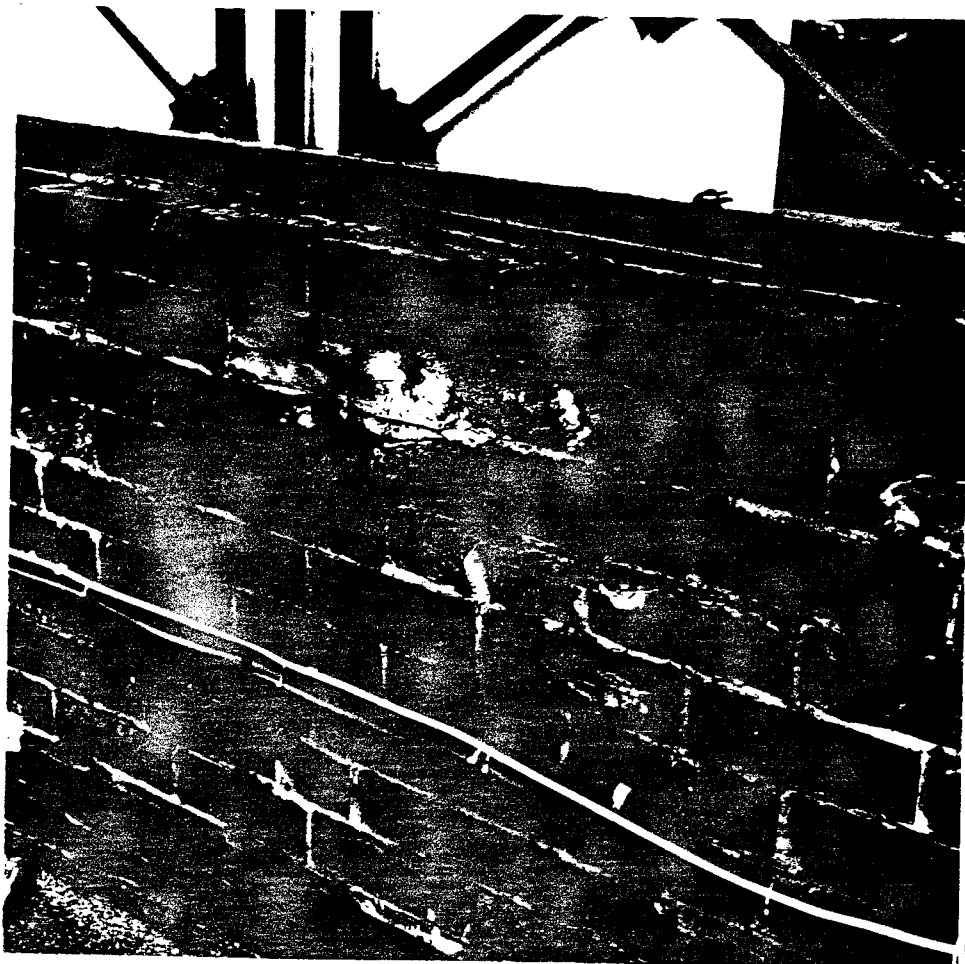
PHOTOGRAPH 16

PARAPET OVER TURNSTILES A-G LOOSE AND
SPALLING BRICKWORK ON INNER FACE OF WALL

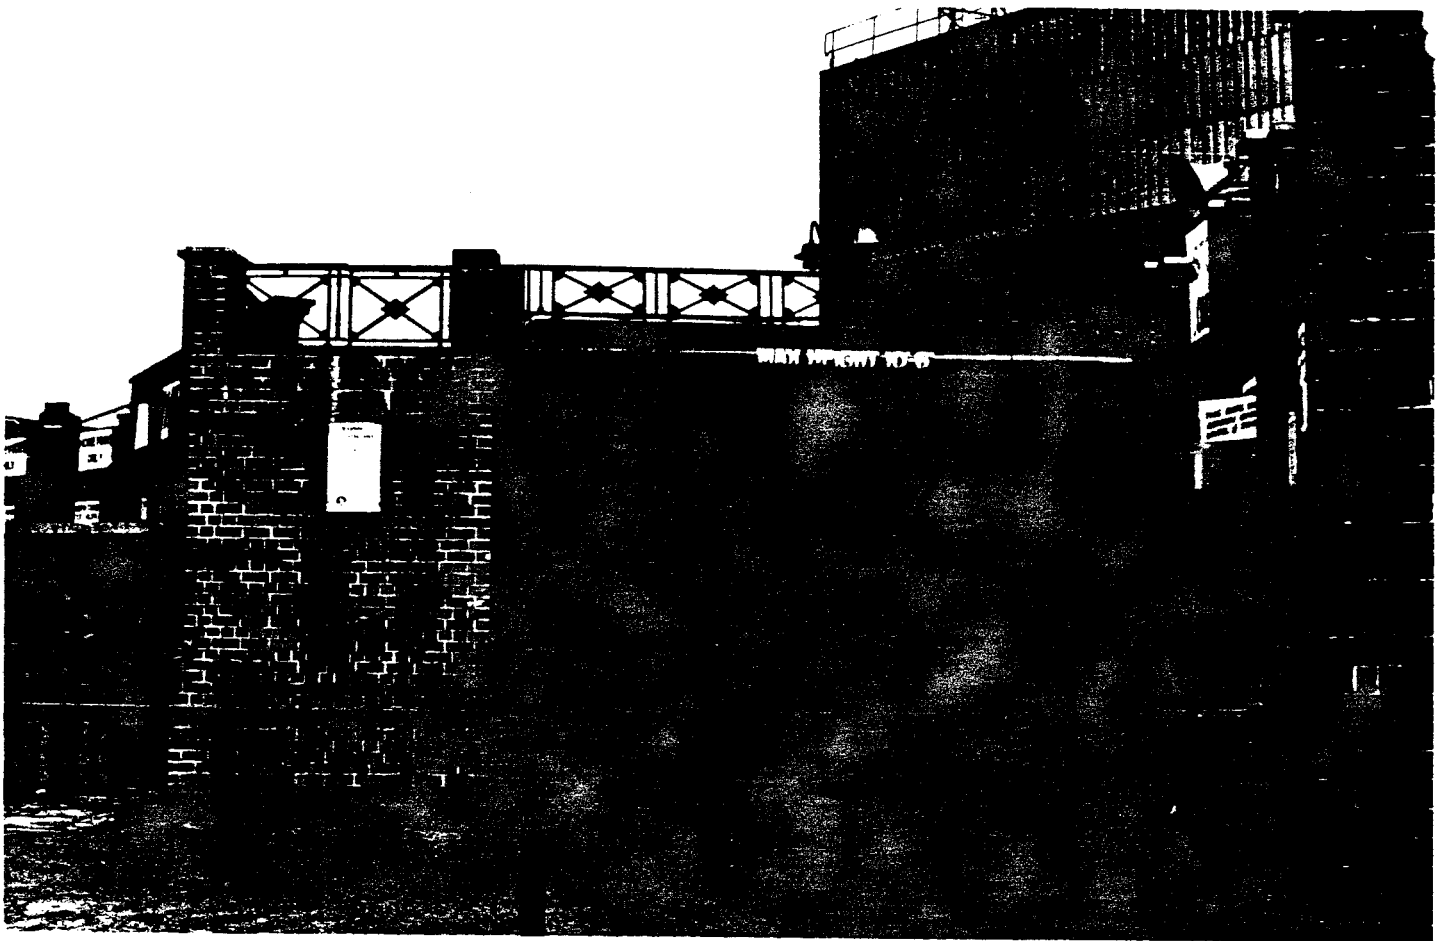
PHOTOGRAPH 17

2.3 As can be seen from the Photographs, the front of the turnstile building does not provide an effective barrier against determined assault. The fixed guide barrier adjacent to Turnstile 'G' provides a convenient foothold and the parapet railings a hand-hold (Photographs 17 and 19). Similarly, the panelled gate adjacent to Turnstile 16, together with its stay and wall brackets, provided convenient means of scaling the wall (Photographs 17 and 18). The cast iron railings are, in fact, broken in two at this point (Photograph 18).

EXTERNAL VIEW OF GATE 'B' NOTE MISSING COPING TO BRICK PIER ADJACENT TO LA GATEPOST AND 'CLIMBING AIDS' PROVIDED BY PANDELLED GATE TO LEFT AND BARRIER IN FOREGROUND

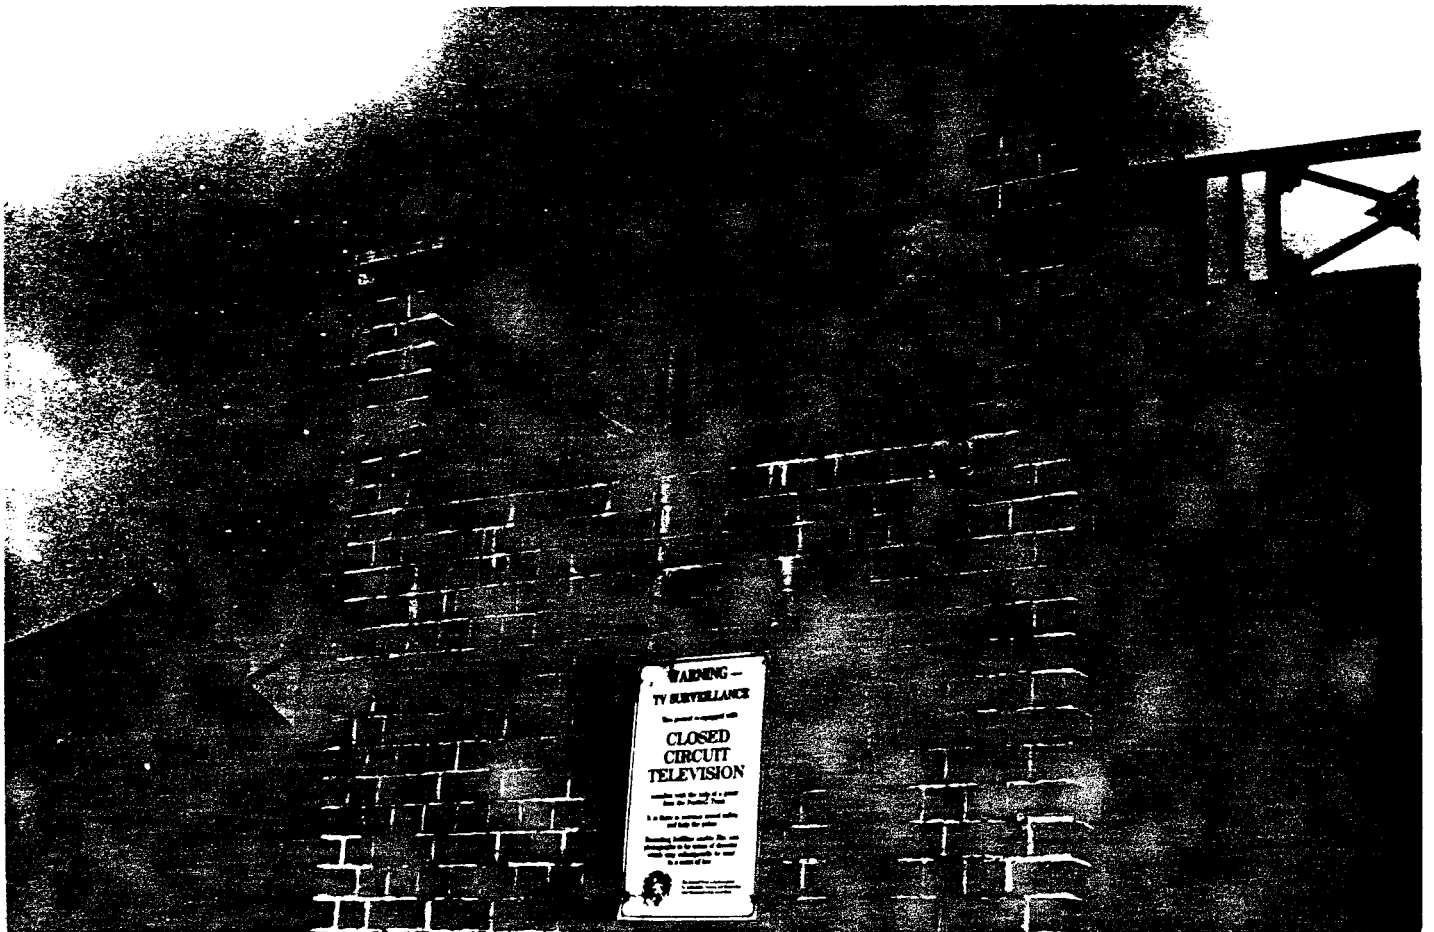
PHOTOGRAPH 18

PARAPET WALL AS ABOVE SHOWING BROKEN RAIL INFILL

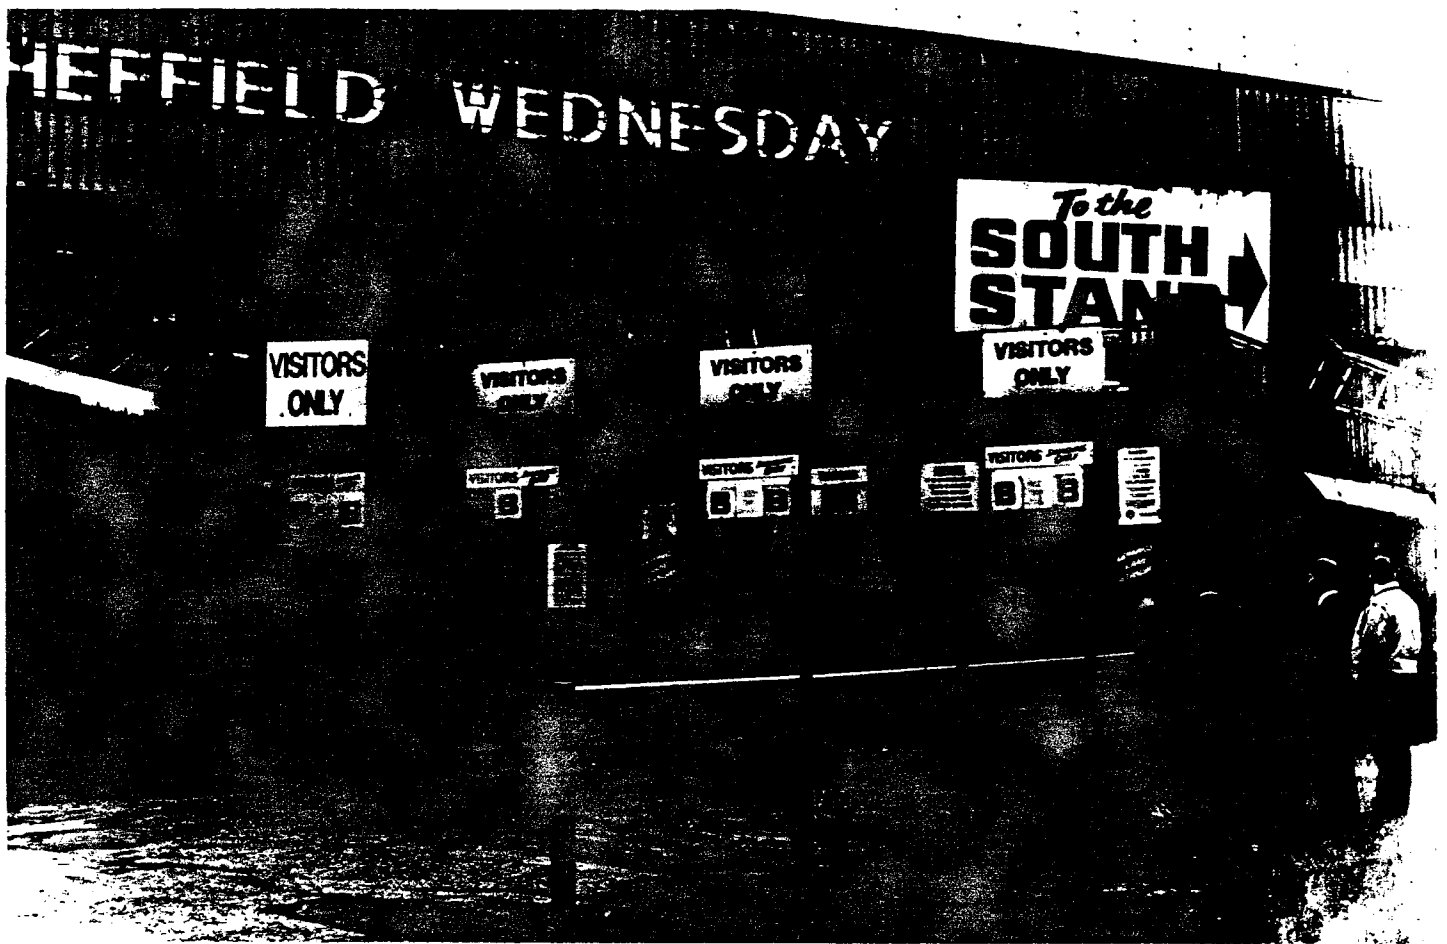
PHOTOGRAPH 19

EXTERNAL VIEW OF TURNSTILES A-G NOTE AID TO CLIMBING WALL PROVIDED BY BARRIER IN FOREGROUND

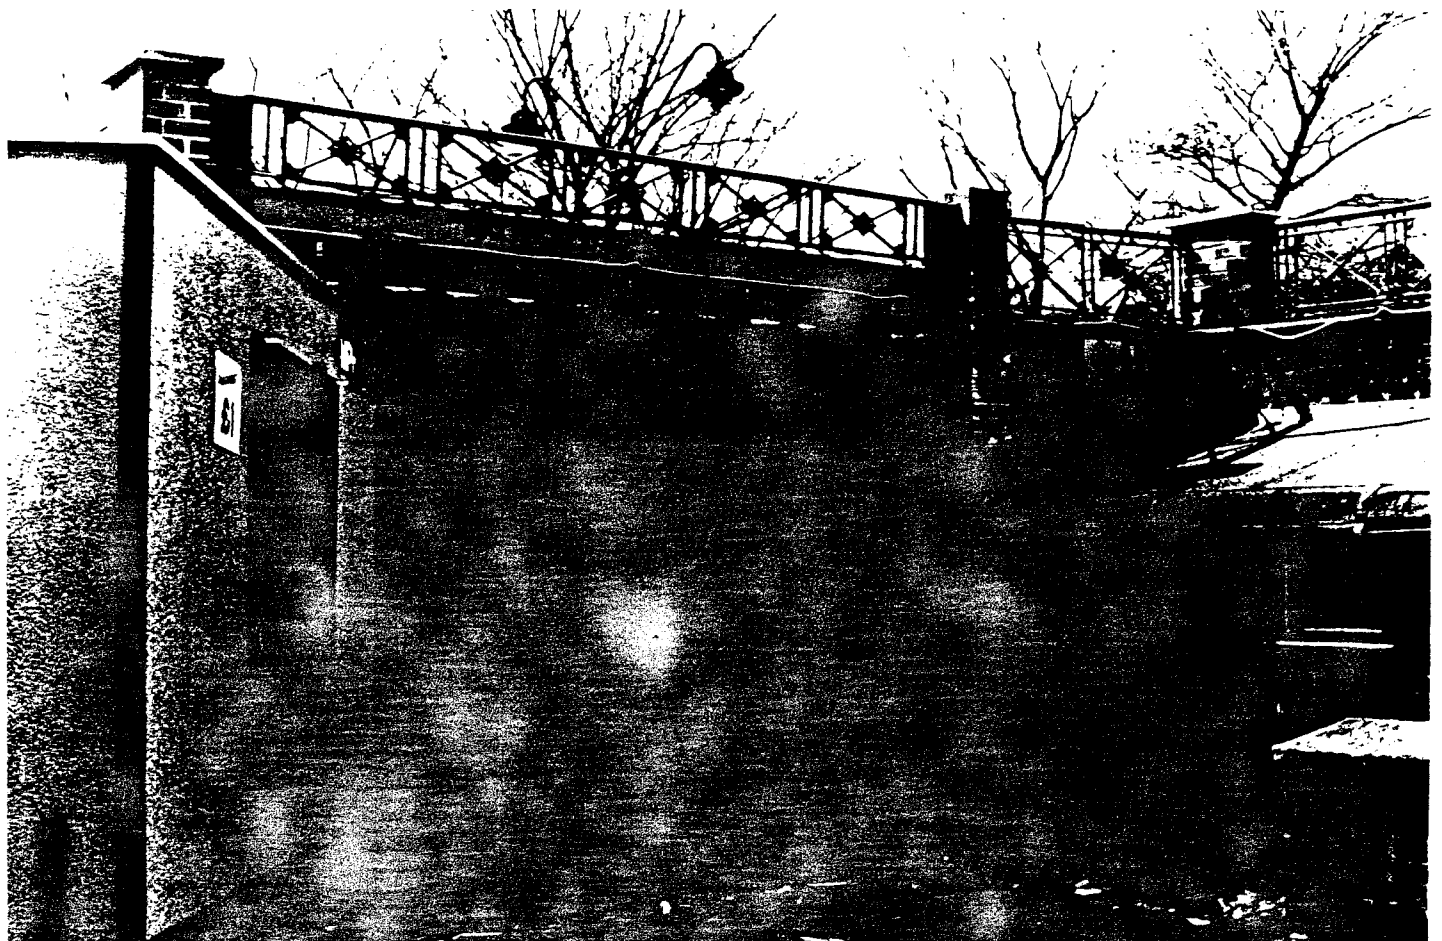
PHOTOGRAPH 20

INTERNAL VIEW OF GATE B SHOWING CONCRETE COPING DISPLACED FROM BRICK PIER OVER TURNSTILE 16 ADJACENT TO GATEPOST
