HEALTH AND SAFETY EXECUTIVE

Examination of Crush Barriers from Pens 3 and 4

IR/L/MM/89/11

Date: 11 December 1989

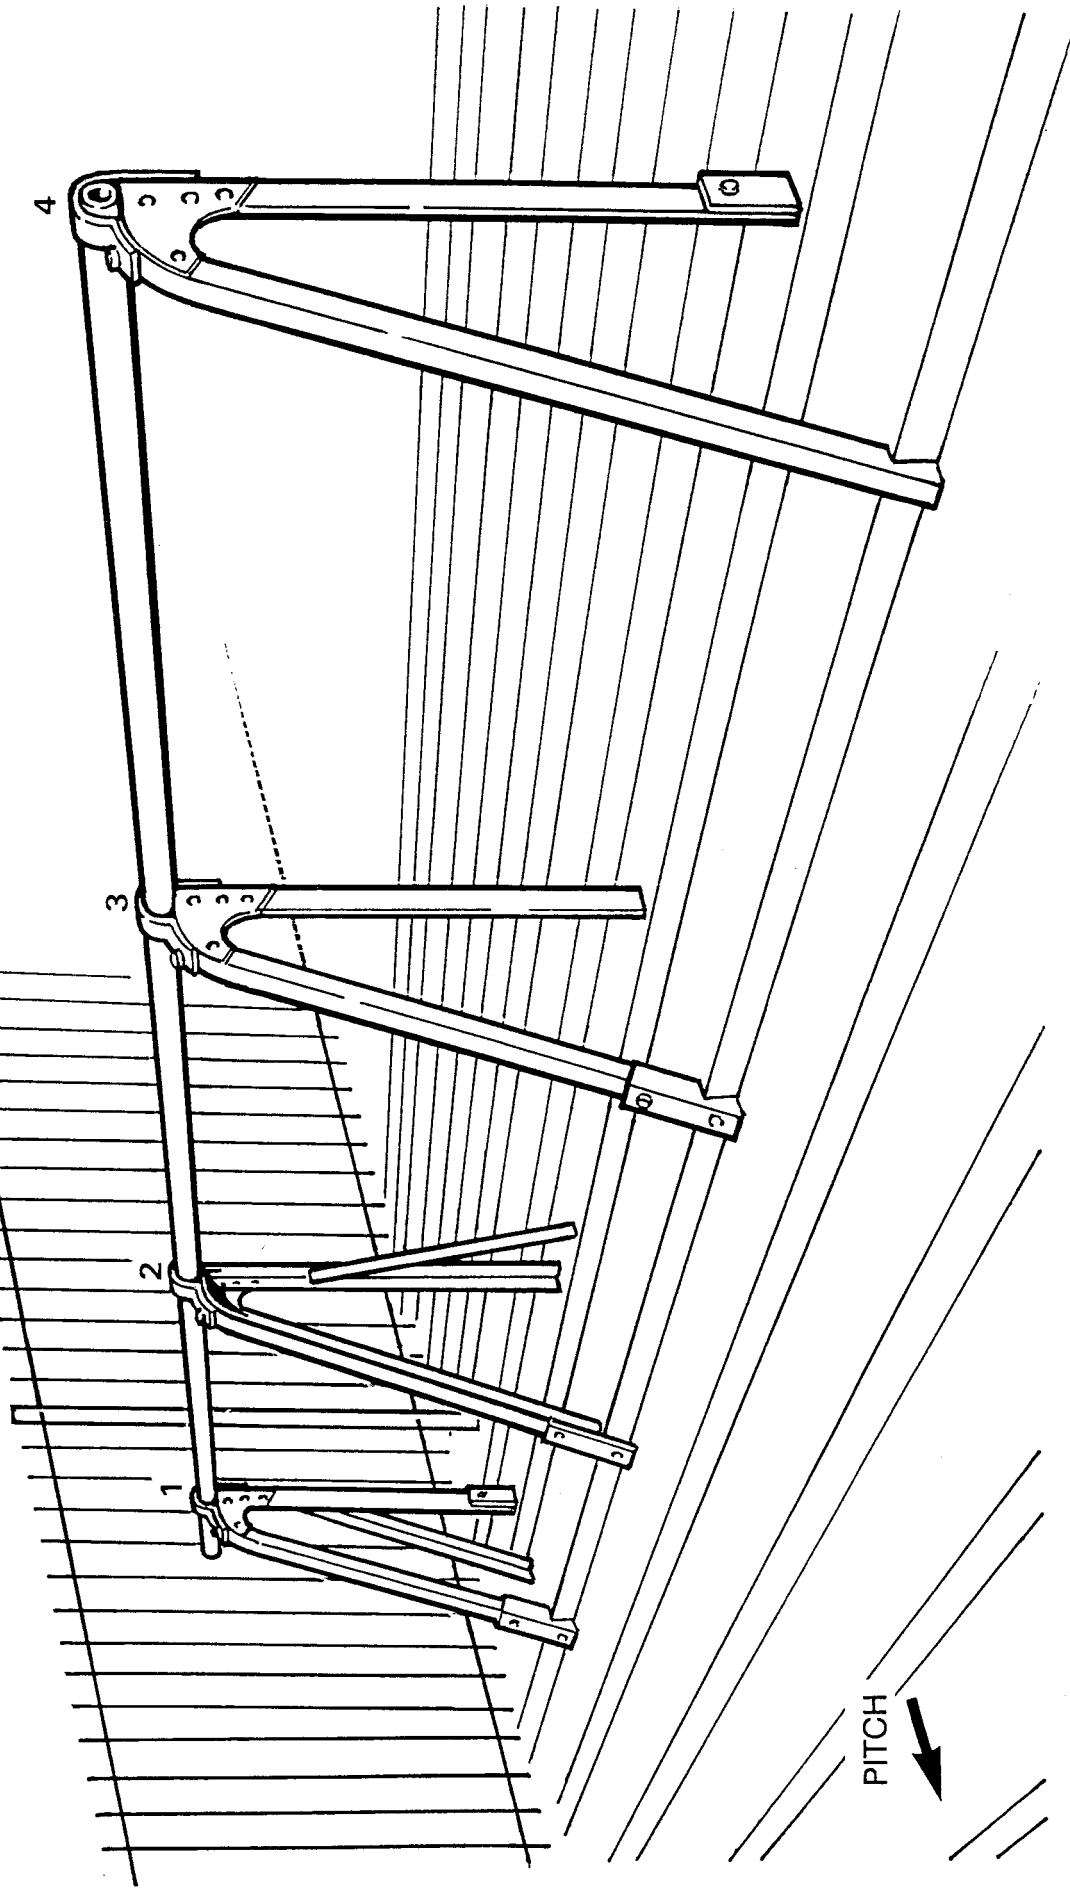
Fig. 1 - Reconstruction of Barrier 124A

Barrier 124A was located on the seventh, eighth and ninth steps of Pen 3 adjacent to Pen 2. The overall length of this barrier before collapse was estimated to be 7.5m including a tube overhang of 0.6m near the radial fence adjacent to Pen 2. The horizontal distance from this barrier to the perimeter fence at the front of Pen 3 was approximately 3.5m, and the distance of the tube end from the radial fence, separating Pens 2 and 3, was 28mm. There were no other barriers between barrier 124A and the perimeter fence. A sketch of this barrier, showing our opinion of its appearance before the incident, is shown in Figure 1.

Support 4, shown in the foreground of Figure 1, had been moved forward and twisted towards the front left-hand corner of Pen 3, viewed from the pitch. The lower portion of the front leg had remained straight, although by comparison with the front legs of other barriers, it appeared to have moved forward through an angle of 25 degrees approximately. In so doing the front leg had broken away from the edge of the concrete step in which it had been supported. Several pieces of detached concrete were observed nearby, two of which matched the fracture on the step, shown in Figure 3. The upper portion of the front leg had suffered localised bending and it had been twisted inwards with respect to the other supports on this barrier.

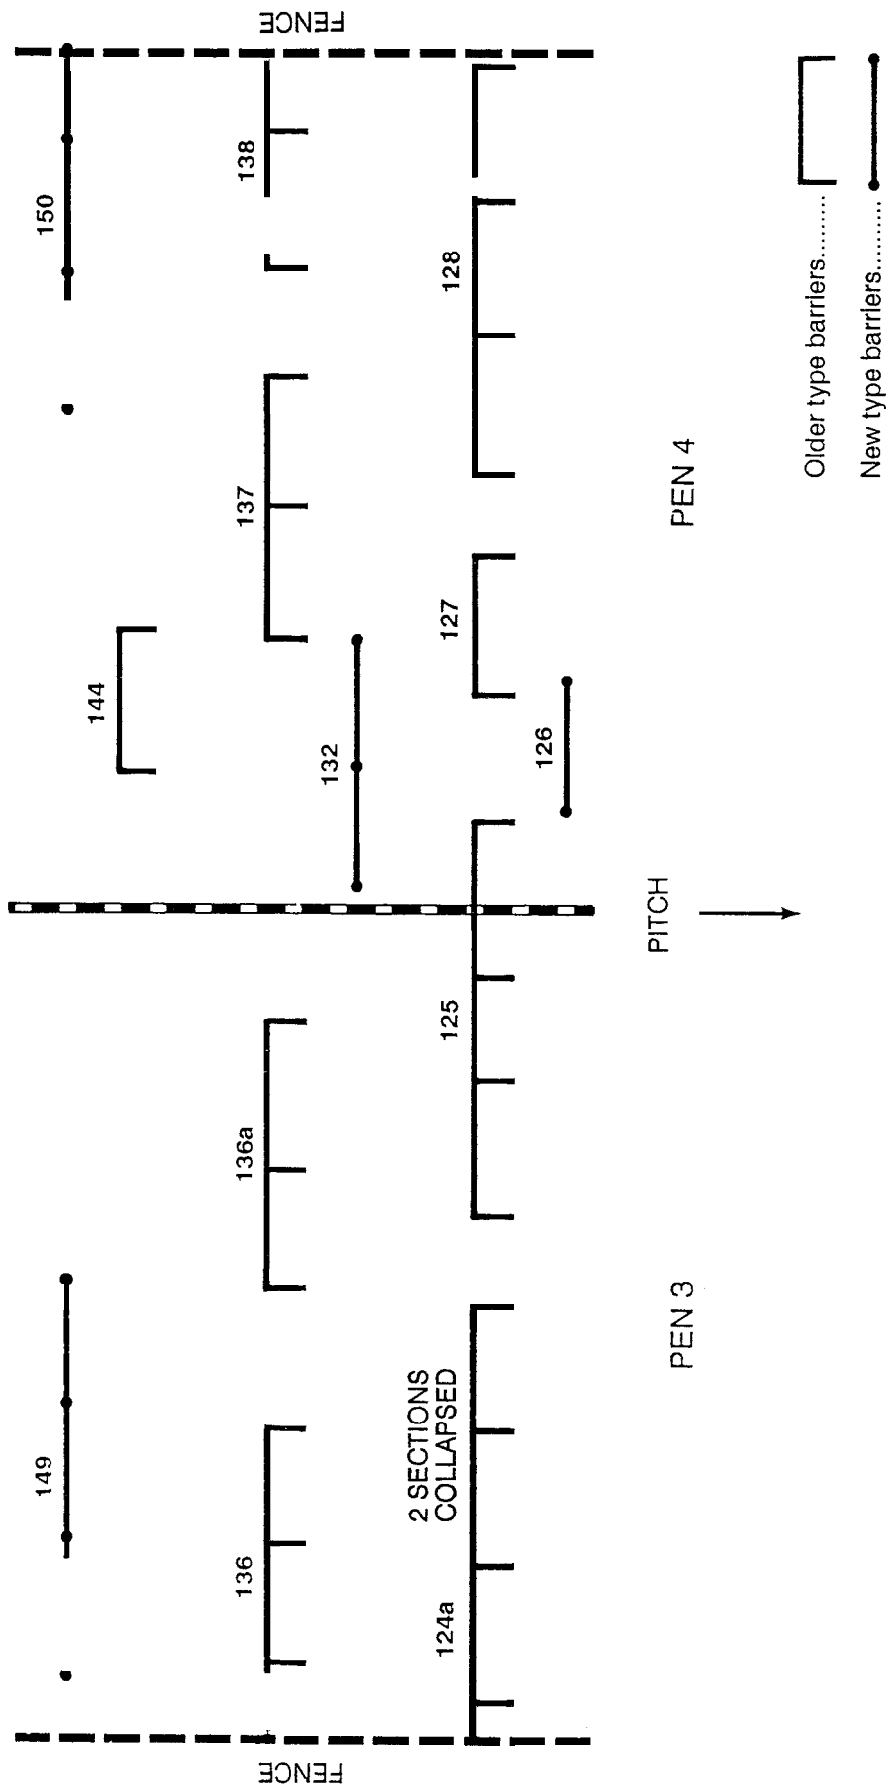
Fig. 4 - Layout of barriers in PENS 3 & 4

The remaining barriers in Pen 3 and those in Pen 4 were examined. The layout of all the barriers in Pens 3 and 4 is shown schematically in Figure 4. On each barrier the supports were numbered sequentially from left to right as viewed from the pitch. Several barriers had been fabricated with rectangular hollow section supports and these appeared to be somewhat newer than the rest. Most of the old-style barriers had been modified in some way, for example by reinforcing of the support legs and welding of the horizontal tubes. Corrosion was evident at all joints and intersections, and rust "jacking" had occurred at many of the gusset plate/support leg junctions.

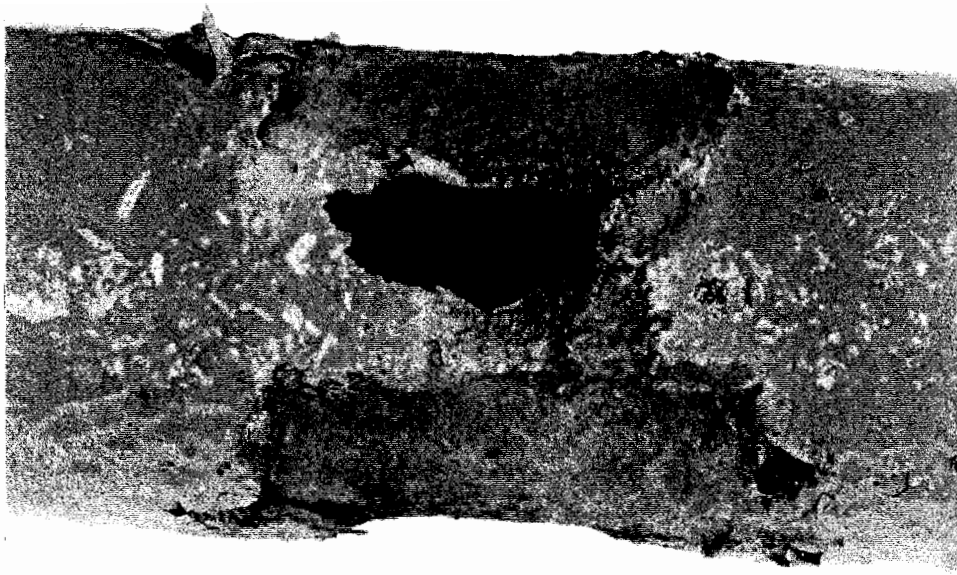
Fig. 13 - Hole in tube at support 1.

An oval hole, shown in Figure 13 and measuring 35 x 15mm, was revealed in the tube under the strap on support 1, at the 4 o'clock position when viewed from the end nearer support 1. This hole had apparently been formed by external corrosion of the tube under the strap.

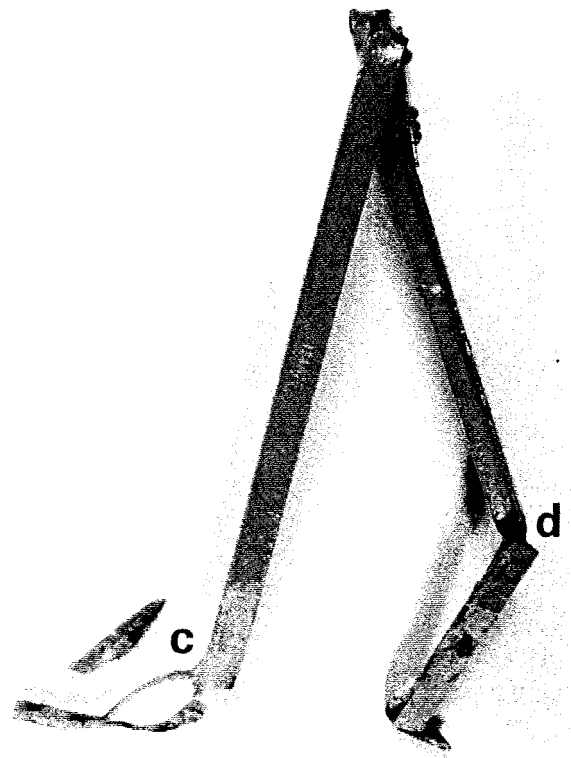
Fig. 15 - Support 4.

The rear leg of support 4 had been deformed and kinked at the lower end near the junction with a piece of reinforcing steel angle which had been bolted on top of the original angle section. The latter had been thinned by corrosion in the area where this deformation had occurred. The rear leg also exhibited localised deformation and cracking in the vicinity of the lowest gusset plate attachment hole. The gusset plate appeared to be relatively undeformed but had been moved inwards towards the other supports. The tube retaining strap appeared to be intact and still in position.

Supports 1 and 2 had not been deformed. Supports 3 and 4 are shown after excavation in Figures 14 and 15 respectively. Although the extent of the deformation of supports 3 and 4 was noted on site (see section 2.1 of this report), a number of additional features became apparent in the laboratory.

The legs of supports 3 and 4 had been corroded, particularly at the junctions with the concrete step and/or additional reinforcing angles. At these locations the residual thickness was in the range 3.1mm to 5.9mm, compared with a nominal thickness of 6.3mm elsewhere. A considerable amount of metal had been lost by corrosion from the sub-surface region of the supports. For example, on the rear leg of support 4, a ligament of metal 8mm wide and 2mm in thickness was all that remained of the original nominal 50 x 50mm angle section at a distance of 150mm below the surface.

In general, the width of the steel angle from which the support legs had been made was in the range 49 - 52mm and the thickness remote from corroded regions was in the range 6.0 - 7.4 mm. In some above surface regions of supports 3 and 4 the thickness of the angle had been reduced by corrosion and buckling had occurred during collapse. This can be seen in Figures 14 and 15 in which the thickness of the angle at the positions indicated was:

Support 3	(a)	4.6 to 5.9 mm
	(b)	5.9 mm
Support 4	(c)	1.5 mm
	(d)	5.6 to 5.8 mm
