Health and Safety Executive

SHEFFIELD WEDNESDAY FC

Examination of Crush Barriers
Leppings Lane End Central Pen

Date of report 9th May 1989

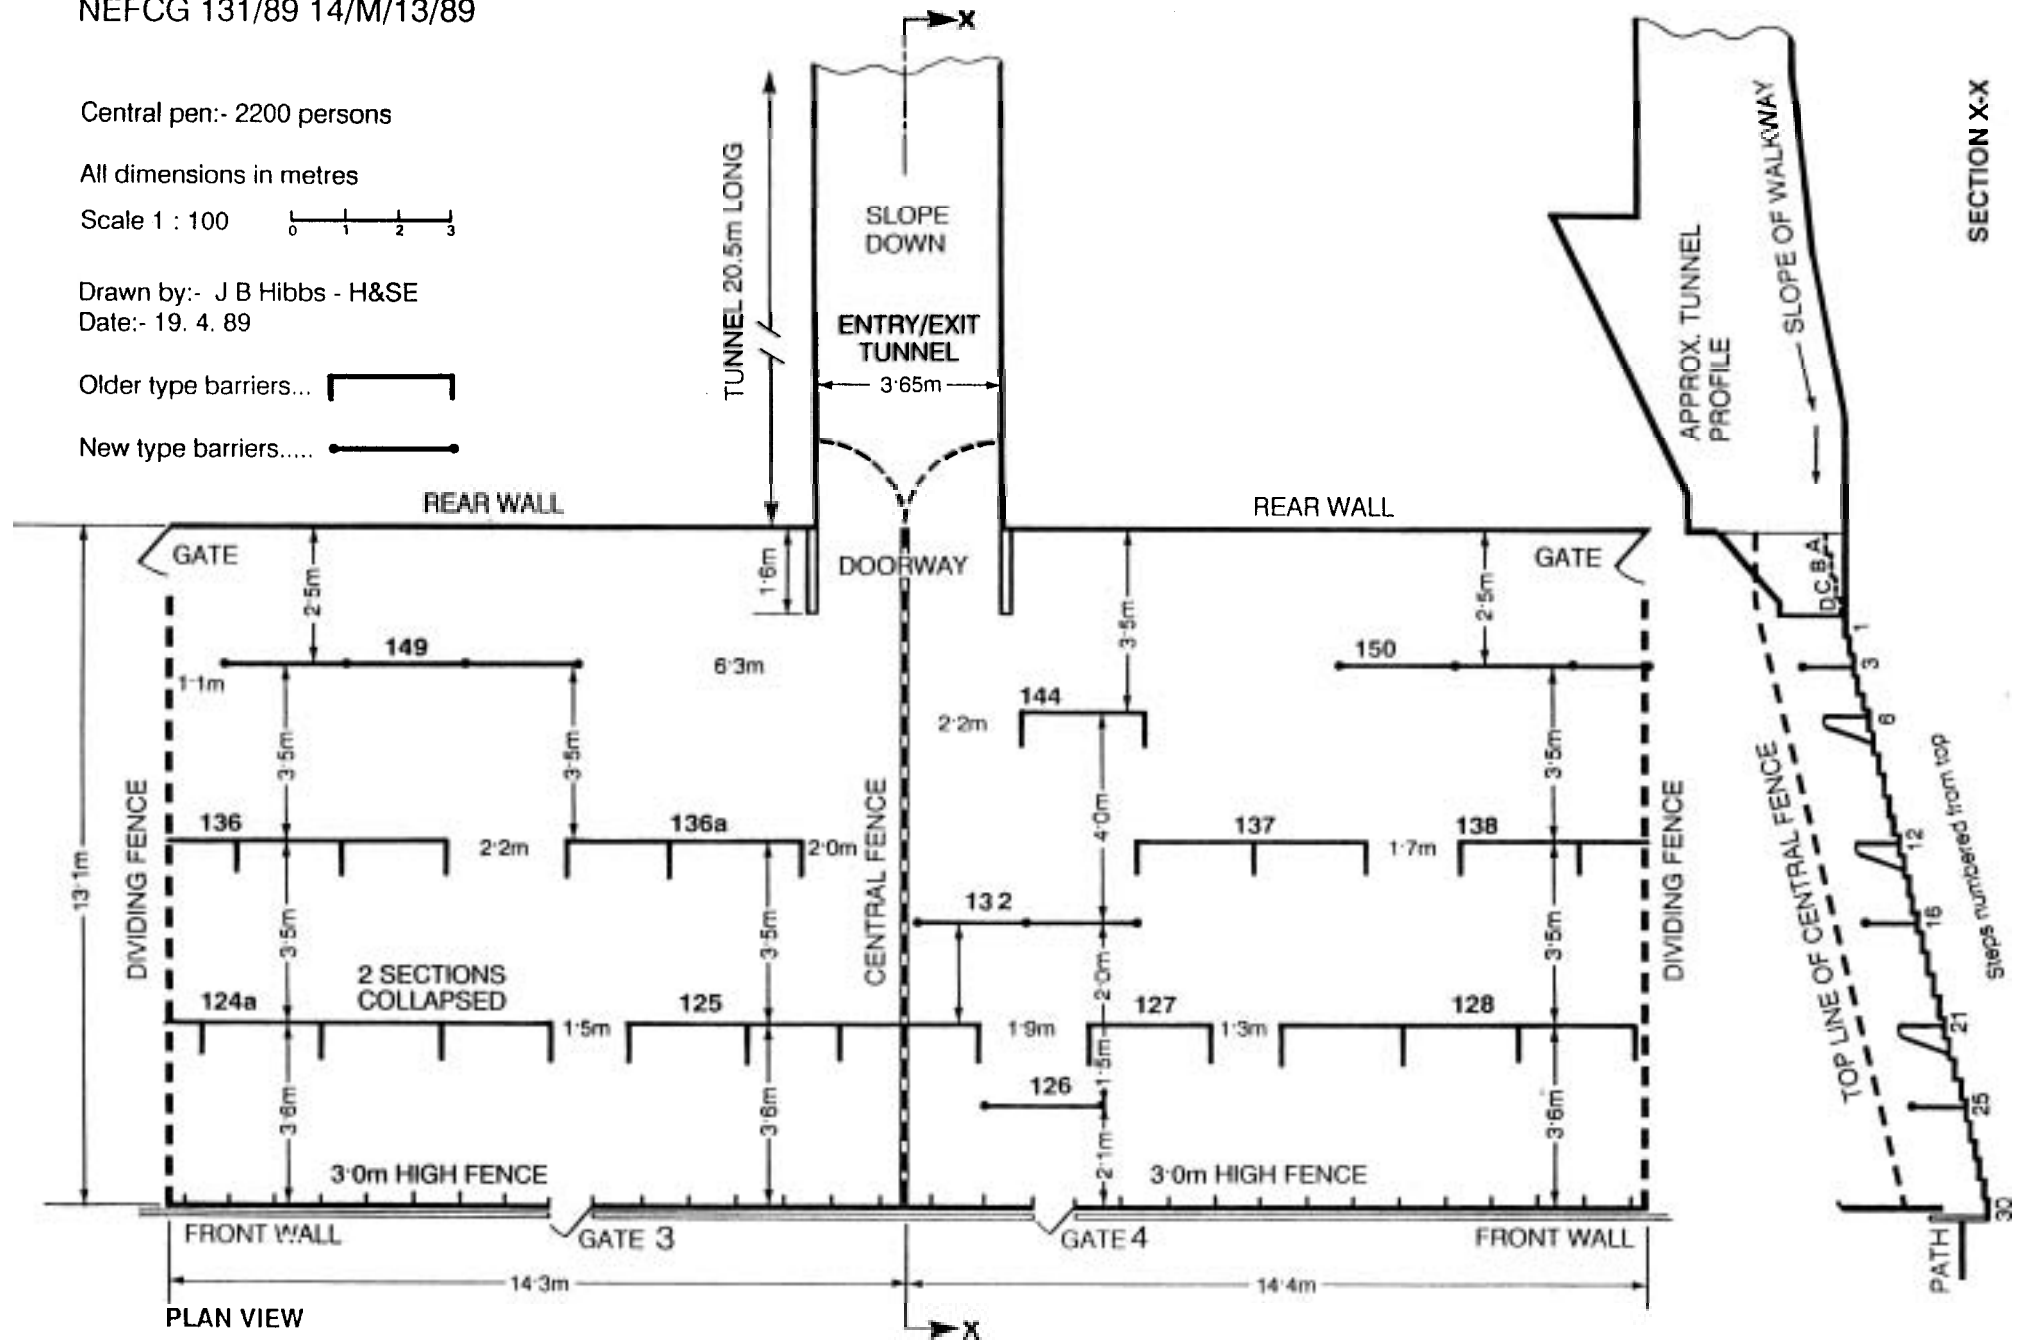
A site plan and end elevation is shown in Fig. 1 which also indicates spacings between barriers etc and confirms the position of the two sections which collapsed at barrier no. 124A. Similar details are also included in Ralph Brade & Associates Drawing No. 1340/02.

The site plan indicates that many of the barrier spacings were outside those recommended by the Code of Practice where it is suggested that gaps between barriers should not exceed 1.4 m width.

The slope of the terrace was found to be approximately 14 degrees and Table 1 on page 37 of the Code of Practice recommends a horizontal distance between barriers in peak viewing areas for the type 'A' barrier of 3.8 m at a terrace gradient of 15 degrees. Examination of the site plan confirms that in general the barriers were arranged within this figure and consecutive gaps between rows of barriers were in accordance with Fig. 3 on page 36 of the Code except at the areas immediately in front of the entry/exit tunnel area.

Where necessary the spacing of barriers should be adjusted to suit the recommendations given in the Code of Practice and additional barriers should be provided across the entry/exit tunnel opening area.

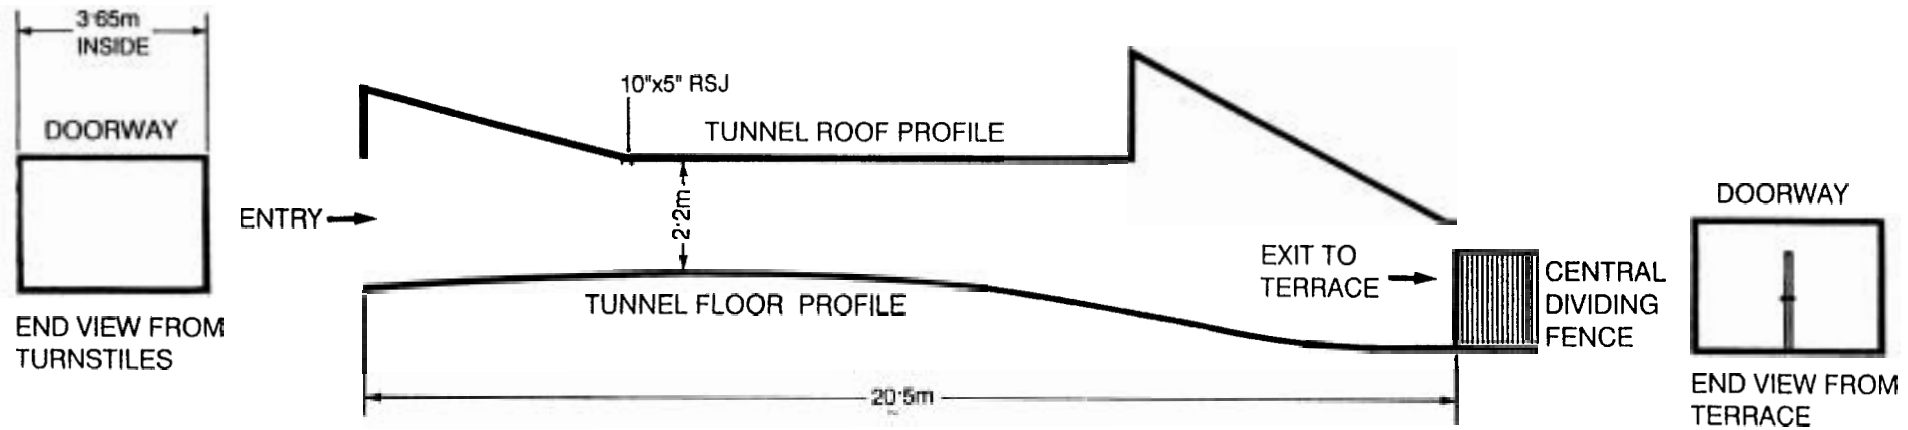
Fig.2 - Sheffield Wednesday F.C. Leppings Lane end. Tunnel to central pen
NEFCG 131/89 14/M/13/89

A sectional view of the entry/exit tunnel is shown in Fig. 2 and in Ralph Brade & Associates Drawing No. 1340/03.

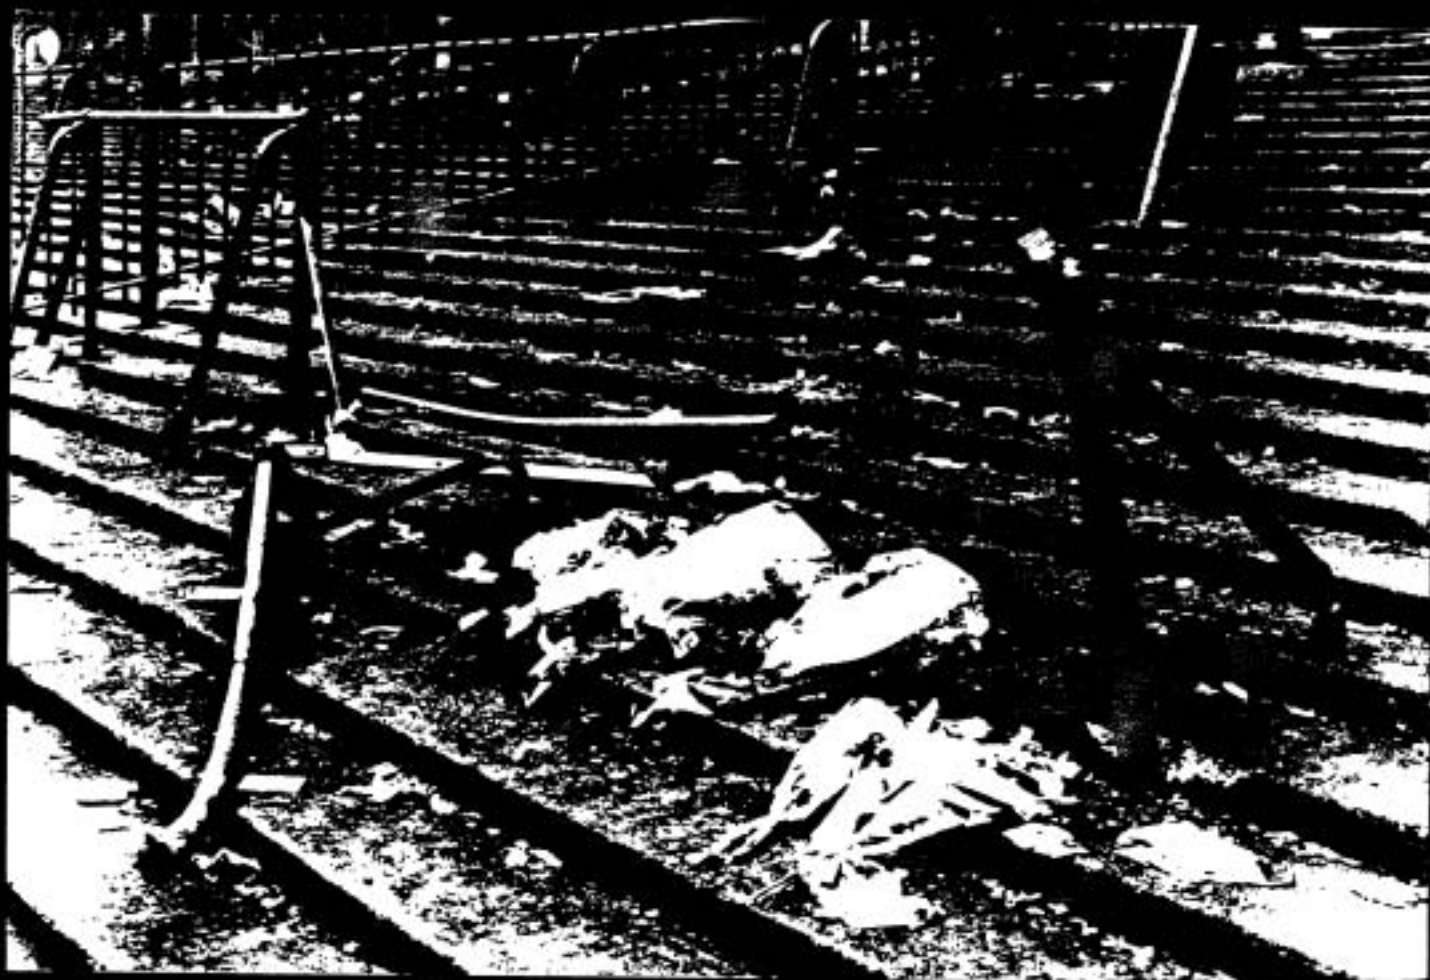
A general view of the collapsed section of barrier 124A is shown in Fig. 3 where it can be seen that both of the horizontal tubes had been severely bent prior to the bending over and collapse of the leg supports. The bottom ends of the latter had remained in position in the ground although the right hand front column at the end of the barrier had broken away a small section of the concrete step.

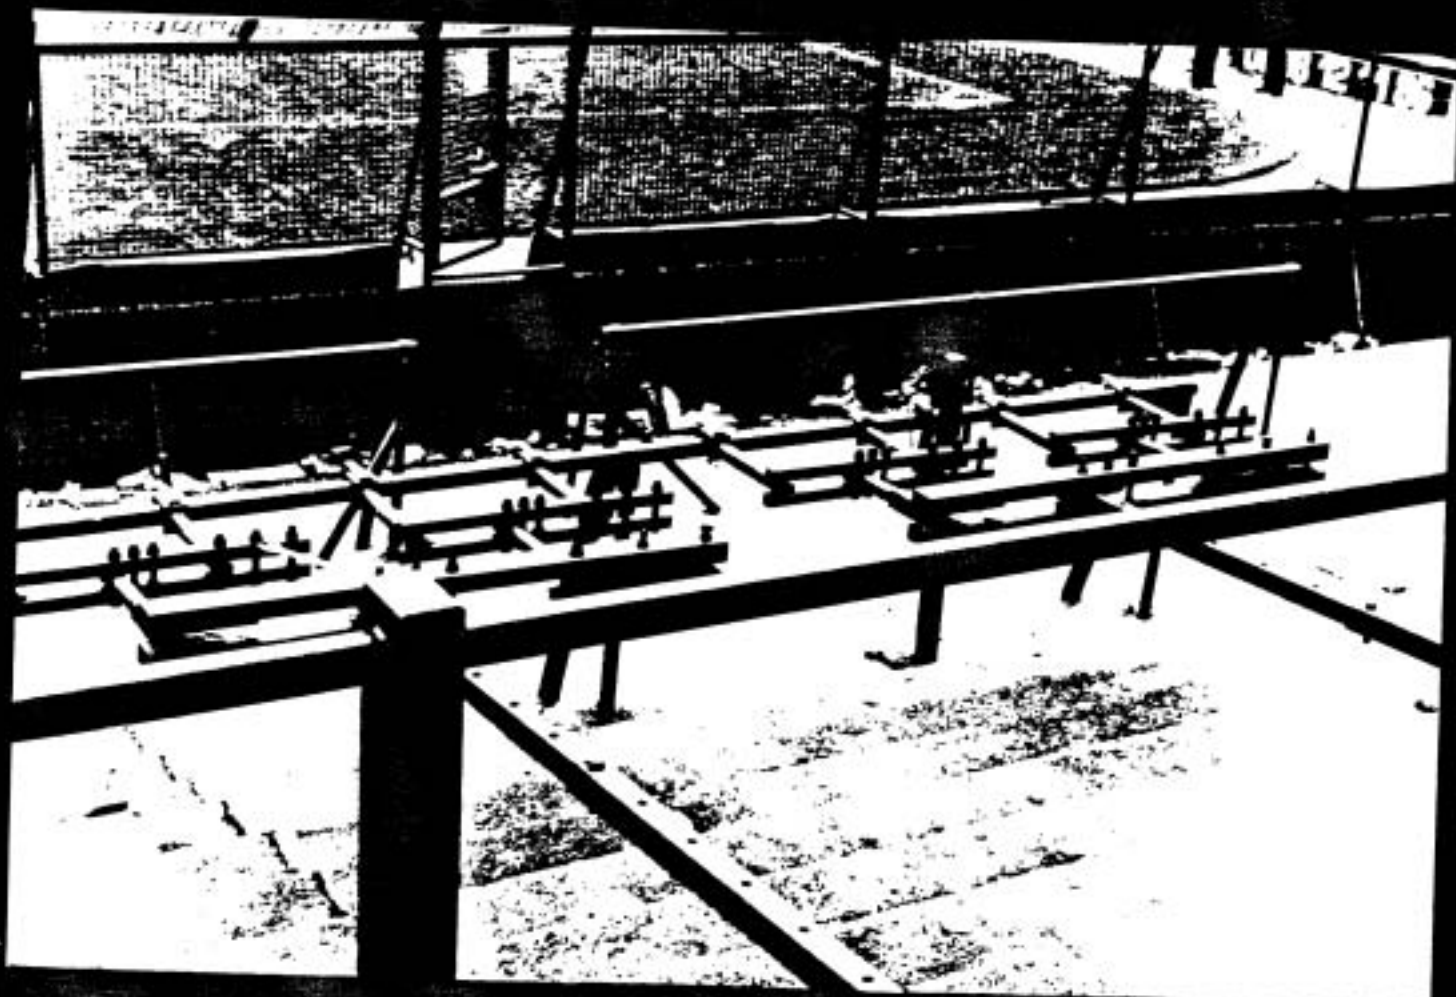
The tube which was originally in position between connections 124A/2 and 124A/3 is shown lying on the terrace steps in Fig. 7 and the fractures at the corresponding ends of this tube are shown in Figs 8 and 9 respectively. The grass at the left hand side of the fracture in Fig. 8 confirms that the tube was recovered from the pitch after the incident.

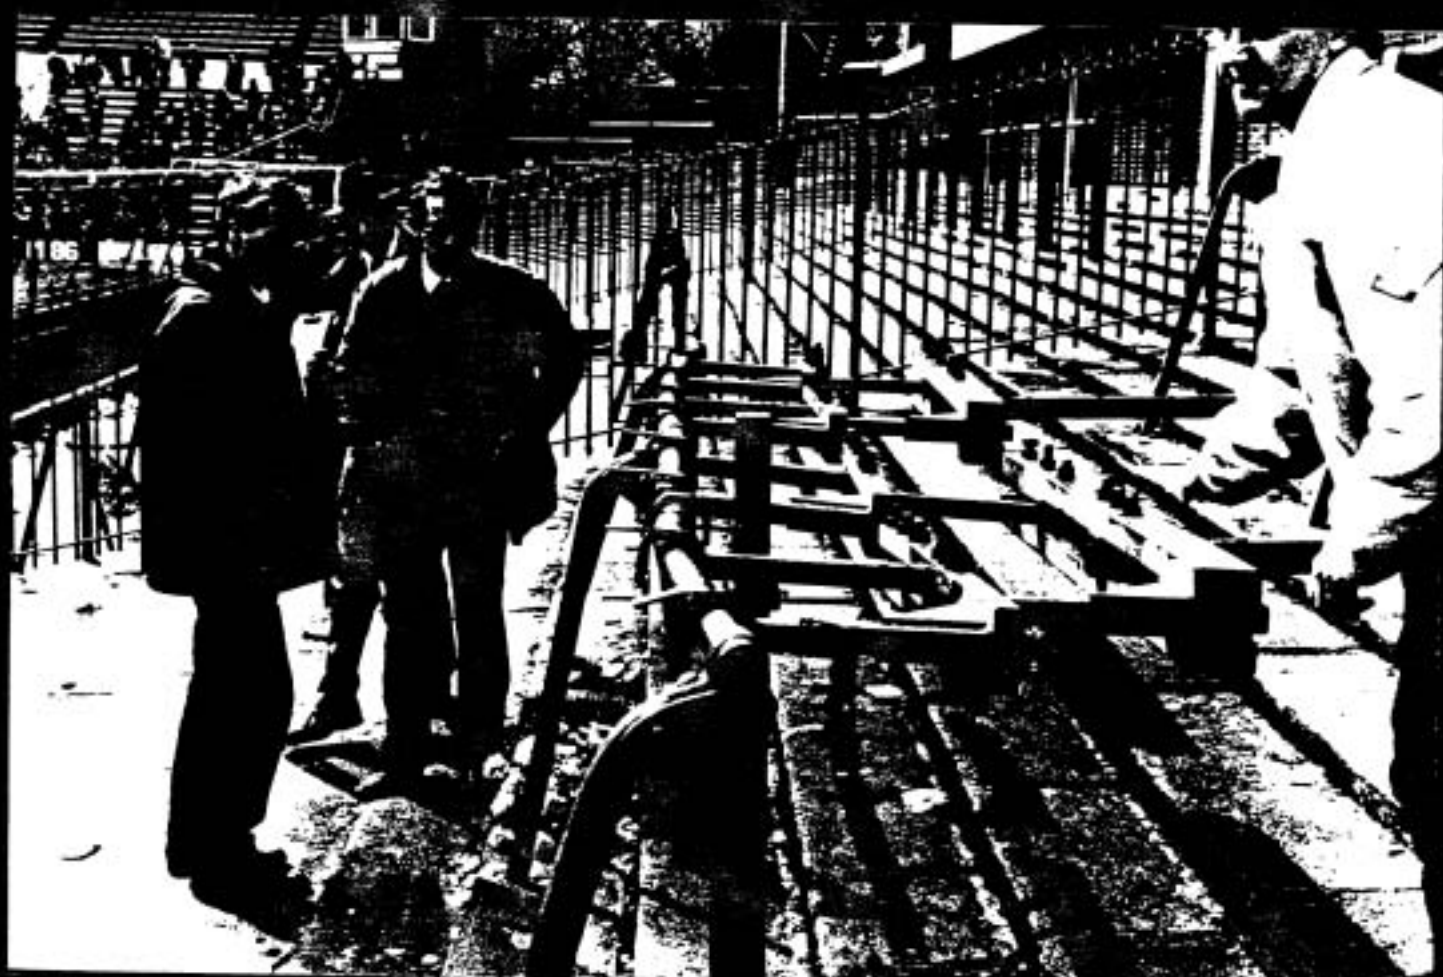
A further load was applied to this barrier to initiate its failure and at 500 lbs/ft run the deflection was 20 mm which gradually increased to 29 mm. The barrier recovered to 11 mm and had undoubtedly failed under this load. The condition of the barrier after this overload test is shown in Fig. 13. Initiation of fracture/tearing had been produced at the central leg immediately below the gusset plate and adjacent to the lower of the 2 rivets in the rear section of the leg as shown in Fig. 14. The commencement of twisting of the leg is shown in Fig. 15.

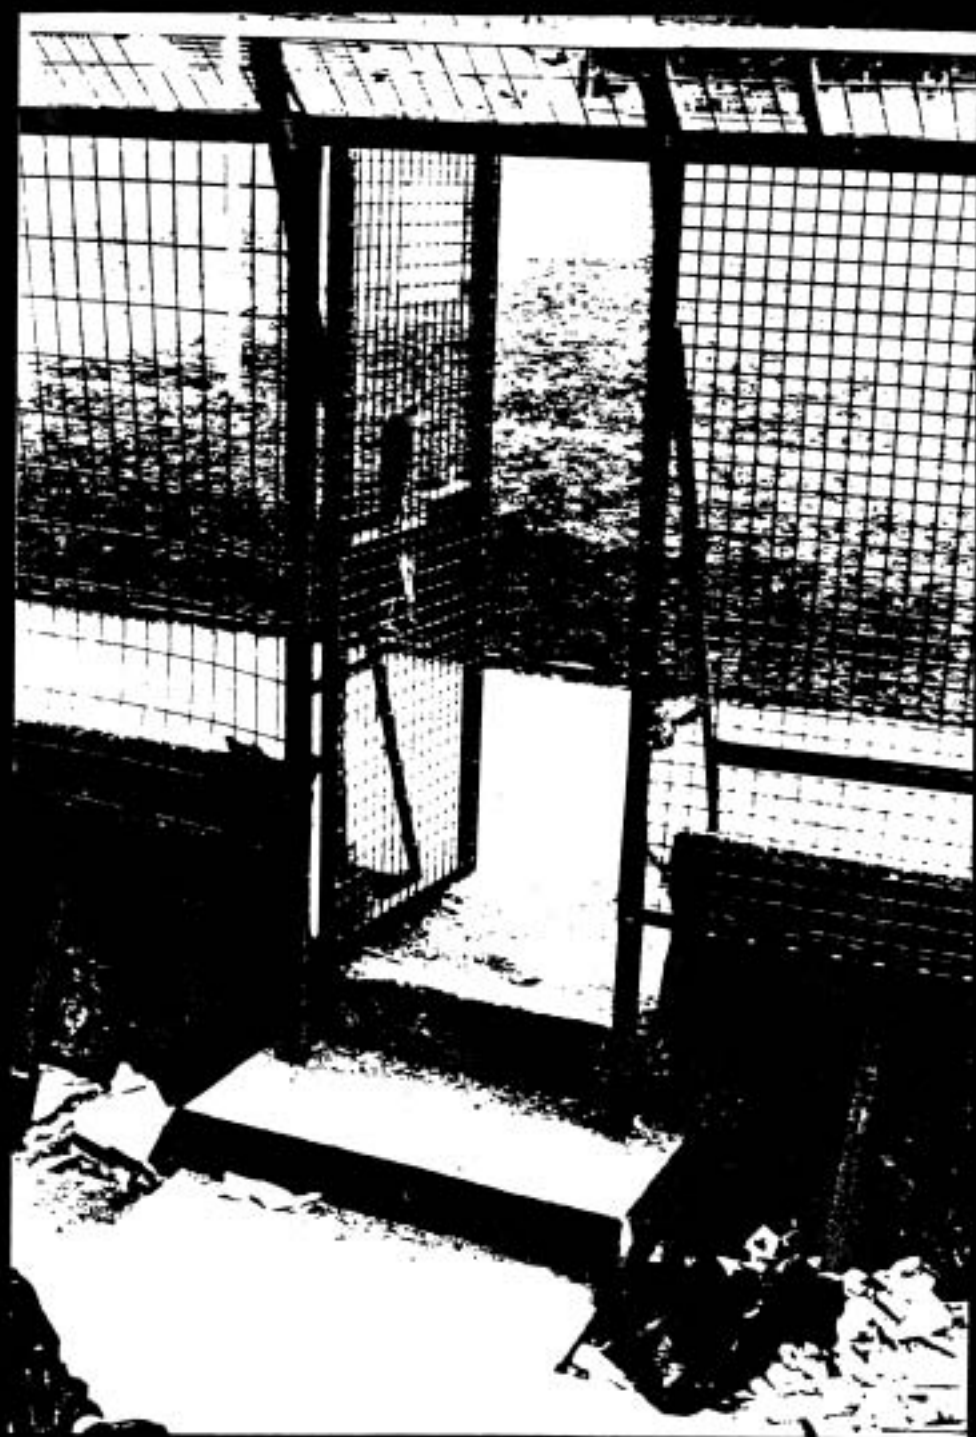
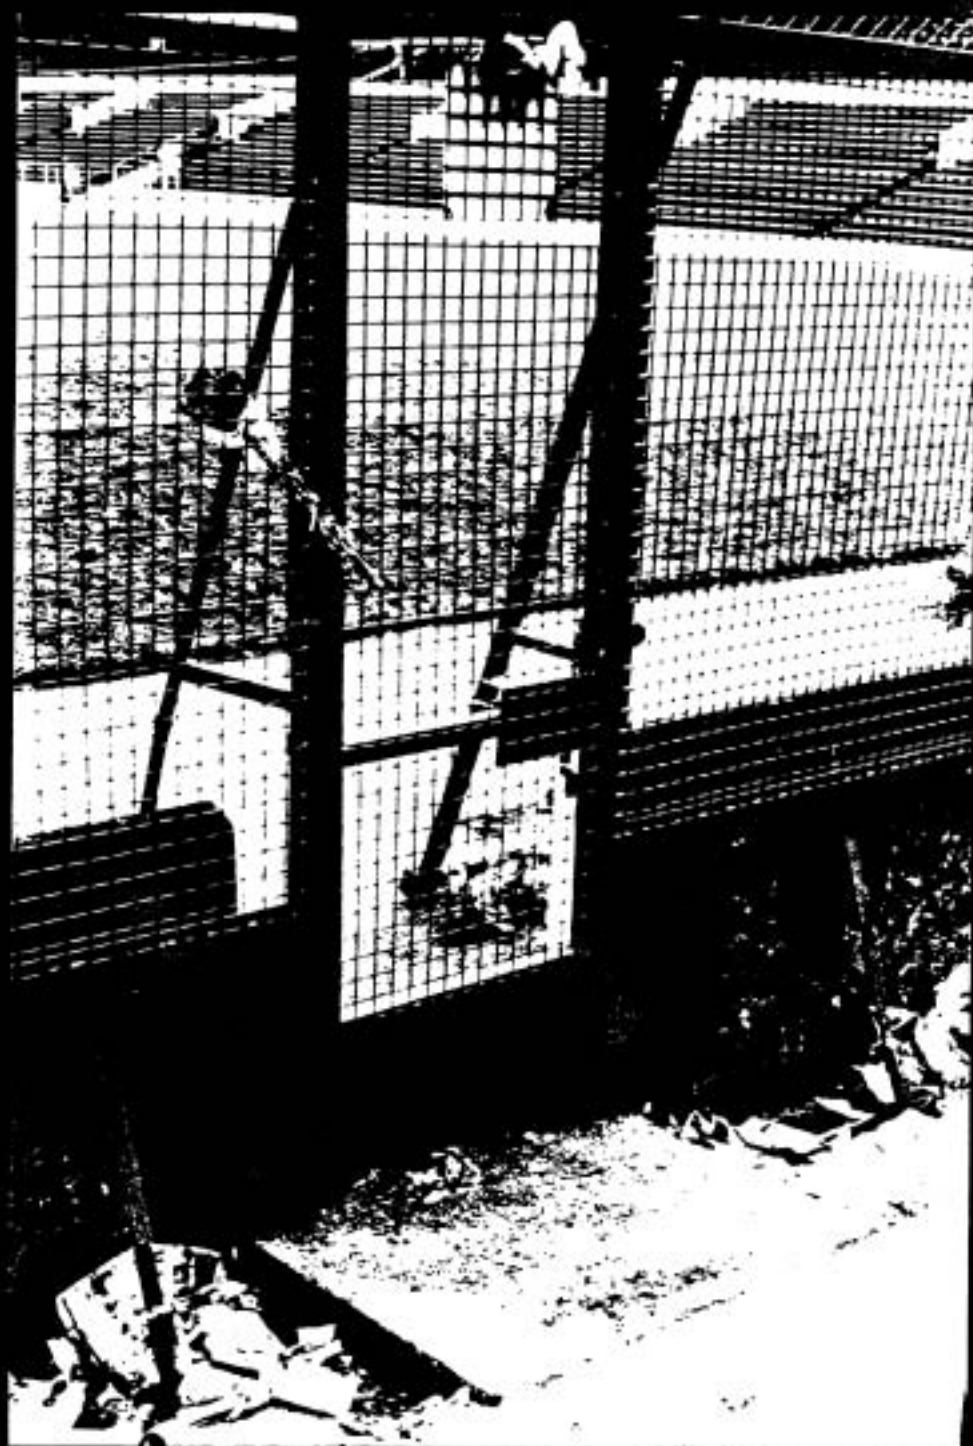
It was noted that the step configurations at the two gates were slightly different. Both level concreted approach areas (plinths) commenced at the third terrace step level but at gate 3, two risers of 0.165 m (6.5 inches) and 0.22 m (8.6 inches) with an intermediate tread of 0.480 m (19 inches) were seen. (See FIGS 16, Negs ^{44 & 45} ~~8904-106/38~~). The approach plinth at gate 3 was found to be 1.185 m (46.75 inches) wide and the step-up from the lowest terrace step at each side was 0.340 m (13.5 inches high).

At gate 4 the level concreted approach area (plinth) again commenced from step 3 of the terrace and extended forwards to the wall by a distance of 0.86 m (34 inches) to a single step up through the gateway which was 0.340 m (13.5 inches) high. The concreted plinth area to gate 4 was 1.125 m (44.25 inches) wide and the step-up from the lowest terrace step at each side was approximately 0.190 m (7.5 inches). See FIGS 17 - 19 which confirm the step arrangements at gate 3 and 4.
