Low-Cost and Low-Tech Reinforcement Systems for Improved Earthquake Resistance of Mud Brick Buildings

Dominic M. Dowling and Bijan Samali

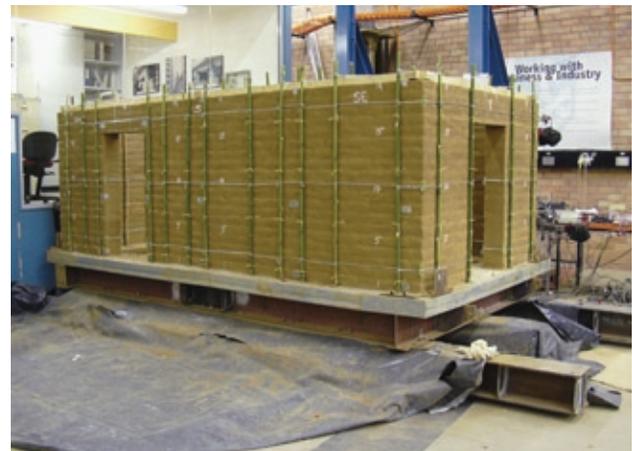
FIGURE 2 Model house 4A prior to testing; south and east walls are visible.

A model house (1:2 scale) was constructed, retrofitted, and tested on the UTS shake table (fig. 2). Its dimensions were 3.53×1.84 m (11.6×6.0 ft.), with a wall thickness of 0.15 m (5.9 in.) and a height of 1.2 m (3.9 ft.). The model house featured two doors and one window; the direction of shaking was north-south, perpendicular to the long walls.

The sequence of construction and retrofitting of the model house was: (1) construct unreinforced house and allow to dry; (2) mark and drill holes in rows at top, middle, and bottom of each wall; (3) insert polypropylene string loops through holes; (4) fill holes with mud, allow to dry; (5) place timber ring/crown beam on top of wall and connect with bamboo dowels

and wire; (6) place external vertical bamboo (inside and outside house), tied with through-wall polypropylene string ties; (7) place and tension galvanized fencing wire horizontally between bamboo poles (top, middle, and bottom); and (8) connect bamboo poles and ring beam with wire loops.

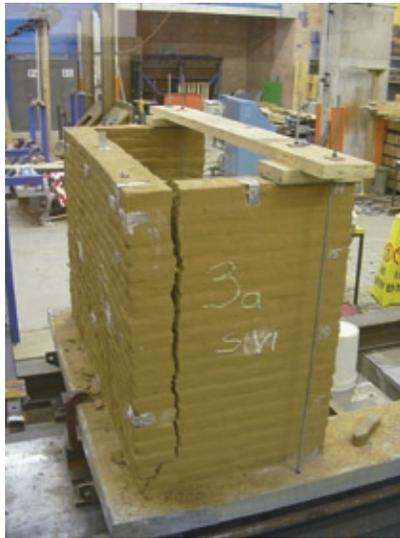
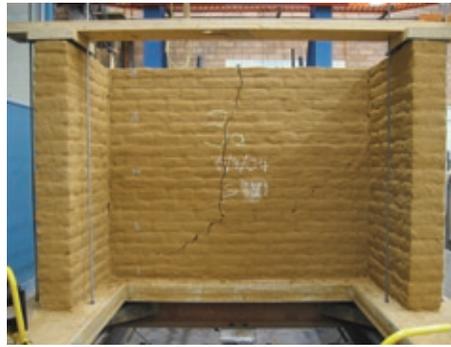
FIGURES 3A AND 3B Specimen 3A after simulation S6 (75%). The in-plane wall and corner connection (a) and the out-of-plane wall (b) are shown.

Specimen 3A represented a common, unreinforced adobe structure. Sudden, brittle failure occurred during the moderate, 75% intensity simulation, S6 (figs. 3a and 3b). The primary failure modes for the unreinforced

specimen 3A (and lightly reinforced specimens 3B, 3C, and 3D) were: (1) vertical corner cracking at the intersection of orthogonal walls; (2) midspan vertical cracking in the out-of-plane long wall; and (3) horizontal and diagonal cracking in the out-of-plane long wall, with a propensity for overturning of the affected panel. These damage patterns are consistent with common damage to real houses subjected to real earthquakes. This feature confirms that the selected specimen configuration, boundary conditions, and input spectra

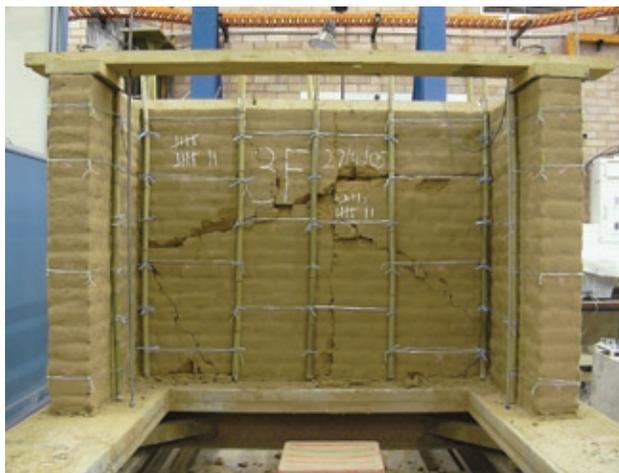
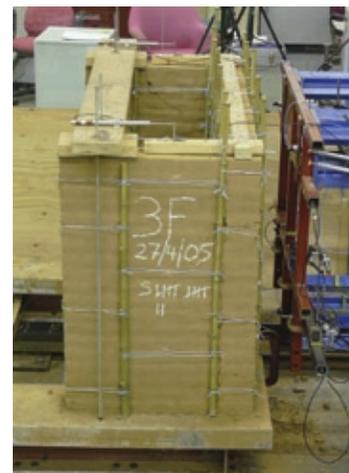
FIGURES 4A AND 4B Specimen 3F after simulation S12 (100% repeated). The out-of-plane wall (a) and the in-plane wall and corner connection (b) are shown.

Specimen 3F was built as a common, unreinforced structure (as was specimen 3A); it was then retrofit-strengthened with external vertical bamboo poles, external horizontal fencing wire, and a timber ring beam (using the same procedure as described above for the model house). Specimen 3F performed extremely well. The reinforcement system was

observed to delay the onset of initial cracking and reduce the severity of cracking, even during the series of high-intensity simulations (figs. 4a and 4b).

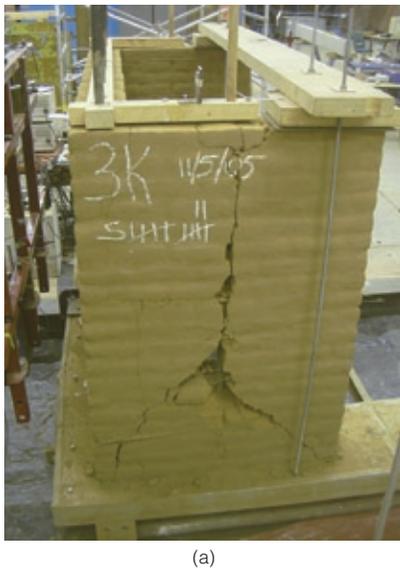
FIGURES 5A AND 5B Specimen 3K after simulation S12 (100% repeated). The in-plane wall and corner connection (a) and the out-of-plane wall (b) are shown.

Specimen 3K included internal vertical reinforcement (25 mm [1 in.] diameter timber broom poles), plus internal horizontal chicken wire mesh reinforcement. This method and derivations thereof have been widely promoted as an effective earthquake strengthening

Concerns also exist about the durability of the natural materials commonly used as internal vertical reinforcement (e.g., bamboo, reeds, timber), which cannot be checked or replaced when encased in the structure. Despite these practical limitations, specimen 3K performed well during testing (figs. 5a and 5b). The reinforcement acted to reduce the severity of cracking, although it was observed that the internal vertical poles introduced discontinuities to the structure, evidenced by vertical cracking concentrated

around the location of the vertical poles. This feature may be attributed to a difference in dynamic response between the stiff adobe wall and the flexible timber poles, as well as the reduced cross-sectional area of the wall around the poles.

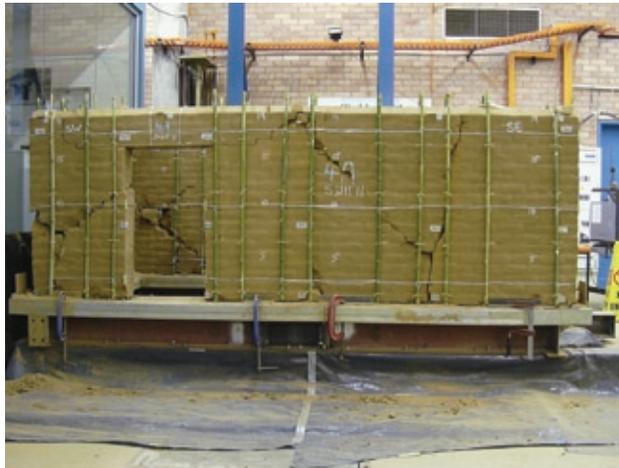
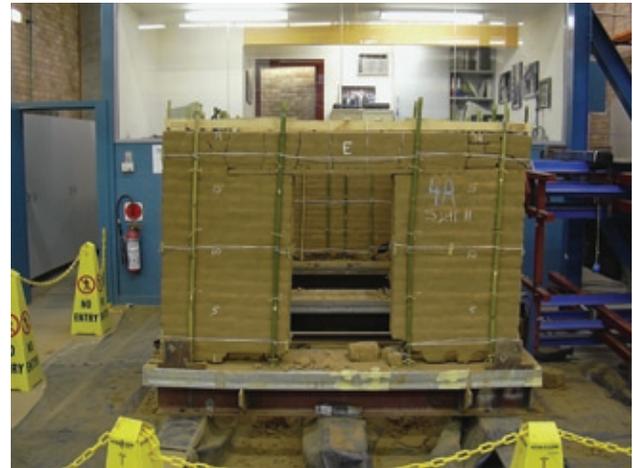
FIGURES 11A AND 11B Model house 4A: damage after simulation S8 (shakedown). The south wall (a) and the east wall (b) are shown.

house 4A increased during subsequent simulations. Figures 11a and 11b show the condition of the house after simulation S8 (shakedown). Despite being severely damaged, the structure resisted collapse, even after the series of severe earthquake tests.

The reinforcement system acted as a netting to contain the structure, even after significant damage. Cracking was distributed around the structure, with major damage occurring around the window and door openings. Vertical cracking at the corner intersections was largely prevented. This represents a major positive
