Technical issues and energy efficient adaptive reuse of heritage listed city halls in Queensland Australia

Journal:	<i>International Journal of Building Pathology and Adaptation</i>
Manuscript ID	IJBPA-02-2018-0020.R3
Manuscript Type:	Original Article
Keywords:	heritage city halls, adaptive reuse, climate change, technical issues, energy efficiency

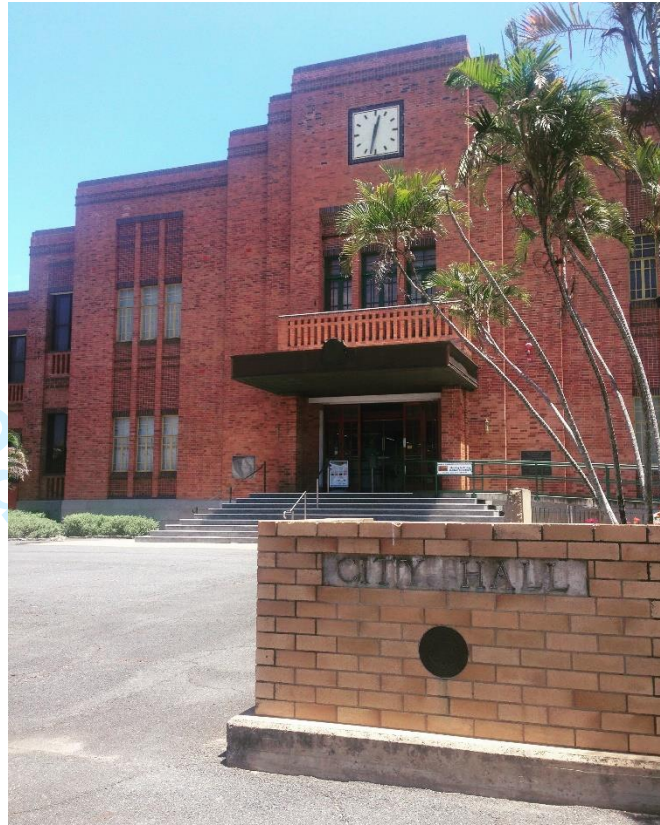
38
39
40 *Figure 1*

29
30 This hall was constructed from 1939 to 1941 using brick and concrete on a granite base (Figure
31 1) (Maryborough Chronicle, 1938). The building was analysed based on archival sources
32 including the Conservation Management Plan, on-site observation and research and interviews.
33 The interviews were conducted with the architect, Project Officer Communities and Facilities,
34 and the Coordinator Facilities who were experienced and knowledgeable about the adaptation
35 of the building and its challenges.
36
37

Figure 1 Rockhampton City Hall, 2017 (Source: Author)

41
42
43 The design of the original building was based on natural light and ventilation, with external
44 verandas around the building. However, subsequently the verandas were enclosed and
45 converted to office spaces. Cook (2017b) stated that provision of natural lighting and
46 ventilation in the original design were important features in terms of energy efficiency;
47 however, these aspects were no longer supported after the installation of walls and a mezzanine
48 floor in the reception hall, enclosing of the verandas, the construction of solid partitions, and
49 the rearrangement of original partitions (Cook, 2017b). These alterations led to the provision
50 of technical building services such as air conditioning and upgrading of lighting systems. The
51 technical adaptation of the building resulted in some technical challenges shown in Table 2
52 (Blake, 2008).
53
54
55

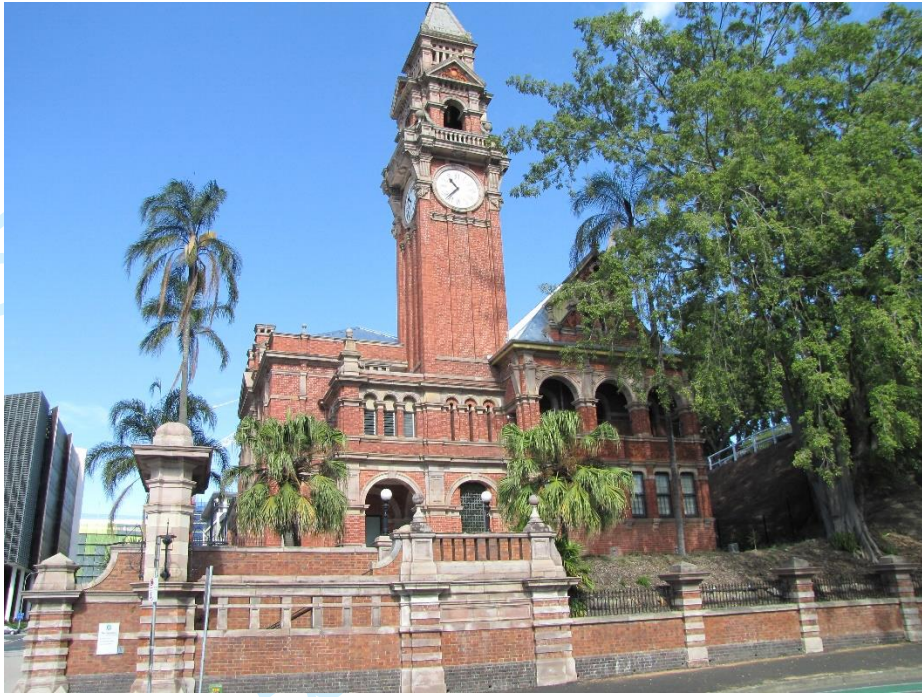
52 *Figure 2*

45 The two storey building was constructed in 1891-92 of red brick, sandstone, and marble in the
46 free classical style known as Italianate Classical Revival (Figure 2) (The Queensland
47 Government, 2016a). The building was analysed through archival research, on-site research,
48 reference to the Conservation Management Plan, and an interview with the archivist.
49
50
51

Figure 2 South Brisbane Municipal Chambers, 2017 (Source: Author)

53
54 The chambers were designed mostly based on daylighting and natural ventilation. The lighting
55 of the staircase was provided by a very large window and the council chambers had three large
56 windows providing daylighting (The Brisbane Courier, 1892). However, in its conversion to
57 the Conservatorium of Music during the 1950s, the alteration works involved demolition of
58 interior walls and installation of mechanical air ventilation and soundproofing of doors and
59 windows (The Courier Mail, 1955). Air-conditioning equipment was installed and located in
60

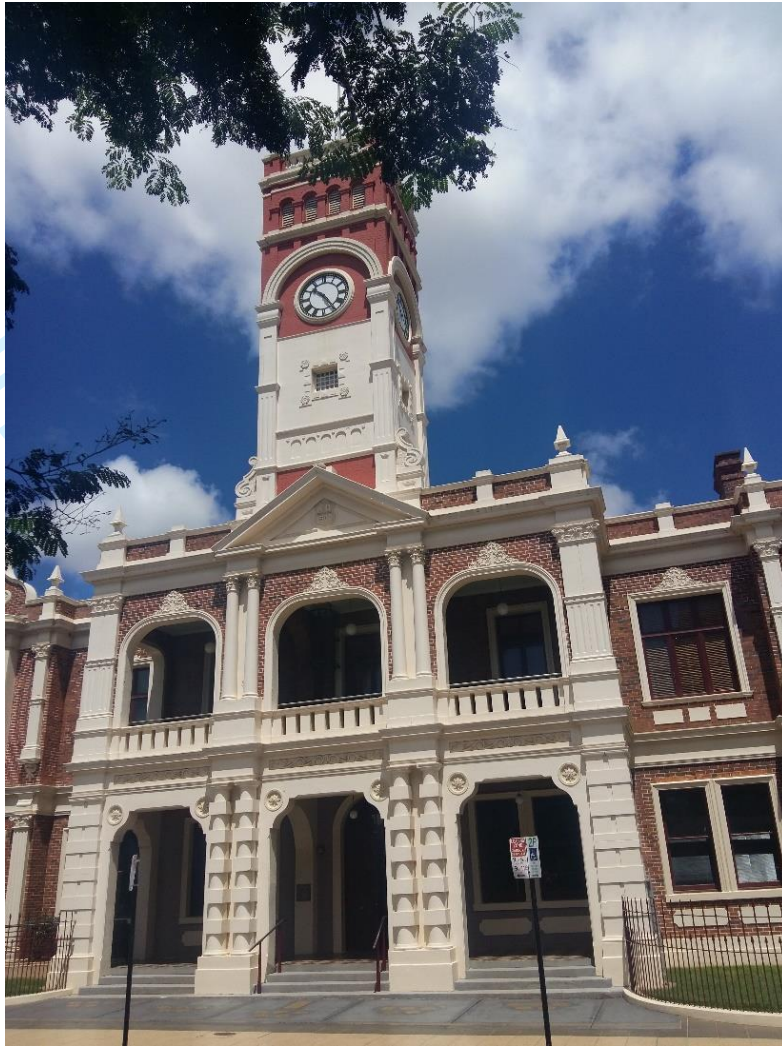
48 *Figure 3*
49
50

41 This two-storey brick structure, constructed in 1900, is located in the Darling Downs/ South
42 West Queensland (Figure 3) (L Marquis, 1992). The building was analysed through archival
43 research, on-site research, reference to the Conservation Management Plan, and interviews
44 with the architect, project manager and engineer.
45
46
47

Figure 3 Toowoomba City Hall, 2017 (Source: Author)

51 This building underwent alterations and additions over-time due to different requirements and
52 standards. During the mid-1930s, the need to upgrade the theatre arose, when local musical and
53 theatrical groups complained the ventilation did not work (L Marquis, 1992). Although the
54 building was designed to work with the climate using available technology at the time, it was
55 not successful in satisfying occupants over time and needed upgrading based on user demands.
56 During the 1937 refurbishment, the ventilation was improved and skylights were installed to
57 light the art gallery and main stairs (The Queensland Government, 2016b). This enabled the
58
59
60
