Application of the damage index method for plate-like structures to timber bridges

B. Samali^{*,†}, J. Li, F. C. Choi and K. Crews

Centre for Built Infrastructure Research (CBIR), Department of Civil and Environmental Engineering, Faculty of Engineering and IT, University of Technology Sydney, PO Box 123, Broadway, NSW 2007, Australia

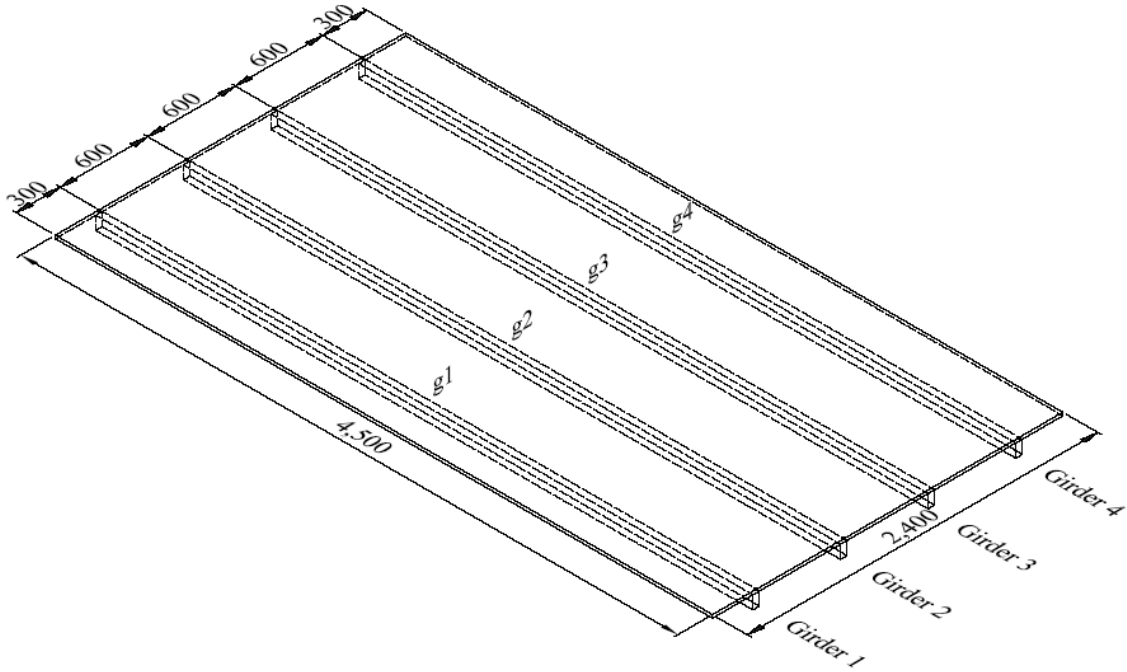
Figure 1. Geometric configuration of the laboratory timber bridge.

A four-girder laboratory timber bridge was built in the laboratory to verify the damage detection method for timber structures. The basic dimensions of the structure are shown in Figure 1. The bridge consisted of four girders of treated radiata pine sawn timber measuring 45mm x 90mm in cross section with a span length of 4.5m. The deck consisted of four pieces of 21mm thick x 2.4m wide and 1.2m long structural plywood of grade F11. The deck and girders were connected using 50mm self-tapping screws with 137.5 mm spacing. No gluing was applied in order to avoid fully-composite action, to simulate the interactions in a real timber bridge. The longitudinal modulus of elasticity (MOE) was determined using four-point bending test for each of the four girders and the deck. This was done in order to select timbers that have similar material properties and used for material property input in the finite element models. The moisture content was estimated to be around 7-8% for the beam and was around 11-12% for the plywood using a wood moisture detector. The ends of the bridge girders were supported on concrete blocks, and rigidly connected to the strong floor. A specially designed support system as shown in Figure 4 was used between girders and the concrete block to ensure a well-defined boundary condition that is very close to a pin-pin condition. The full bridge model is depicted in Figure 7. The laboratory timber bridge, namely, Deck2, was used to designate the undamaged state as denoted by D2. The results form the basis of comparison for various damage cases utilising the extracted modal parameters and their derivatives.

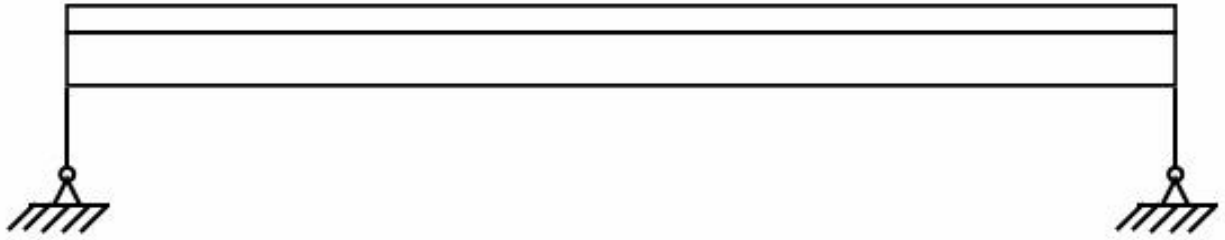
Figure 3. Modelling of bridge supports.

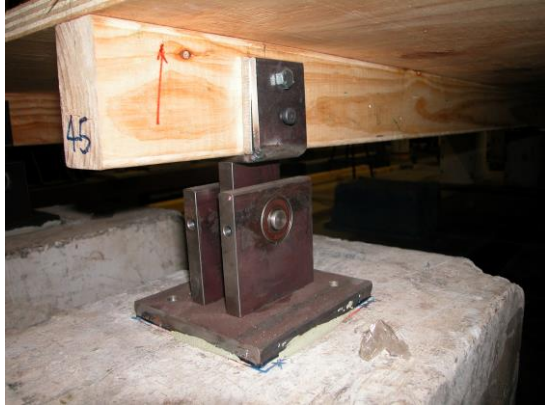
Figure 4. Fabricated pin support.

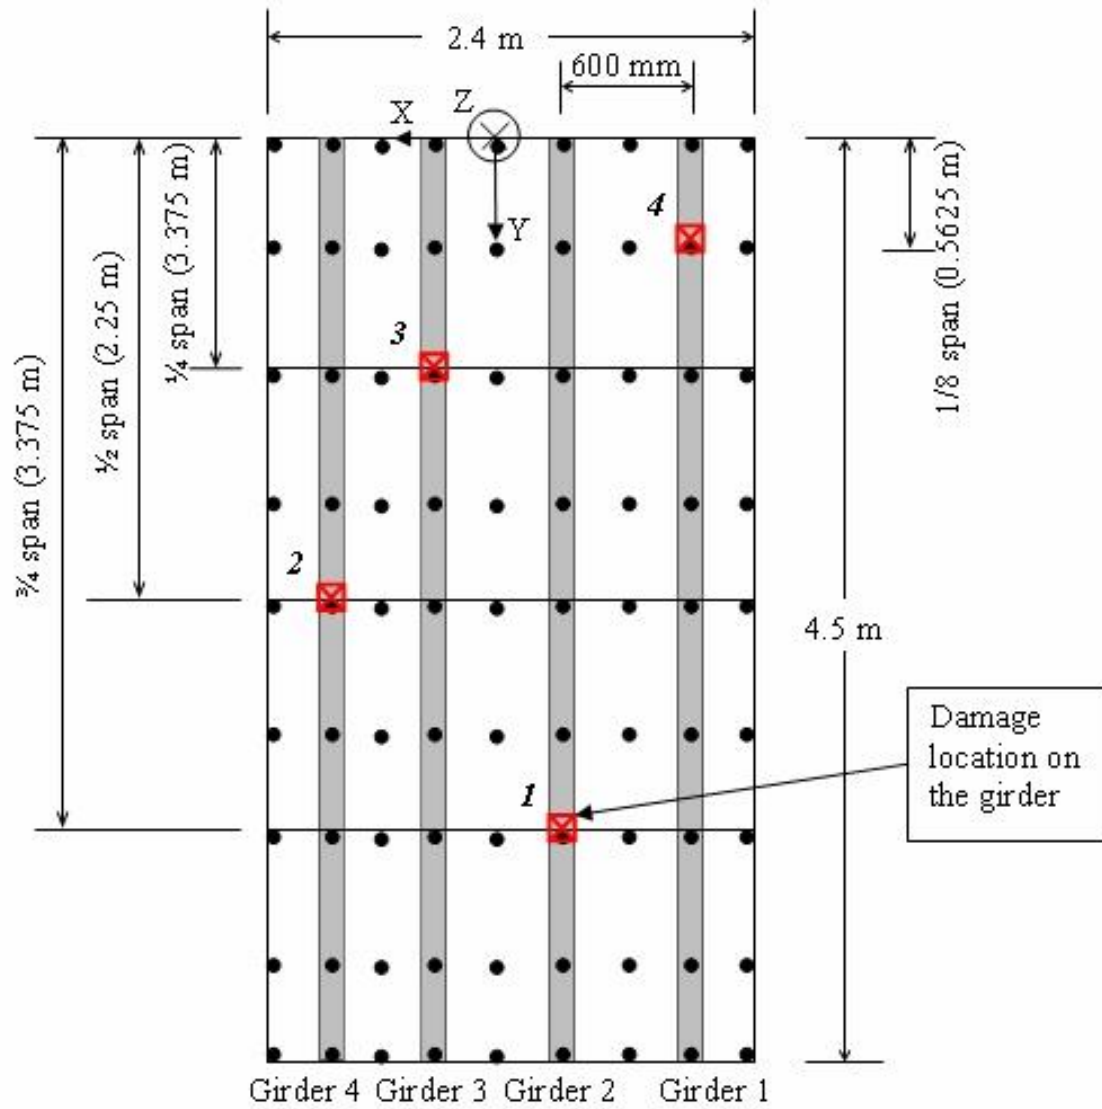
Figure 5. Plan view of damage locations on the bridge model.

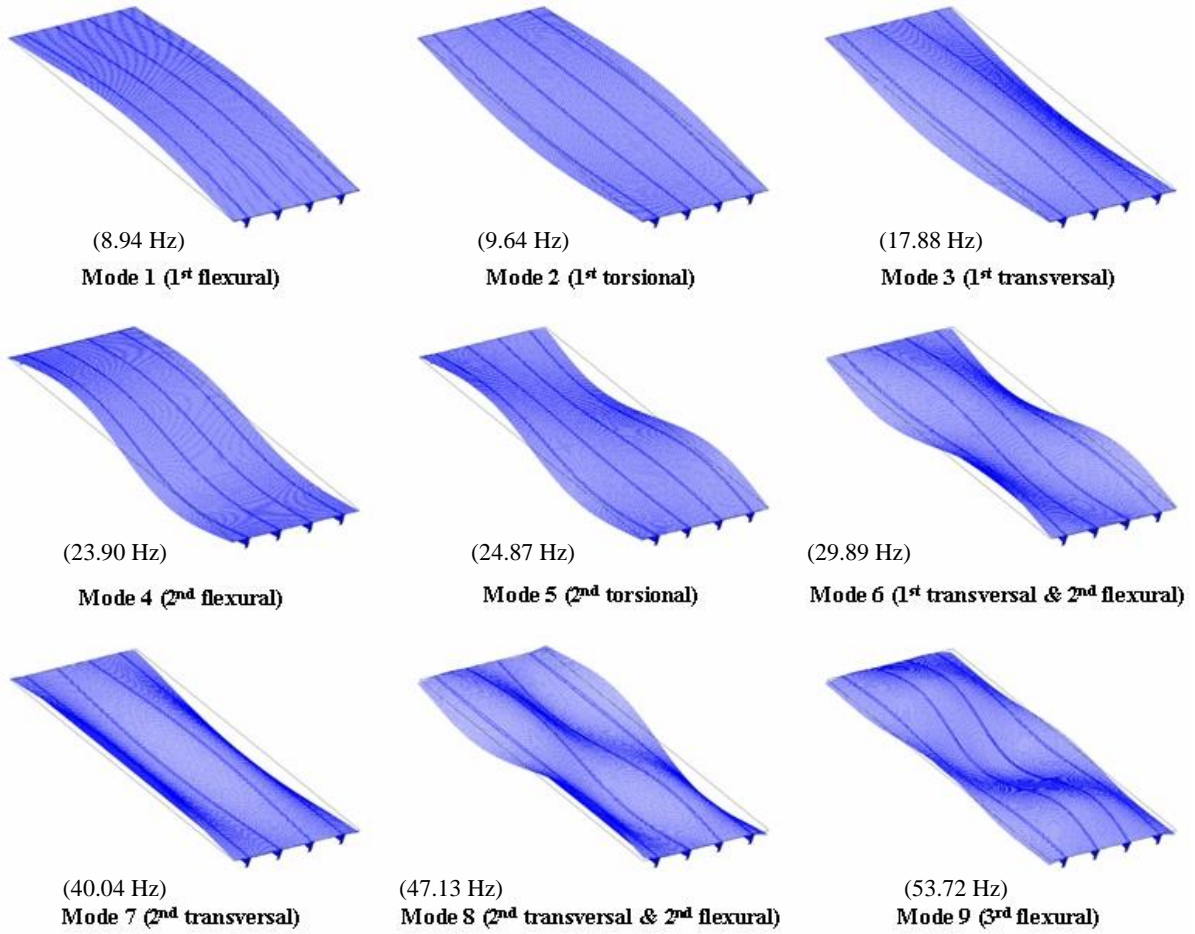
Figure 6. Nine vibration mode shapes of the laboratory timber bridge FE model.

and ‘severe’ corresponding to 27.1%, 65.7% and 87.5% loss of ‘I’ (moment of inertia), respectively. The nine mode shapes extracted from the FE model are shown in Figure 6. In this paper, a few selected damage cases (as highlighted in Table 1) are presented to demonstrate the results of damage detection using the modal based damage detection method.

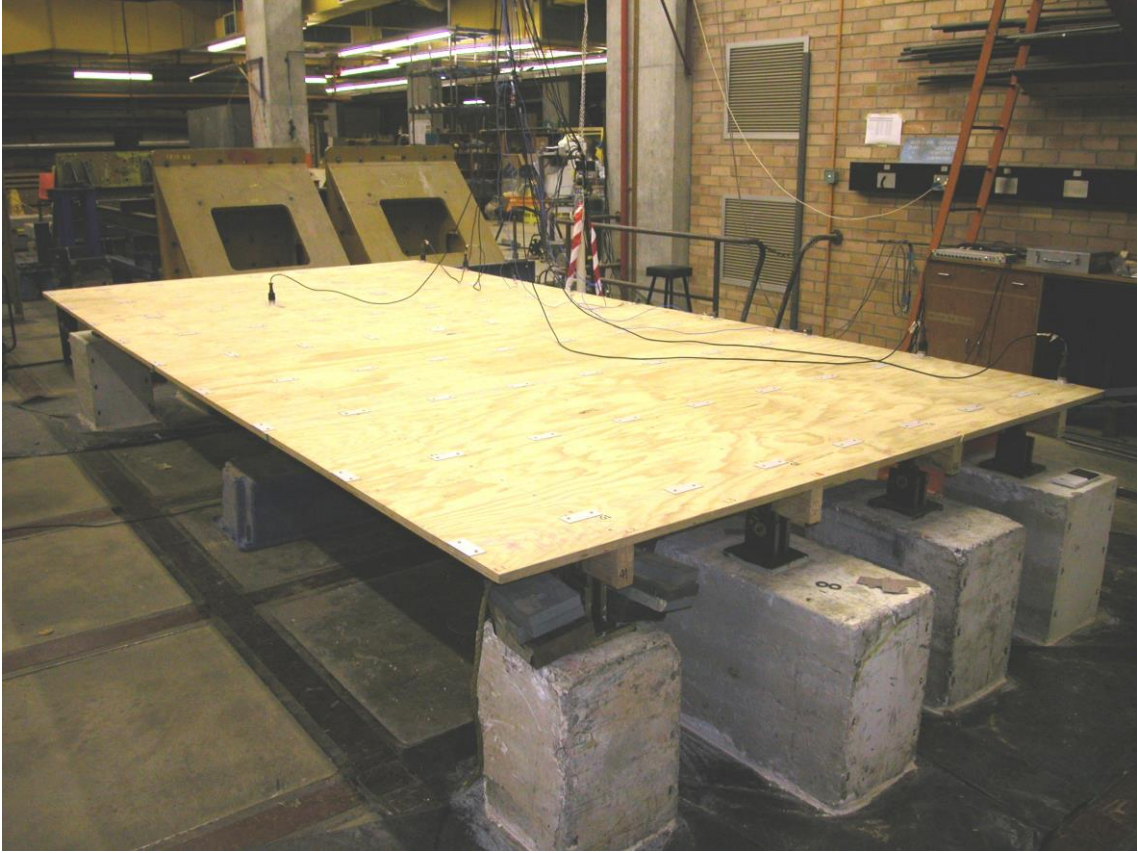
Figure 7. The laboratory timber bridge.

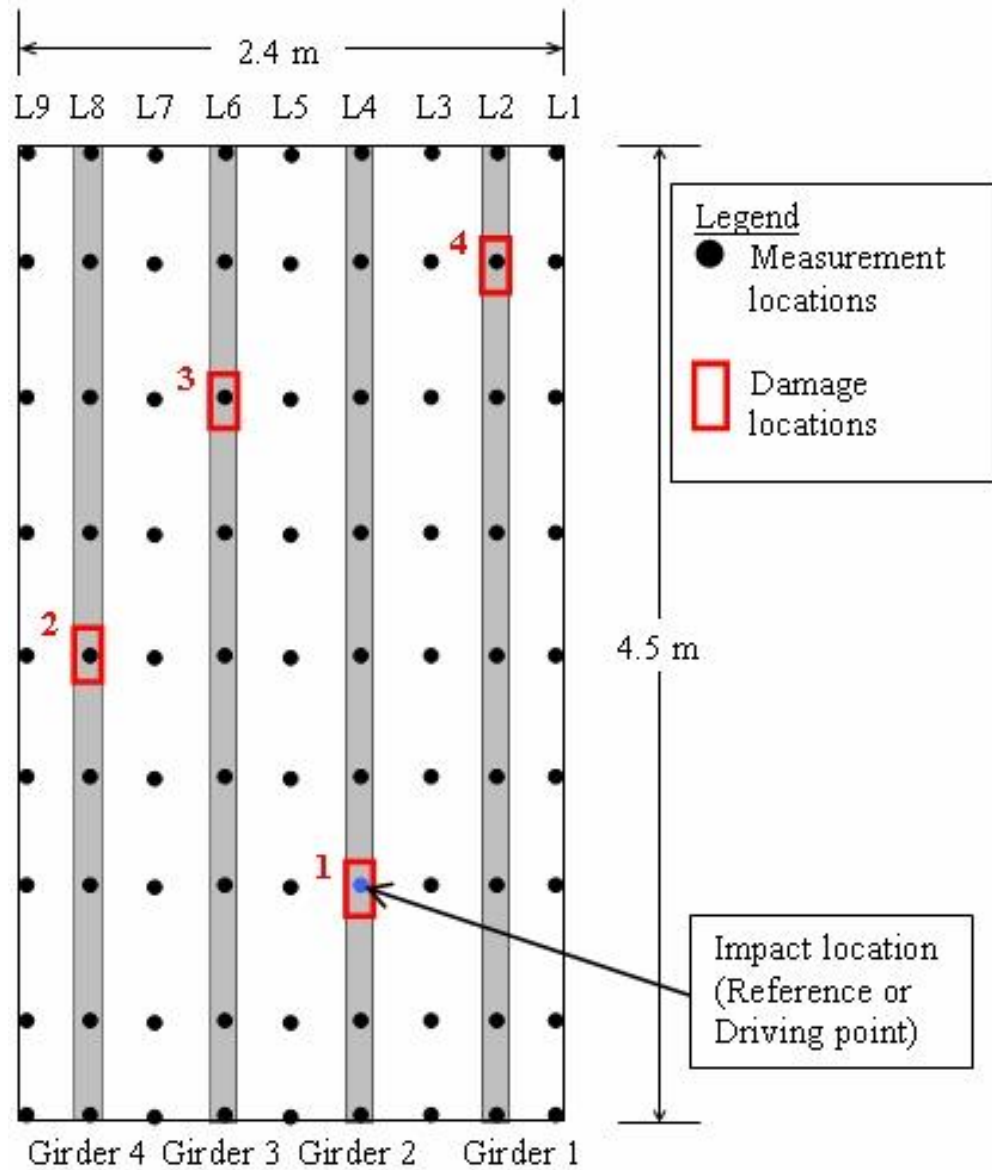
Figure 8. Plan view of damage locations and measurement locations on the bridge.

The inflicted damage cases considered for the experimental studies are described in Table 1 and Figure 8. The three inflicted damage severities are shown in Figure 9. In this paper, similar damage cases correspond to the numerical studies in order to demonstrate and correlate the damage detection results.

The system identification method used in this study employs an impact modal hammer to excite the test sample at the reference or driving point as shown in Figure 8. The impact location (reference or driving point), at 3/4 of the span length and directly located above girder 2 (g2), is a strategic location and can excite more modes simultaneously. The response signal along the span

was recorded using nine low impedance piezoelectric accelerometers and one stationary accelerometer was used at the driving point. For the laboratory timber bridge, there were 81 measuring points as depicted in Figure 8. Due to limited number of sensors available, the data acquisition for the 81 points was done in 9 tests. The nine non-stationary accelerometers were moved from line-to-line, i.e., from line 1 (L1) to line 9 (L9) as illustrated in Fig. 8, until all measurement locations were covered. These accelerometers were used to measure the acceleration response on the top surface of the laboratory timber bridge as illustrated in Figure 10. The nine measurement points per line were deemed sufficient for accurate reconstruction of mode shapes using interpolation techniques. The driving point measurement ($3/4$ of span length on L4 or girder 2 (g2), refer to Figure 8) enabled the experimental mode shapes to be mass normalised. Each accelerometer with a magnetic base was attached onto a small steel plate, with approximate dimensions of 40mmx90mmx1mm, and secured on the top of the deck. The distance between each accelerometer was $1/8$ of the span length (562.5mm) starting from one end support of the bridge to the other end as shown in Figures 8 and 10.

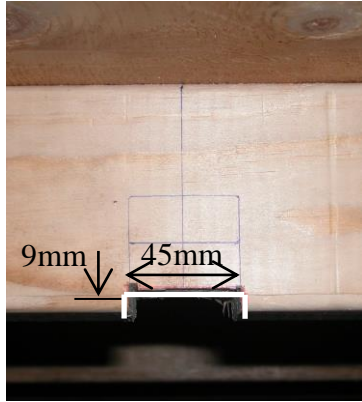
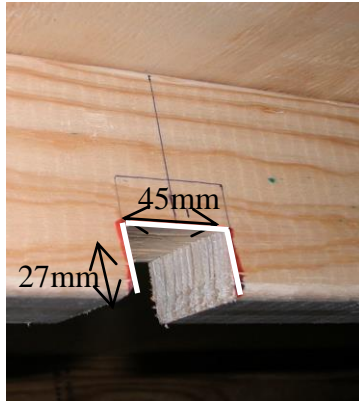
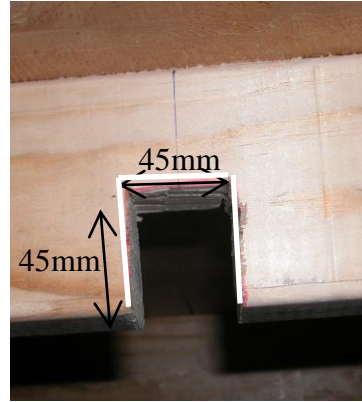
(a) Light damage (L).

(b) Medium damage (M).

(c) Severe damage (S).

Figure 9. Side view of various inflicted damage.

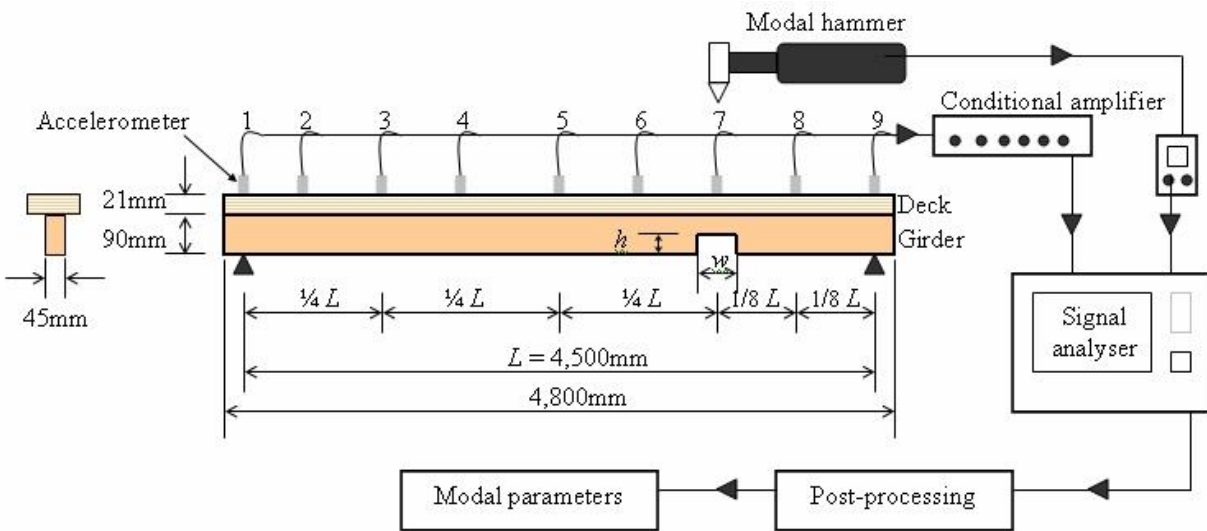
Figure 10. Modal tests on the laboratory timber bridge.

The modal test set up and its instrumentation layout is shown in Figure 10. The processing of results is based on the use of digital signal processing techniques and using the fast Fourier transform (FFT) algorithm to process the time domain data to produce frequency domain data in terms of frequency response function (FRF) between different points on the test structure. In this study, the modal testing and experimental modal analysis yield natural frequency, damping ratio and their corresponding mode shapes. The tests were mainly performed under similar environmental conditions, that is, temperature of $22^{\circ}\text{C}\pm 2^{\circ}$ and ambient humidity of $60\%\pm 5\%$ to minimise environmental factors on the modal parameters.

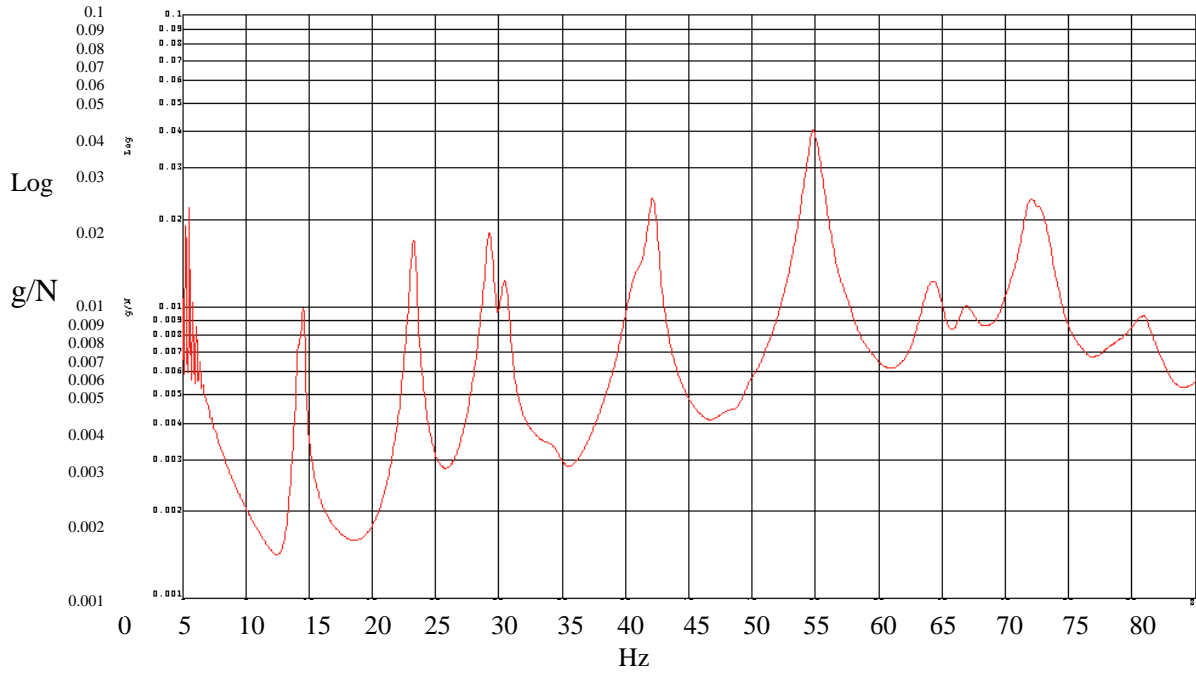
Figure 11. A typical FRF spectrum for the laboratory timber bridge.

The frequency response functions (FRFs) were acquired using LMS CADA-X [23] signal acquisition module and a dynamic analyser HP E1432A Vxi. A typical acquired FRF spectrum using the system for the laboratory timber bridge is shown in Figure 11. The measurements were recorded using the dynamic response at 10,000 Hz sampling rate for a frequency span of 500Hz and 8,192 data points, thus giving a resolution of 0.061Hz per data point. By employing an averaging of 5 ensembles, this reduces the interference of noise.

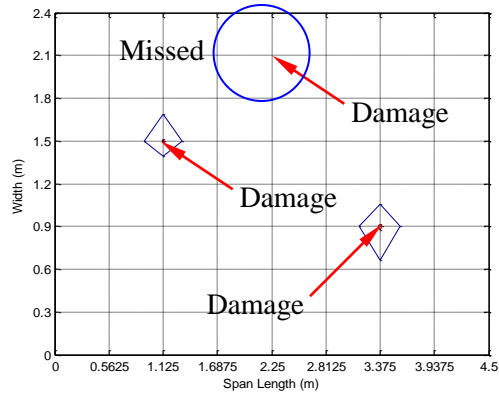
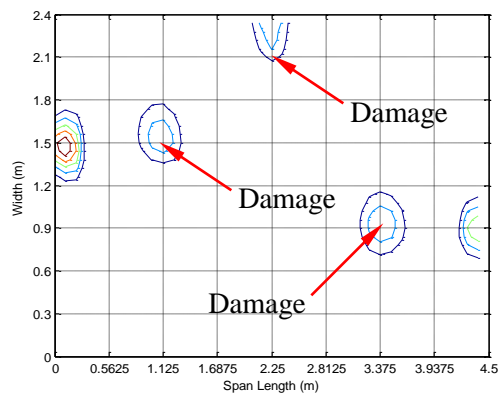
(a) Damage localisation results using “as is” data (9 modes).

(b) Damage localisation results using 2-D cubic spline interpolation (9 modes).
 Figure 13. A three damage scenario case g2Sg4Sg3S using the experimental data.

The comparison of damage localisation results obtained from the 'as is' experimental data and the interpolated experimental data using 2-D cubic spline were made using the DI-P method with the first nine modes on a three damage location case. From the contour plot of Figure 13(a), using the 'as is' data for the calculation of damage indicator with the first nine modes, we failed to locate the damage at position (2.25m, 2.1m), which is 2.25m along the span length and 2.1m across the width (the convention of (2.25m, 2.1m) is used in the following discussions) for case g2Sg4Sg3S. Even though using the 'as is' data in the DI-P method was able to detect two out of three severe damage locations, it is considered insufficient as it would potentially pose a danger to a structure if any severe damage remains detected. A 2-D cubic spline interpolation was adopted for the plate-like structure to expand the number of data points from the 'as is' data in order to enhance the possibility of damage detection using the DI-P method [28]. In the contour plot of Figure 13(b), applying the expanded data using the 2-D cubic spline technique, the method has clearly shown the locations of damage with two false positives (indication of spurious damage locations). The one missed damage location by using the 'as is' data may have been caused by the estimation of discrete curvature at the midspan (2.25m) being overshadowed by the two adjacent equal or higher severity damage at $\frac{1}{4}$ and $\frac{3}{4}$ span (1.125m and 3.375m). Adding more data points between the original data points subsequent to interpolation, the difference of curvature between two adjacent damage locations was better defined. Hence, from the reconstructed data, the damage at midspan was not subsided. However, it is important to note that there is slight distortion of data near both supports as depicted in the contour plot of Figure 13(b), which are not seen in Figure 13(a). This may be due to the cubic nature of the

interpolation and may be avoided by using a high-order interpolation technique as suggested by Worden et al. [29]. It is anticipated that such data distortion may also happen to the free edges. (Improving the cubic spline mode shape reconstruction technique to avoid the distortion of data was not included in the scope of work for this study and it is proposed to be undertaken in future work.) In general, it is obvious that without sufficient number of sensors, in many circumstances the damage localisation method cannot produce reliable results.

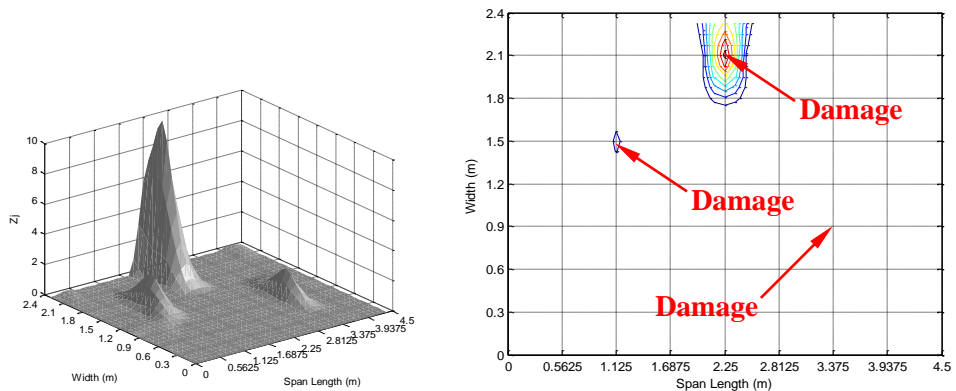
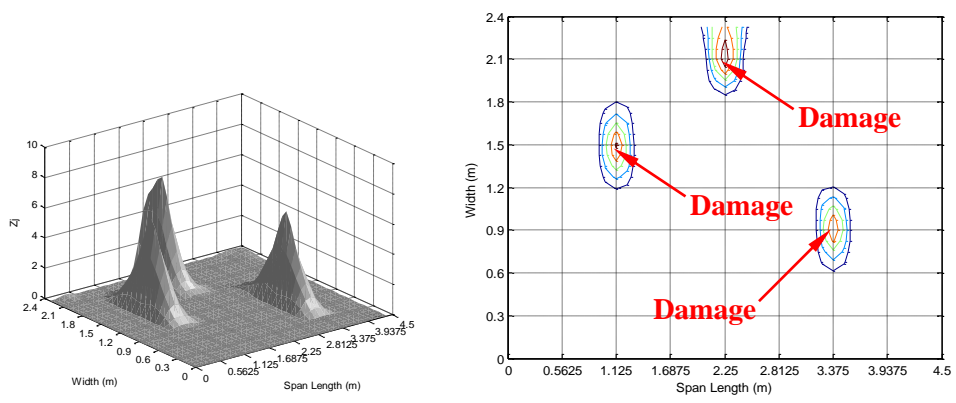
(a) Damage case g2Sg4Sg3S using 3 modes.

(b) Damage case g2Sg4Sg3S using 9 modes.

Figure 14. A three damage case g2Sg4Sg3S using the numerical data.

To study the effect of number of modes used, a three damage location case of numerical results was used. The results of the damage indicator using the DI-P method are shown in Figure 14. Using the first three modes in the method for damage cases g2Sg4Sg3S (see the contour plot of Figure 14(a)), the method could not detect the severe damage at positions (3.375m, 0.9m) and (1.125m, 1.5m). While for the same case using nine modes, as illustrated in the contour plot of Fig. 14(b), all severe damage locations were identified. It is noted also that the damage index values for the three severe damage locations, calculated with nine modes (see surface plot of Figure 14(b)), are quite similar and agreed well with the actual damage condition. This shows that using a higher number of modes improves damage detection using the DI-P method.

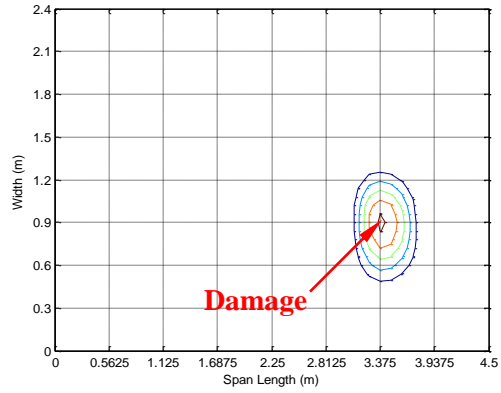
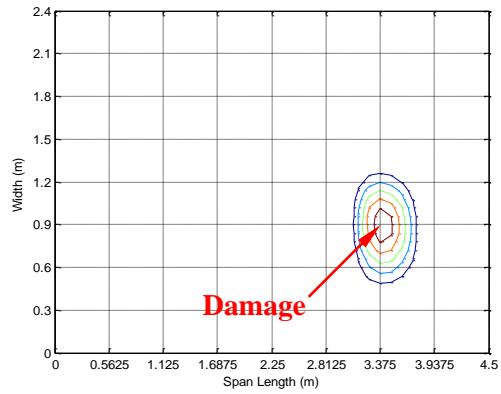
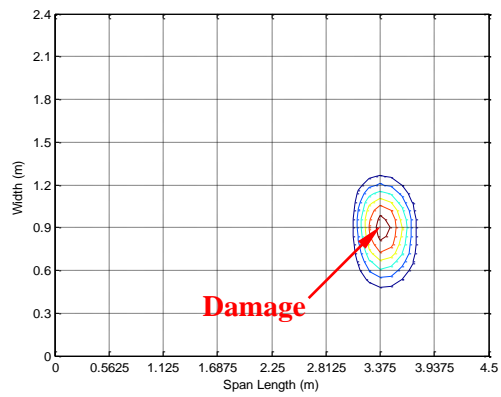
(a) g2L (light damage).

(b) g2M (medium damage).

(c) g2S (severe damage).

Figure 15. Single damage cases using the numerical data.

For damage localisation using the DI-P method in the numerical studies, the paper presents a few damage cases of single and two damage locations. The single damage case applied the DI-P method and computed, using the first nine modes and the numerical data. The results are illustrated in Figure 15. For single damage cases of light, medium and severe (g2L, g2M and g2S), the DI-P method was able to identify the damage location at position (3.375m, 0.9m) as shown in the contour plots of Figures 15(a) to (c).

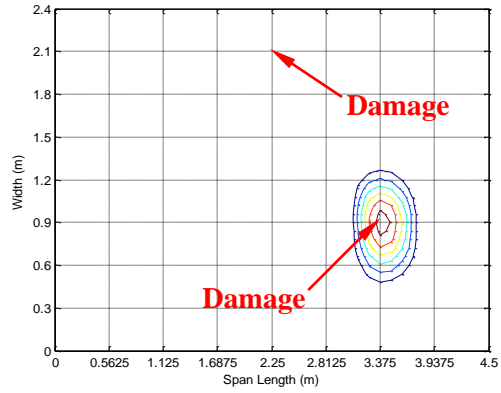
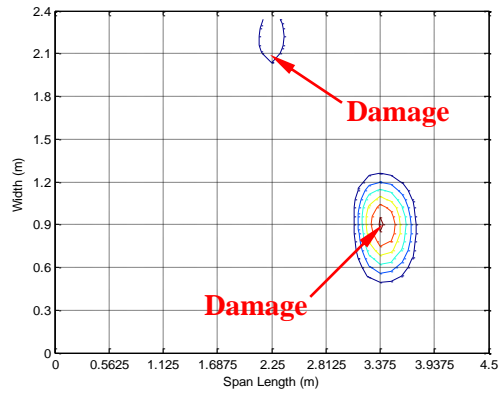
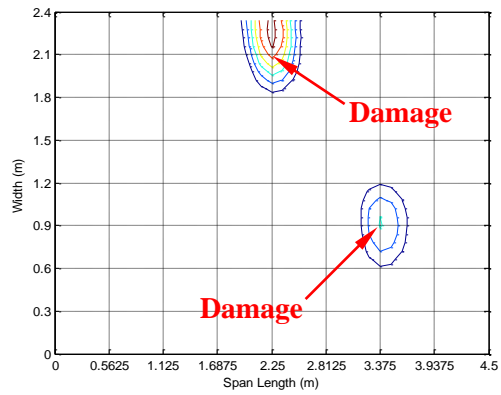
(a) g2Sg4L.

(b) g2Sg4M.

(c) g2Sg4S.

Figure 16. Two damage cases using the numerical data.

The results of two damage cases using the DI-P method are shown in Figure 16. It is obvious that all severe damage locations at position (3.375m, 0.9m) were identified for damage cases g2Sg4L, g2Sg4M and g2Sg4S as shown in Figures 16(a) to (c), respectively. The medium damage at position (2.25m, 2.1m) was also identified for case g2Sg4M (see Figure 16(b)). However, the light damage at position (2.25m, 2.1m) was not identifiable for case g2Sg4L as depicted in Figure 16(a). This may be due to the change in mode shape curvature caused by the severe damage (87.5% loss of 'I') overwhelmingly dominating the calculation of Z_j and

distorting the prediction of the light damage (27.1% loss of 'I'). The medium damage (65.7% loss of 'I') was identified as seen in Figure 16(b) because this damage was more severe compared to the light one, as well as the fact that the two damage locations are well separated, providing sufficient changes in mode shape curvature. From Figure 16(b), it was found that locations of both medium and severe damage show different index values, indicating their probability of existence of damage, which reflects well the inflicted damage. This indicates that the DI-P method could possibly be used in the numerical results to indicate the severity of damage, qualitatively.

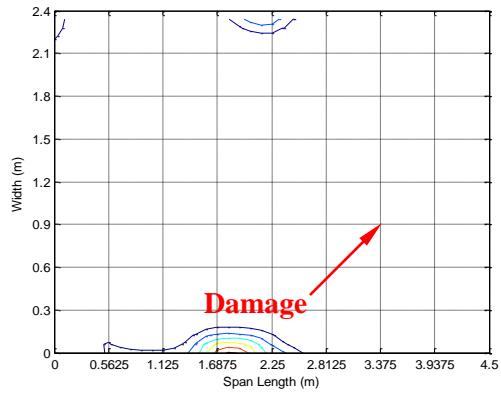
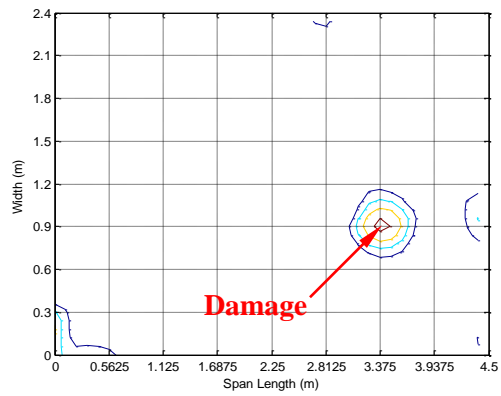
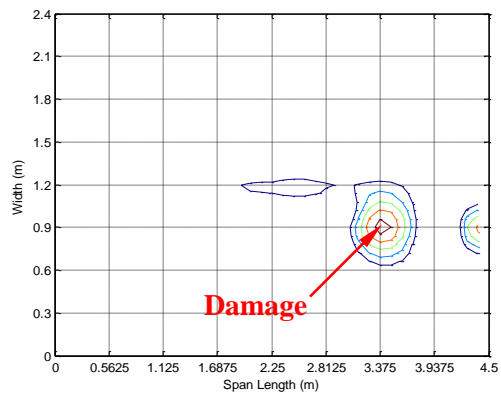
(a) g2L.

(b) g2M.

(c) g2S.

Figure 17. Single damage cases using the experimental data.

Damage cases discussed in the numerical studies are also reported for the experimental studies to verify the effectiveness of using the damage index method for plate-like structures (DI-P) to detect damage in timber bridges. The single damage cases using the method with the first nine modes are illustrated in Figure 17. For the light damage case g2L (the smallest damage) as depicted in Figure 17(a), the method could not locate the damage at position (3.375m, 0.9m). For the medium and severe damage cases g2M and g2S as illustrated in Figures 17(b) and (c), respectively, the damage locations were detected quite clearly even though there are false positives. For single damage cases, it is noticed that the lowest level of damage that could be identified, in the single damage scenarios, is medium damage of case g2M. The light damage for case g2L could not be identified in the experimental studies, which is considered less effective compared to the numerical studies. Nevertheless, the single damage of medium and severe type was identified and this is critical in terms of avoiding catastrophic failure.

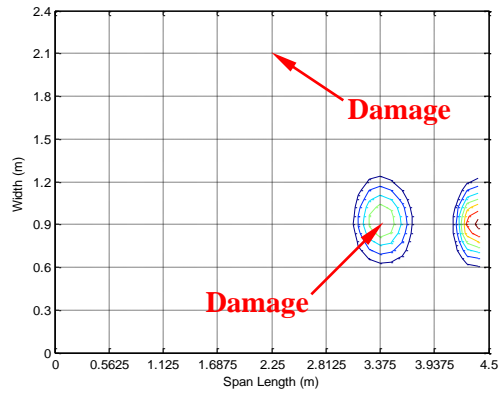
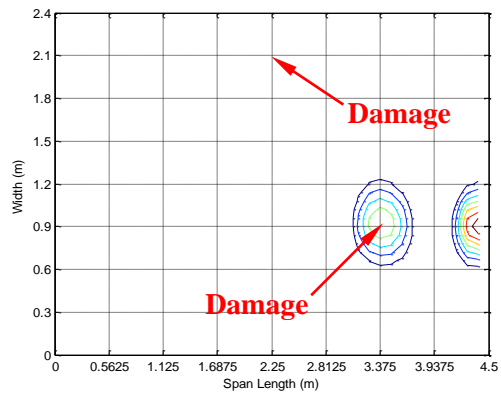
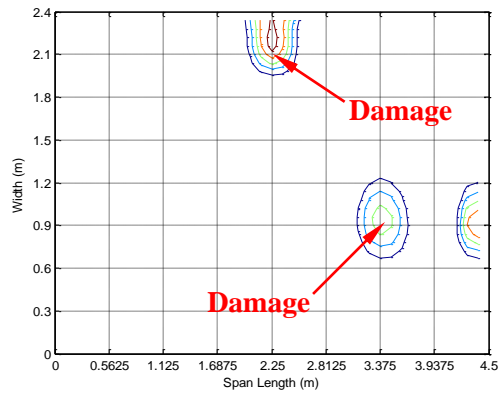
(a) g2Sg4L.

(b) g2Sg4M.

(c) g2Sg4S.

Figure 18. Two damage cases using the experimental data.

The two damage cases considered in the experimental studies using the DI-P method are shown in Figure 18. Observing from the results, severe damage locations at position (3.375m, 0.9m) were identified for damage cases g2Sg4L, g2Sg4M and g2Sg4S (see Figures 18(a) to (c)) as well as severe damage at position (2.25m, 2.1m) for case g2Sg4S. However, the light and medium damage at position (2.25m, 2.1m) were not identified for cases g2Sg2L and g2Sg2M as depicted in Figures 18(a) and (b), respectively. A possible explanation is that the change in mode shape curvature caused by the severe damage is dominating the results, and overwhelming the curvature change due to the light and medium damage. From the two damage cases, it should be noted that the second damage at position (2.25m, 2.1m) was not detected until this damage became roughly comparable in severity to the first severe damage at position (3.375m, 0.9m) in the experimental studies. This indicates that the method may encounter problems in identifying multiple damage locations with different degrees of severity using experimental data. However, the method is capable of identifying all severe damage locations and this is critical for ensuring a structure in avoiding catastrophic failure. Detecting medium damage in timber bridges using this method can be achieved as a two stage process. Once the severe damage are identified and repaired, the method can be applied again and then any medium damage can be detected in the absence of any severe damage. Figure 18(c) of case g2Sg4S shows that both severe damage locations show a relatively similar indication of damage. This indicates that both the severe damage locations have similar probability to be identified as damage. The numerical studies show a better damage detection results compared to the experimental studies. This may be due to the fact that experimental data contains noise and inaccuracies, which can affect the probability of damage being detected.
