Cannington, Mandurah and Northam
greyhound racing tracks:
Report 1 – A review of the track shapes,
cross-falls, race dynamics and injury rates

**By Prof David Eager, Md Imam Hossain, Dr Hasti Hayati and
Ms Fatemeh Mahdavi**

1 August 2020

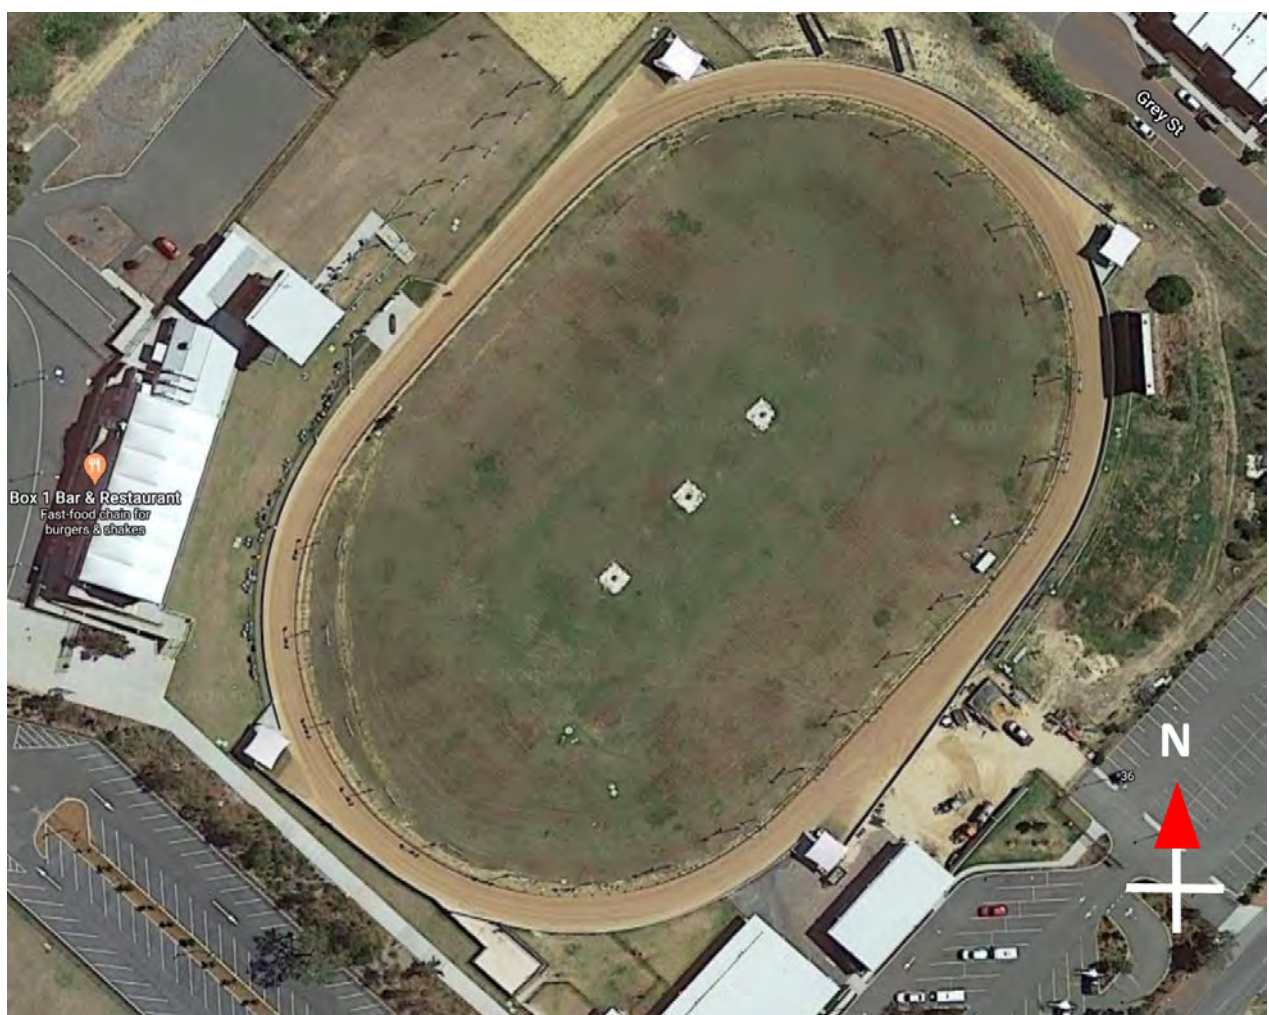
Figure 2 is the satellite plan view⁴ of the Cannington greyhound track as downloaded on 2 January 2020. The Cannington greyhound track is a typical 2-turn track with two straight starts and two bend starts.

Figure 2: Cannington greyhound track satellite plan view orientated so north is at the top of the plan. Throughout this Report for the Cannington greyhound track the end of the track adjacent the 600 m start will be referred to as the Northern Turn. Conversely, the end of the track adjacent the 380 m start and the Catching Pen will be referred to as the Southern Turn (downloaded 28 July 2020).

⁴The use of satellite imagery introduced errors into the calculations contained herein. It is recommended RWWA arrange for the Cannington greyhound track to be surveyed so that future analysis by UTS is conducted using this survey data.

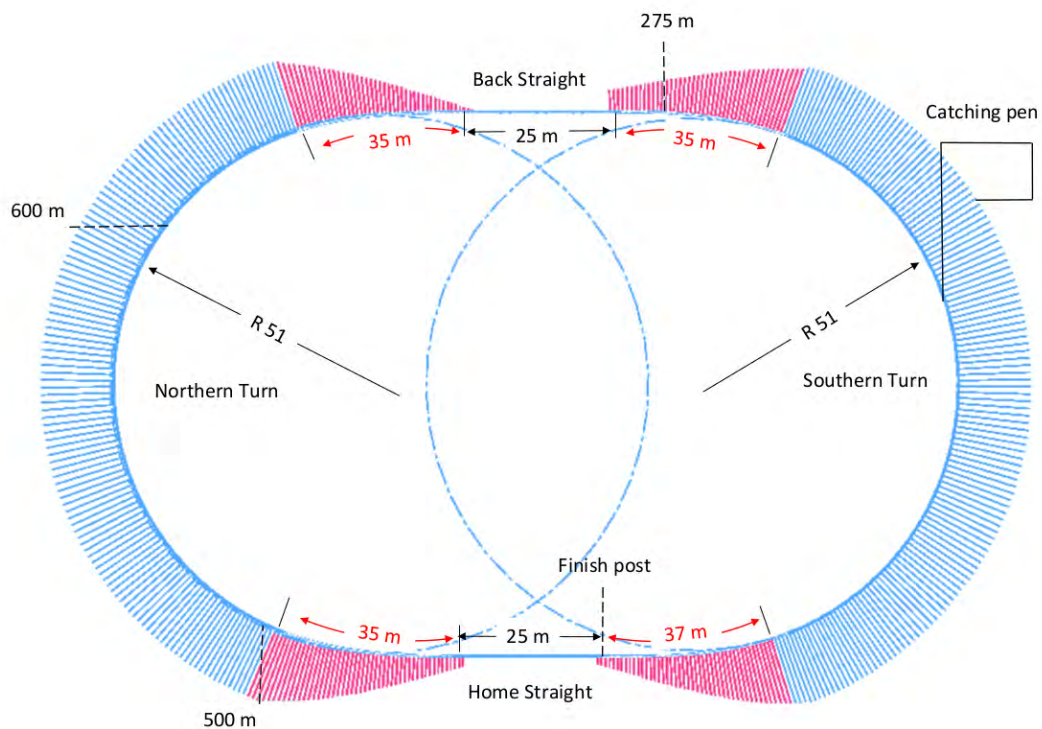
The length of the transition from Back Straight into Northern Turn is approximately 35 m, the length of the transition from Northern Turn into the Home straight is also approximately 35 m, the length of the transition from Home Straight into the Southern Turn is approximately 37 m and the length of the transition from the Southern Turn into Back Straight is approximately 35 m. These transitions are depicted in red within Figure 5.

Figure 5: The existing Cannington greyhound track curvature line plot. The lengths of the perpendicular blue lines are inversely proportional to the magnitude of the radius of curvature calculated 1 m perpendicular from the inner rail. This plot also depicts the existing transitions (with red curvature lines) and their length into and out of both the Southern and Northern Turns. Source: Satellite photo (see Figure 2).

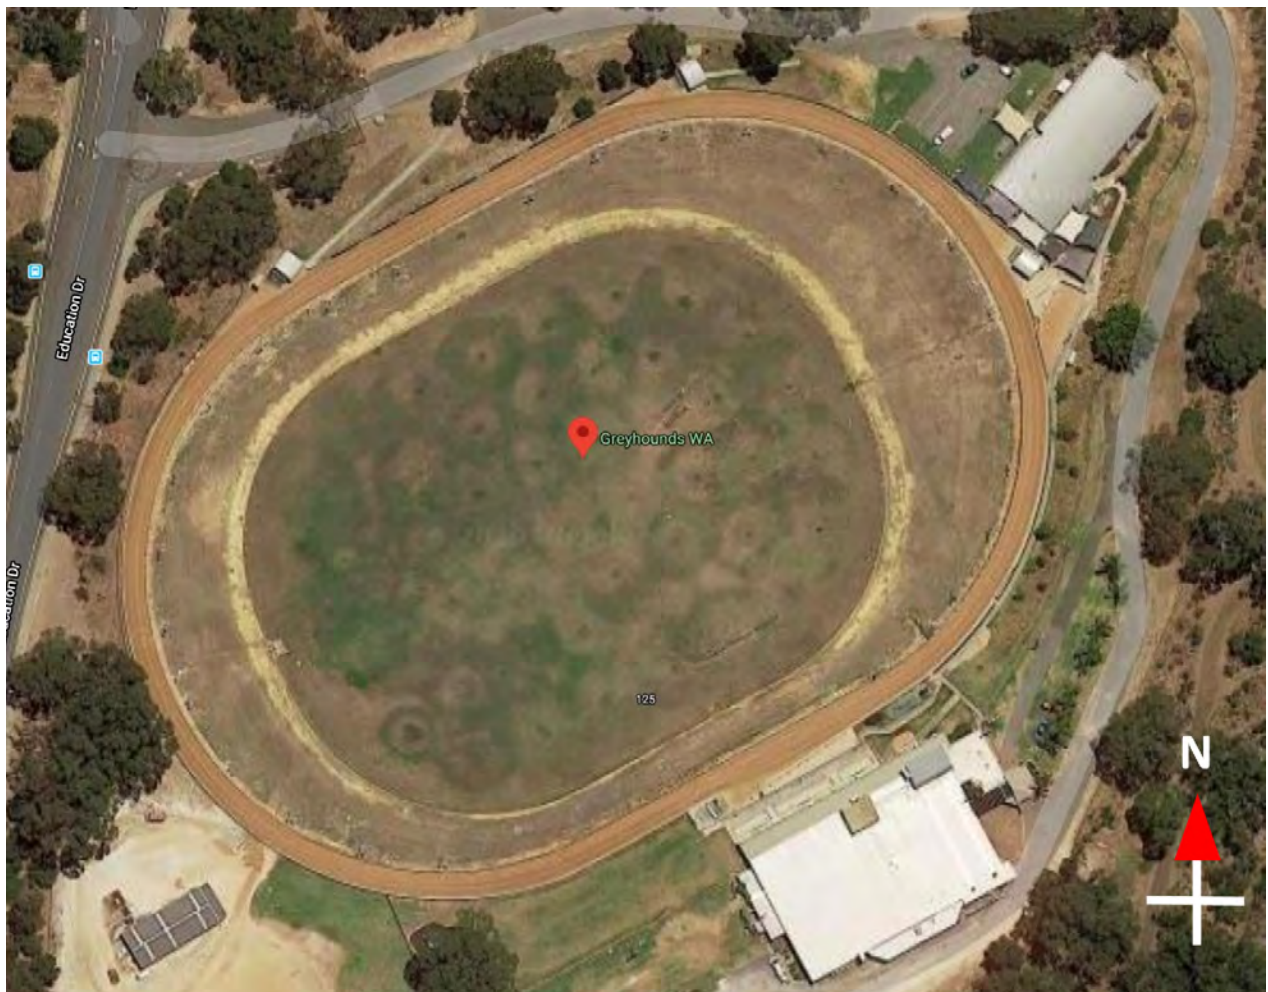
Figure 21 is the satellite view of the Mandurah greyhound track.

Figure 21: Mandurah greyhound track satellite plan view orientated so north is at the top of the plan. Throughout this Report for the Mandurah greyhound track the turn adjacent the kennel block and the catch pen will be referred to as the Northern Turn (downloaded 28 July 2020).

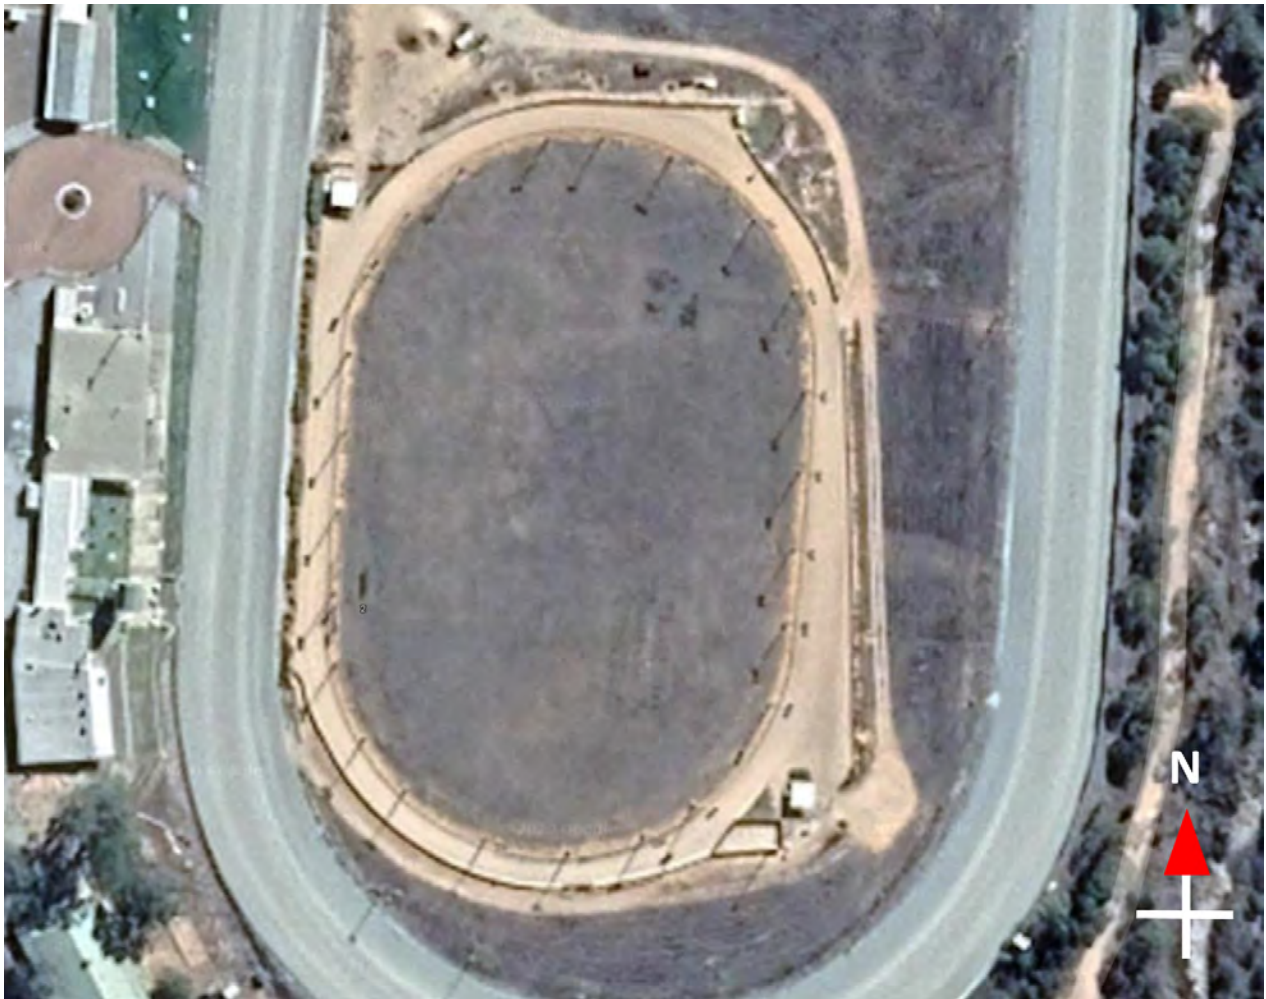
Figure 38: Northam greyhound track satellite plan view orientated so north is at the top of the plan. Throughout this Report for the Northam greyhound track the end of the track adjacent the 509 m start will be referred to as the Northern Turn. Conversely, the end of the track adjacent the 297 m start and the Catching Pen will be referred to as the Southern Turn (downloaded 28 July 2020).

¹¹The use of satellite imagery introduced errors into the calculations contained herein. If RWWA intend to retain the Northam greyhound track is recommended they arrange for this track to be surveyed so that future analysis by UTS is conducted using this survey data.

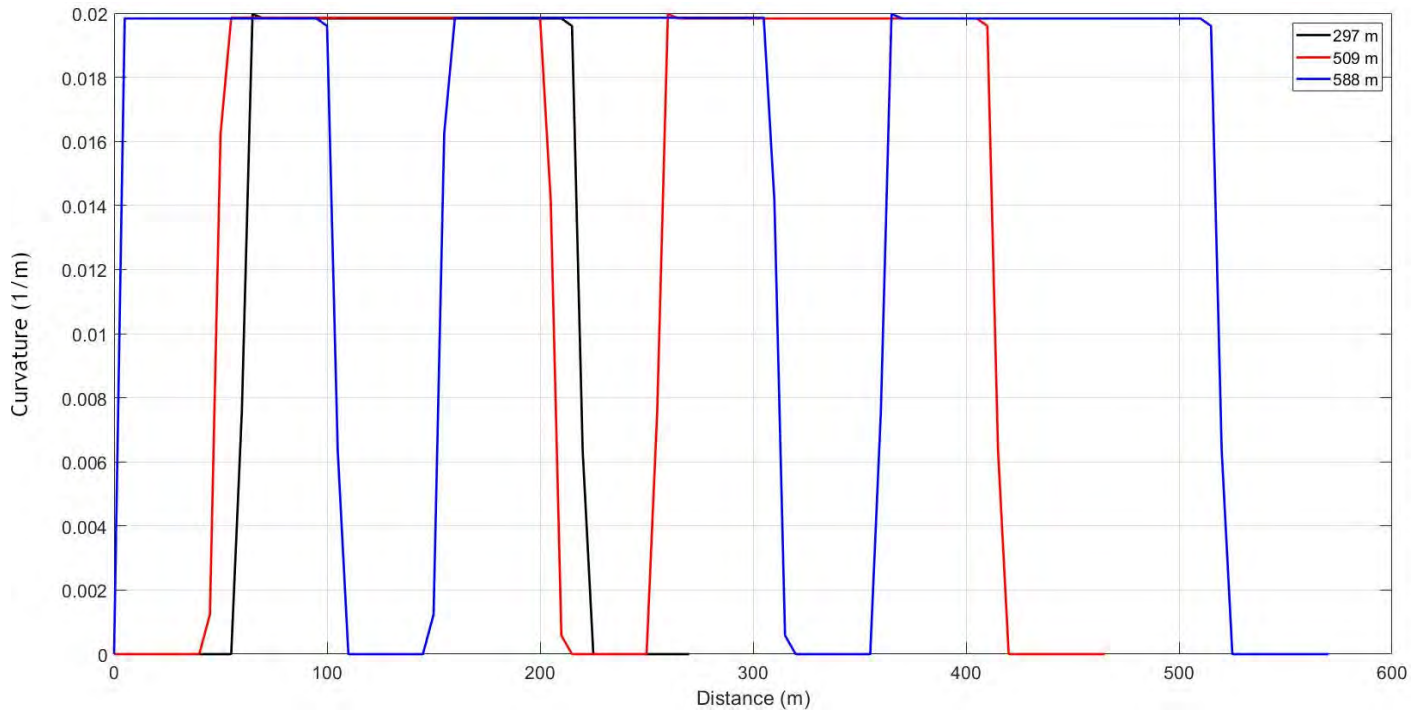
Figure 42: The curvature data for 297 m, 509 m and 588 m starting distances at Northam track. The plots commence at the respective Starting Boxes and end at the Finish Post.

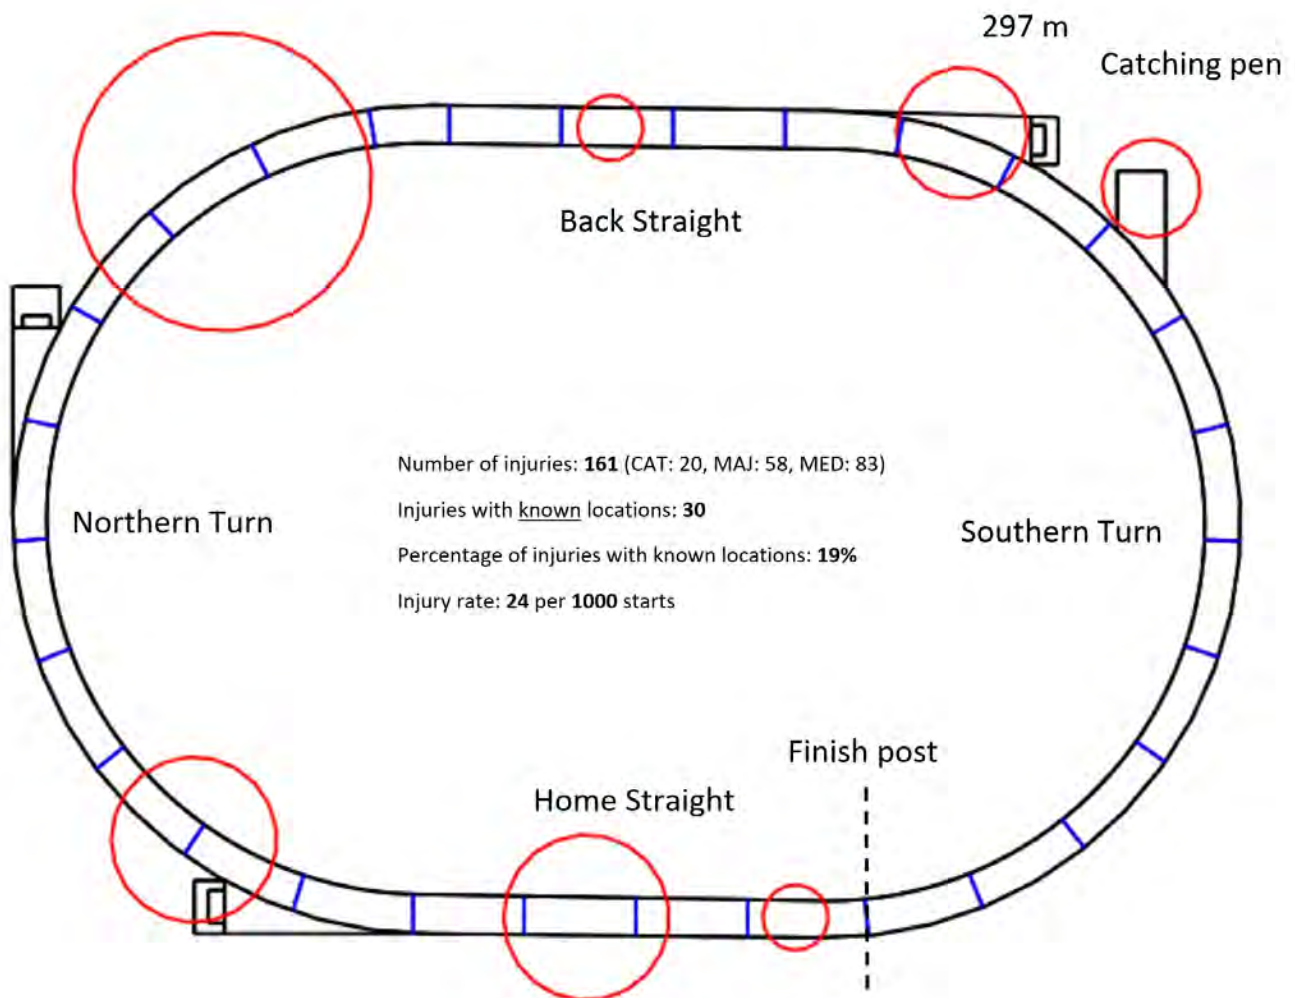
Figure 64: Northam greyhound track injury location *heat maps* for the 297 m start.
 The normalised injury rate is depicted by the relative size of the red circles.
