Membrane Autopsy of a 10 year old hollow fibre membrane from Sydney Olympic Park water reclamation plant

S. Phuntsho^a, A. Listowski^a, H.K Shon^{a,*}, P. Le-Clech^b, S. Vigneswaran^a,

Abstract

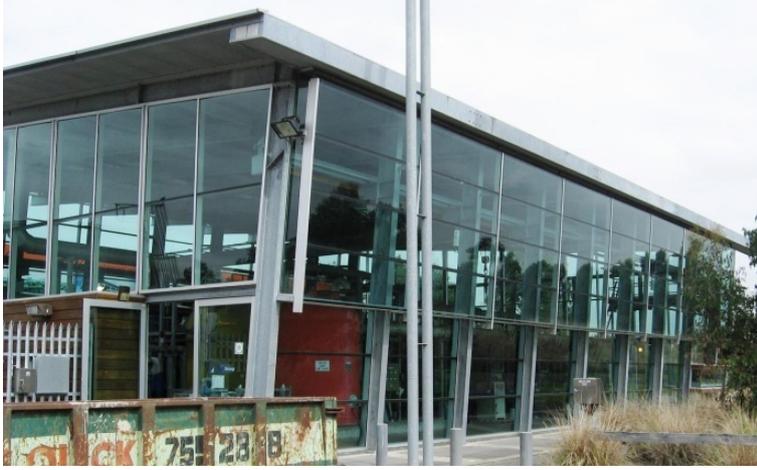
Figure 1: WARMS facility at Sydney Olympic Park

a. Water reclamation centre

b. MF Unit

c. RO Unit

The WRP consists of MF and reverse osmosis (RO) processes. The feed water for the WRP consists of biologically treated (sequencing batch reactor) secondary effluent from the wastewater treatment plant located within the SOP and the storm water retention at Brick-pit pond. The feed water first flows to the buffer tank which is then processed by hollow fibre microfiltration system (US Filter-Memcor). A portion of the effluent from MF is sent directly to the water reclamation tank while the rest is used for RO desalination to lower the conductivity before sending to the reclamation tank. The reclaimed water is used for non-potable purposes such as park irrigation, park water features, toilet flushing, pavement cleaning, etc. The WRP is designed to produce 7.5 megalitres per day (MLD) of filtered water (CMF) and 2.0 MLD of desalinated water (RO). The plant is designed to treat mixture of secondary effluent from a biological sewage treatment plant and the surface storm water runoff from Brick-pit storage. The plant is fully automated and runs 24 hours a day.

MF unit runs at a constant preset flow rate and the day's flow rate is predetermined as per the water requirement. Flow control is achieved by modulating butterfly valve, controlled by a controller. The MF is periodically backwashed initiated automatically when TMP exceeds the predetermined level or every 45 minutes whichever occurs first. Backwash cycle forces compressed air through the wall of the membrane from inside to out to dislodge the foulant build up. Raw water flows through the modules from bottom to top, carrying the dislodged

particles to the backwash outlets. Chemical cleaning is performed fortnightly using EX-A3 chemical (caustic 50% plus wetting agents). Figure 1 shows the WRP, its facilities.

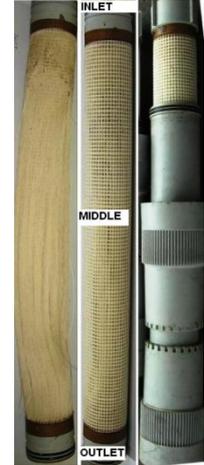
d. MF module sample

The membrane module appeared significantly fouled at the inlet portion of the module than at the middle and the outlet (Figure 1.d). The SEM images of the fibre samples are shown in Figure 2. Foulant deposits some of which appeared like scale formation was observed on the fibre (Figure 2a). After the fouled fibre was cleaned by NaOH solution, a number of spots or patches were observed (Figure 2.b). These patches are likely a result of the change in the

Table 3 shows the different components of the membrane foulant extracted from the hollow fibre membranes using NaOH and HCl solutions from inlet, middle and outlet portion of the membrane module (refer to Figure 1.d). NaOH solution was more effective in extracting organic foulant while HCl was more effective in extracting inorganic components. The foulant at the inlet portion of the membrane contained more organic carbon while the foulant at the outlet contained more inorganic carbon. Total nitrogen was also significant at the inlet portion indicating the presence of more organic fouling at the inlet region of the membrane module.

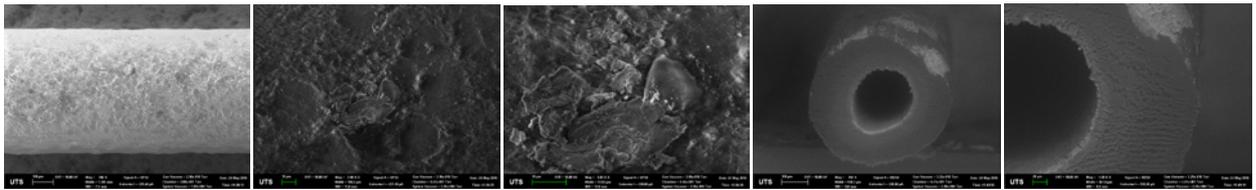
a. Fouled fibre without cleaning

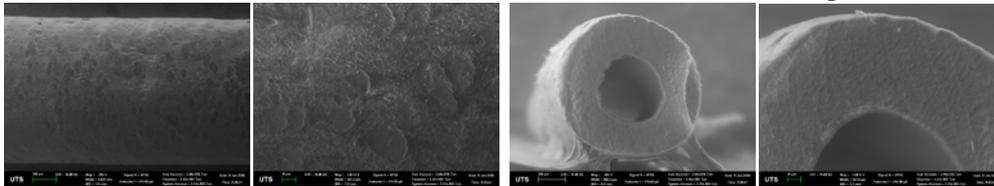
surface of the membrane due to deposits of irreversible foulant. These patches were not visible with the virgin membrane (Figure 2c) where it appeared clean and quite smooth in surface. Bio-fouling could not be conducted immediately due to lack of facilities at the time of collection of the membrane samples.

b. Fouled fibre after 0.1 N NaOH and HCl cleaning

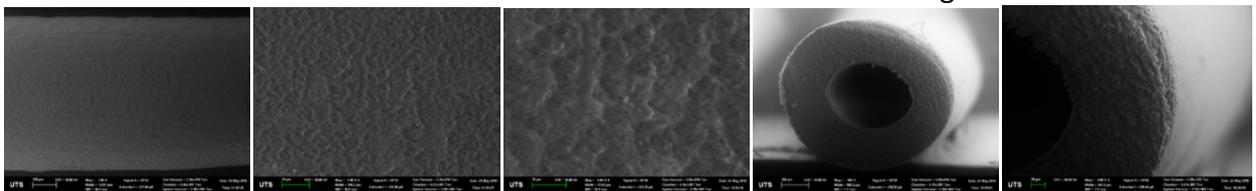
c. Virgin membrane

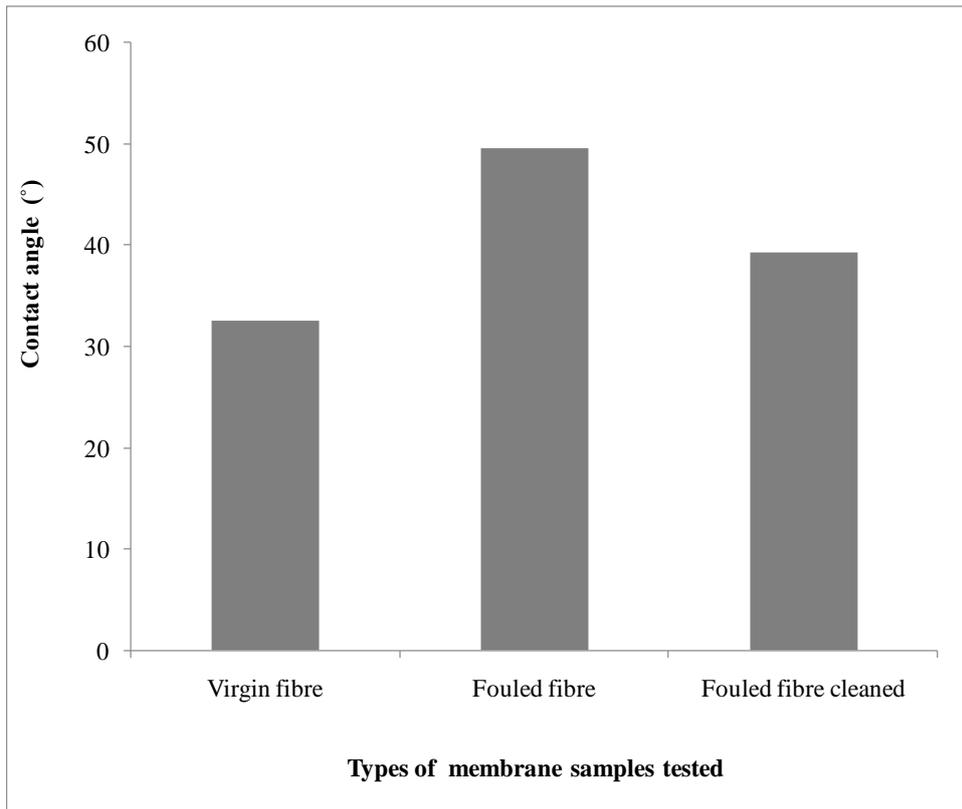
Contact angle is an important parameter for determining the hydrophobic or hydrophilic properties of a membrane surface (Northcott *et al.* 2009). The contact angles for all cases were more than 30°. Generally a water droplet exhibits a contact angle between 0 and 30° on a hydrophilic surface and larger than 30° are considered hydrophobic in nature. Figure 3 shows the contact angles of the fouled fibre, the fouled fibre after cleaning and the virgin fibre. The contact angle of the fouled membrane was higher than the virgin membrane which is likely due to the presence of foulant deposits on the membrane surface. After the foulant was removed by NaOH cleaning, the contact angle slightly decreased however it remained still higher than the virgin membrane. The increase in the contact angle of the fibre is an indication of the membrane losing its hydrophilic property and therefore more susceptible to fouling than the virgin membrane.

Figure 3: Contact angle of hollow fibre membrane

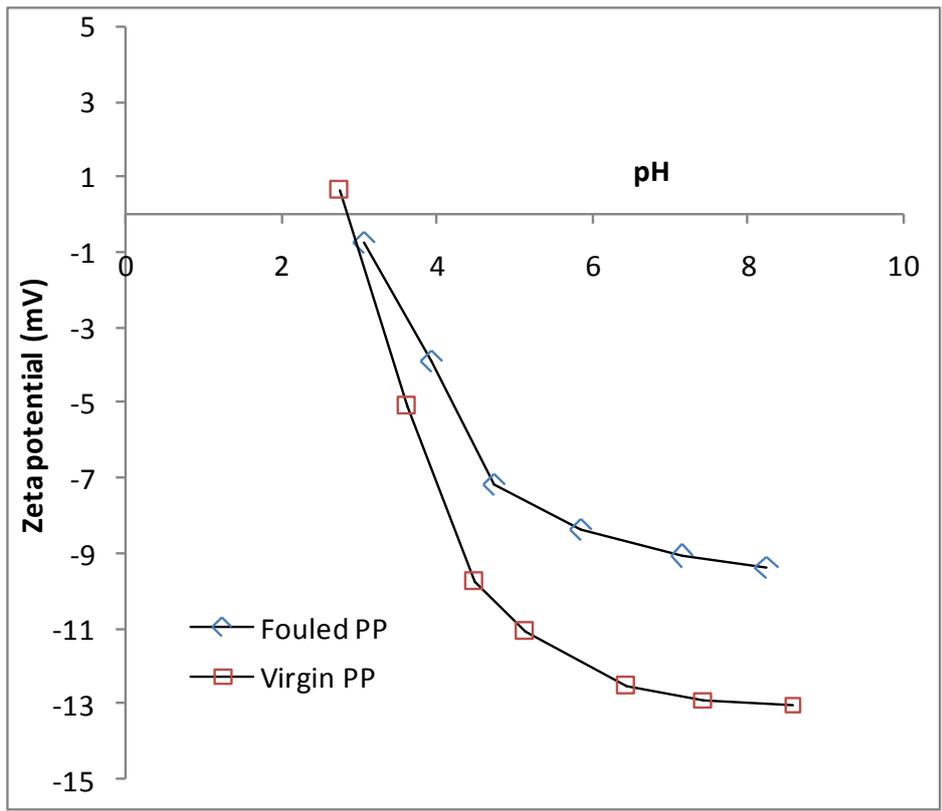
Zeta potential of the membrane fibre is shown in Figure 4. The results indicate that the zeta potential of the fouled membrane is less negative when compare to the virgin membrane. the Zeta potential of all the fouled membranes are generally found less negative (Soffer *et al.* 2002). The decrease in zeta potential of the membrane reduces the net repulsive force (increases attractive force) between the membrane surface and the foulant specimens (which are usually negatively charged) resulting in higher fouling of the membrane. It has been reported that, the foulant layer weakens the electrokinetic flow owing to lower permeate flux, leading to decrease in membrane zeta potential (Chun *et al.* 2002).

Figure 4: Zeta potential of the hollow fibre membrane

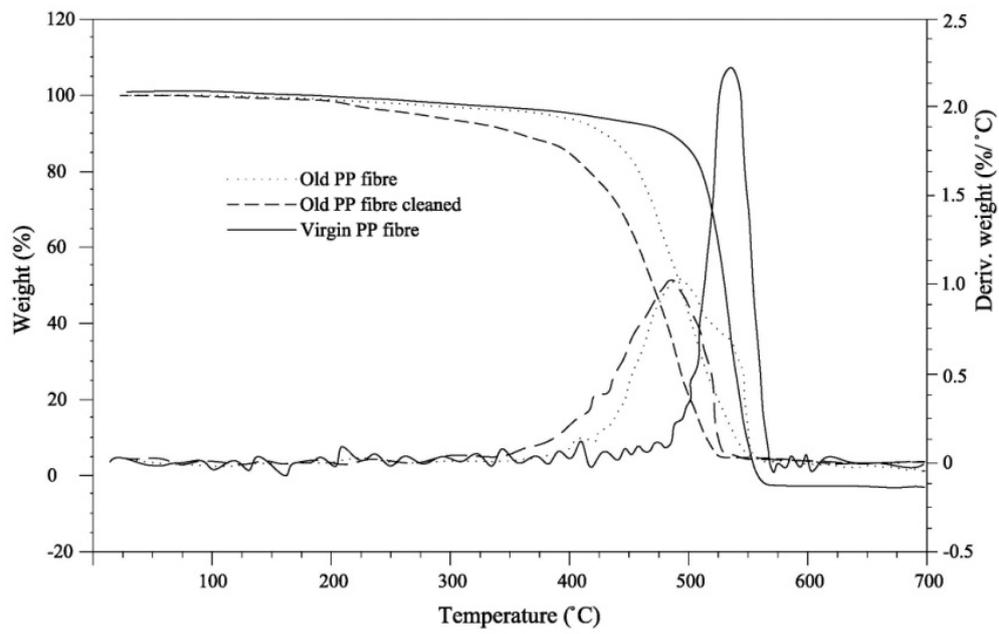
Figure 5 shows the degradation behaviour of a virgin and fouled PP hollow fibre membrane. The virgin PP fibre exhibited maximum degradation rate at 530° C, while the fouled fibre and the fouled fibre after cleaning exhibited maximum degradation rates at much lower temperatures of 485° C and 495° C respectively indicating that the old PP membrane fibre has lower thermal stability than the virgin PP fibre. The degradation rates at these temperatures were much higher and narrower for virgin fibre than the fouled fibre due to absence of other impurities in the virgin material. The fouled fibre showed a much broader and multiple distribution of degradation peak due to the presence of contaminants of different compounds. The percentage mass loss at 500° C of heating was only 13% for virgin fibre while fouled fibre and fibre after cleaning exhibited much higher mass loss of 53% and 38% respectively.

Figure 5: Comparison of thermal degradation of PP hollow fibre membrane samples

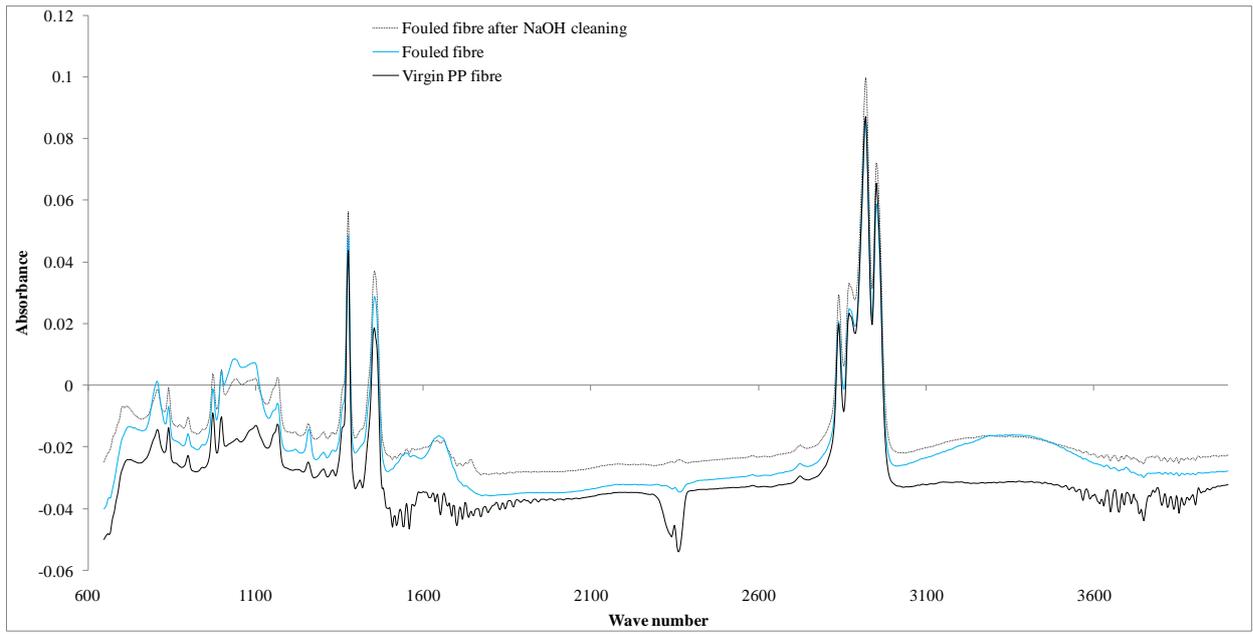
FTIR spectroscopy is used to study the characteristics the chemical structure of the PP membrane surface (Bae *et al.* 2001). FTIR spectra for PP hollow fibre membrane in Figure 6 showed a very similar absorbance for the old fouled fibre and old fibre after NaOH cleaning with the virgin PP fibre. The only unique observation was the small and broad absorbance spectrum between wave number 3100 and 3600 for the two old fouled PP fibres which was not a characteristic of the virgin fibre. This is likely due to the presence of foulant organic species on the membrane surface. Polysaccharides with significant number of hydroxyl group can exhibit a broad rounded absorption band above 3000 cm^{-1} (Howe *et al.* 2002).

Figure 6: FT-IR spectroscopy of PP hollow fibre membrane samples

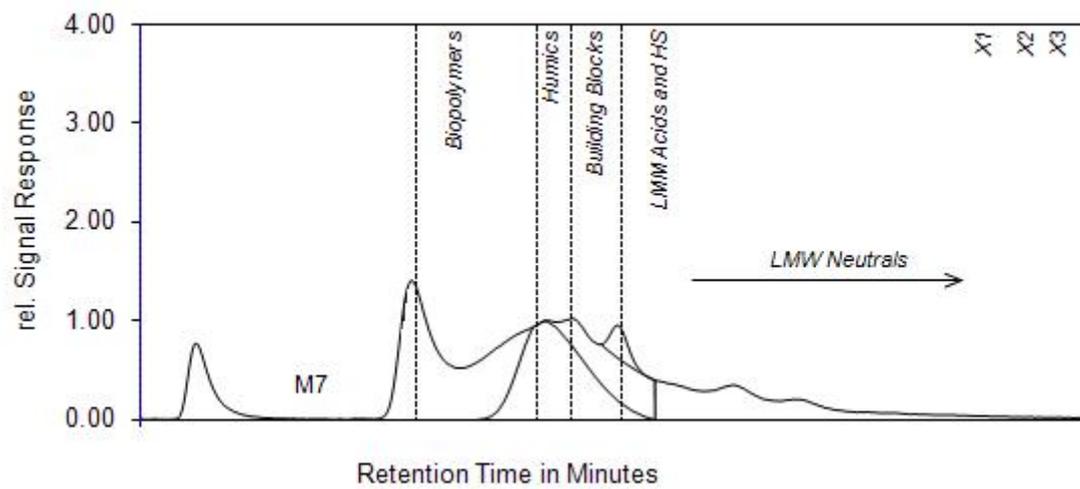
Liquid chromatography - organic carbon, nitrogen detection (LC-OCND) allows the fractionation of the organic matters and their detailed characterisation using organic carbon and nitrogen detectors (OCND). Table 4 shows the various components of DOC present in the membrane foulant extracted from various parts of the membrane module as analysed by LC-OCD. The DOC as expected is much higher at the inlet portion of the membrane module than the middle and the outlet region. DOC had consistently higher hydrophilic component with as high as 98% at the inlet region, 95% at the middle and 93% at the outlet. These results indicate that, hydrophilic components of the organic matter are mostly responsible for fouling off hollow fibre membrane fouling. The hydrophilic carbon was composed of bio-polymers (23-50%), humic substances (26-40%), building blocks (7-12%) and low molecular weight neutrals (10-21%). Hydrophilic compounds are poorly rejected by the membrane (Bellona *et al.* 2004) and therefore it is likely that they are adsorbed more on the membrane pores as foulant during the filtration process. Fan *et al.* (2001) also reported similar findings. A typical LC-OCD chromatogram is presented in Figure 7.

Figure 7: LC-OCD chromatogram of a typical foulant sample extracted from the membrane fibres
