# **Numerical and Experimental Investigations of Vibration-based Assessment of Timber Beams Rehabilitated by Fibre-Reinforced Polymer**

A thesis submitted for the degree of  
Master of Engineering (Research)

Faculty of Engineering and Information Technology (FEIT)  
University of Technology, Sydney (UTS)

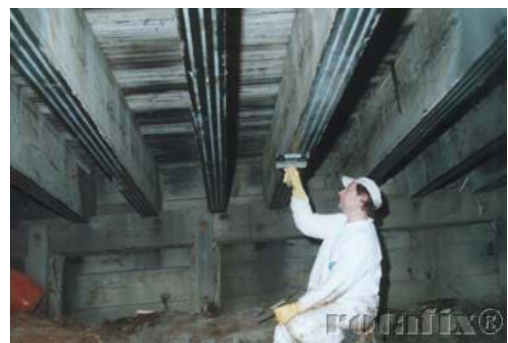
(b) Repairing Timber structure

Fibre reinforced polymer (FRP) has been widely used in civil engineering applications since 90's shown in Figure 1.1 (b). According to Nanni (2000), the market growth of using FRP is reflect to the increased needs for repaired or strengthening of deficient structures and for new infrastructure systems that last longer and cost less to maintain. Furthermore, applications of FRP composites in civil or infrastructure engineering include different methods such as internal reinforcement and externally bonded reinforcement (Nanni, 2000). This popularity of utilizing FRP has arisen due to the well-known advantages of FRP composites, such as good corrosion resistance and ease for site handling due to their light weight. Minimum increases in structural size and weight as a result of FRP strengthening or repair also contribute to their popularity (Smith and Teng, 2002).

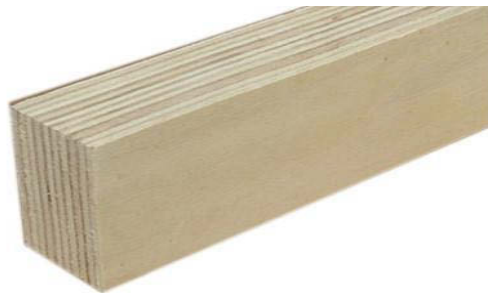
Figure 3.1 Laminated veneer lumber

Laminated veneer lumber is an engineered wood product which uses multiple layers of thin wood veneers assembled with adhesives (Figure 3.1). There are several advantages of using LVL over sawn timber such as stronger, straighter and more uniform. The major elastic property of LVL timber beams is its modulus of elasticity. The Modulus of elasticity can be defined as the change of stress with respect to strain in the elastic range. For this research study, the modulus of elasticity of the test specimens is obtained from manufacture data which was 13 GPa.

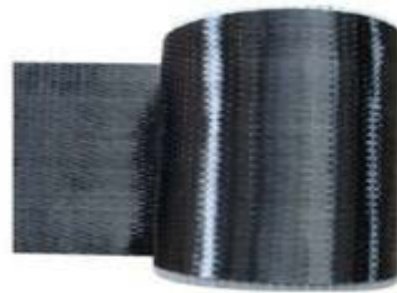
Figure 3.2 Carbon Fibre sheets

directional strength properties. The properties of CFRP depend on the layouts of the carbon fibre and the proportion of the carbon fibres relative to the polymer. Usually, there are two types of CFRP material used in civil engineering applications, which are carbon fibre and carbon fibre sheets. In this study, the carbon fibre sheets CF120 (figure 3.2) is utilized. Based on manufacturer's data, the CF120 has a thickness of 0.117mm and can attain a tensile strength higher than 3700 MPa, and an elasticity modulus of 240 GPa. As no adhesion is applied between individual fibres, the transmission of forces between the fibres is achieved using a polymer or resin matrix. Polymers, which contained the epoxy selected for this investigation, show a few strengths, such as reduced cost, ease of work-ability, and enhanced resistance to environmental impacts. The epoxy is applied to both sides of fabric. An ordinary point roller and hand pressure are used to ensure its effectiveness.

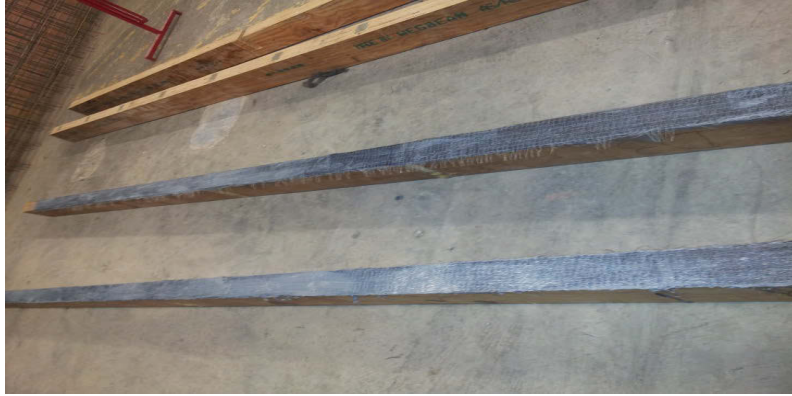
Figure 3.5 LVL Timber beams repaired by CFRP

The CFRP rehabilitation was carried out on Beams 1, 2 and 3 after all damage scenarios. The procedures of CFRP rehabilitation are described as follow. First of all, a small timber block pre-cut into the same size with damaged parts was glued on the damaged timber beam using a polyurethane glue so that the CFRP could be fully bonded to the soffit of the repaired beams. Figures 3.5 and 3.6 specifically illustrate the method of CFRP repairing. Secondly, using an air gun cleaned the dust at the soffit, and sikadur 330 epoxy was then applied on the soffit surface. The first carbon fibre sheet which was pre-cut into required width and length was then laid on top of the epoxy layer. The CFRP sheet was then rolled using a steel roller to ensure proper impregnation of the epoxy in between the CFRP fibres and to drive out any possible air voids. Finally, the second CFRP sheet applied on top of the first sheet using the same procedure.

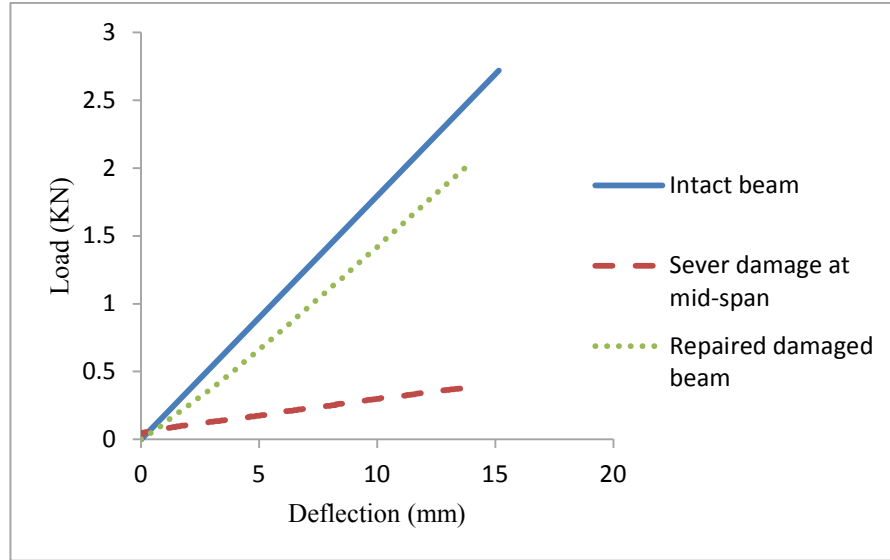
Figure 3.8 Load-deflection curve comparison for Beam 1

Figure 3.9 shows the load-deflection curve comparison for beam 1 at three states intact, severe damage at mid-span and repaired severe damaged. The results illustrate significant drop in slope of load deflection curve which relates to loss of stiffness due to the severity of inflicted damage and an obvious recovery in stiffness after being repaired with CFRP. However, the slope of the load-deflection curve of repaired damaged beam is still less than the intact beam, which presents that the CFRP could not fully repair the severe damage. This result will be used to verify the capability of using modal strain energy method to evaluate the repair effectiveness for damaged timber beam after repairing with CFRP in Chapter 5. The static results of the other cases are shown in Appendix.

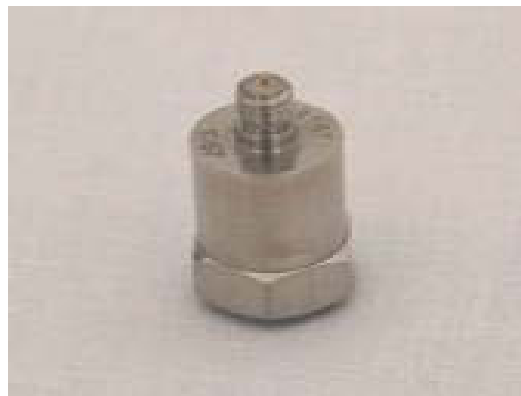
Figure 3.10 Piezoelectric accelerometer

Piezoelectric accelerometers as shown in Figure 3.10 were used in the modal tests to measure the acceleration responses due to an impact action. All accelerometers used in the model test were calibrated against one reference accelerometer selected amongst them in order to obtain a relatively synchronised mode shape data. Nine small steel plate glued on the top of beam and each accelerometer was attached to the plate using a magnetic based. The distance between each accelerometer was  $1/8$  of the span length stating from one end support of the beam to the other end. Nine measuring points were deemed sufficient for reconstructing mode shapes with the required accuracy using interpolation techniques.

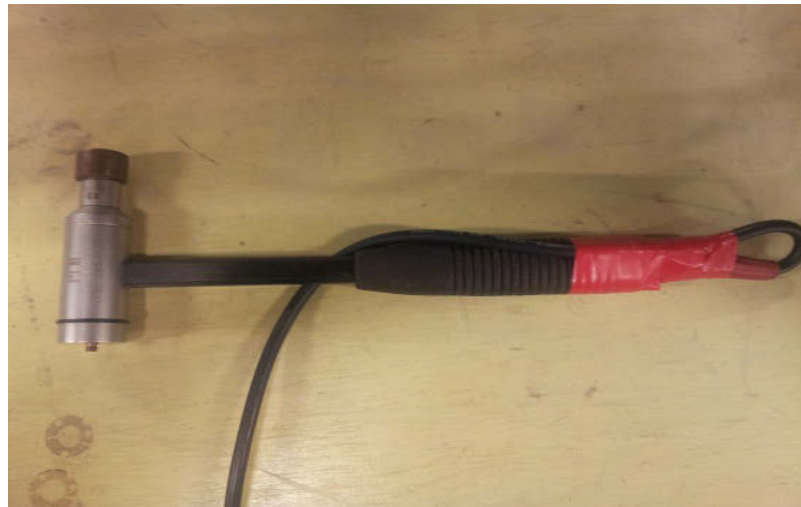
Figure 3.11 Impact hammer

identification. An impact hammer (model HP 086C05) shown in Figure 3.11 was used to excite the test sample at the reference or driving point, i.e. point number 3. The impact location was set at quarter of the span length so that it could excite lower modes simultaneously. The impact hammer was used to generate input force and the data was measured by means of a force transducer in the hammer. The response signals of accelerometers and modal hammer were also amplified and conditioned using a multi-channel signal conditioner (Figure 3.12).

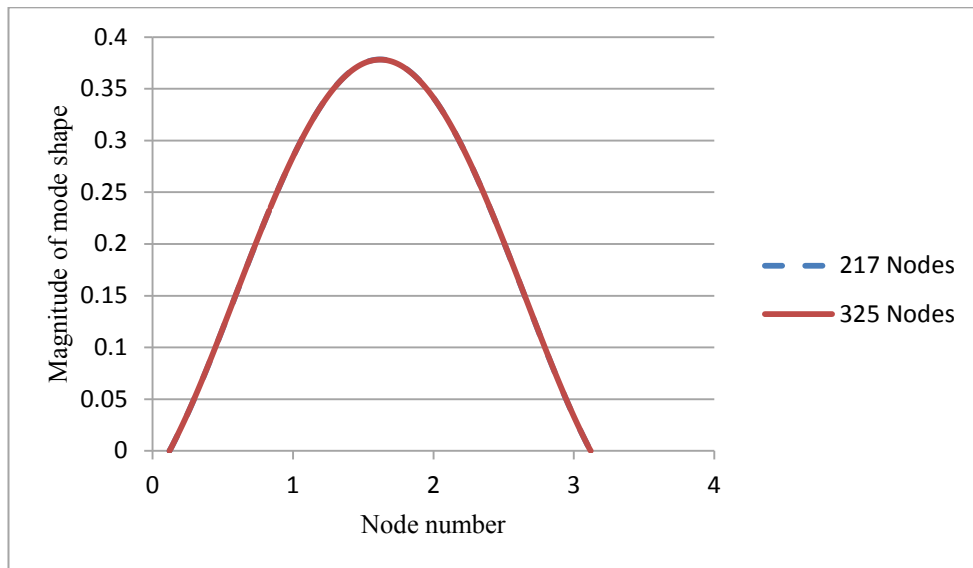
(a) The first mode

(b) The second mode

(a) The third mode

Referring to Figure 4.5, the difference of mode shape results between different mesh densities is insignificant. Based on the comparison, it can be concluded that all meshed models are comparable and they are deemed good enough for the numerical work required in this study.

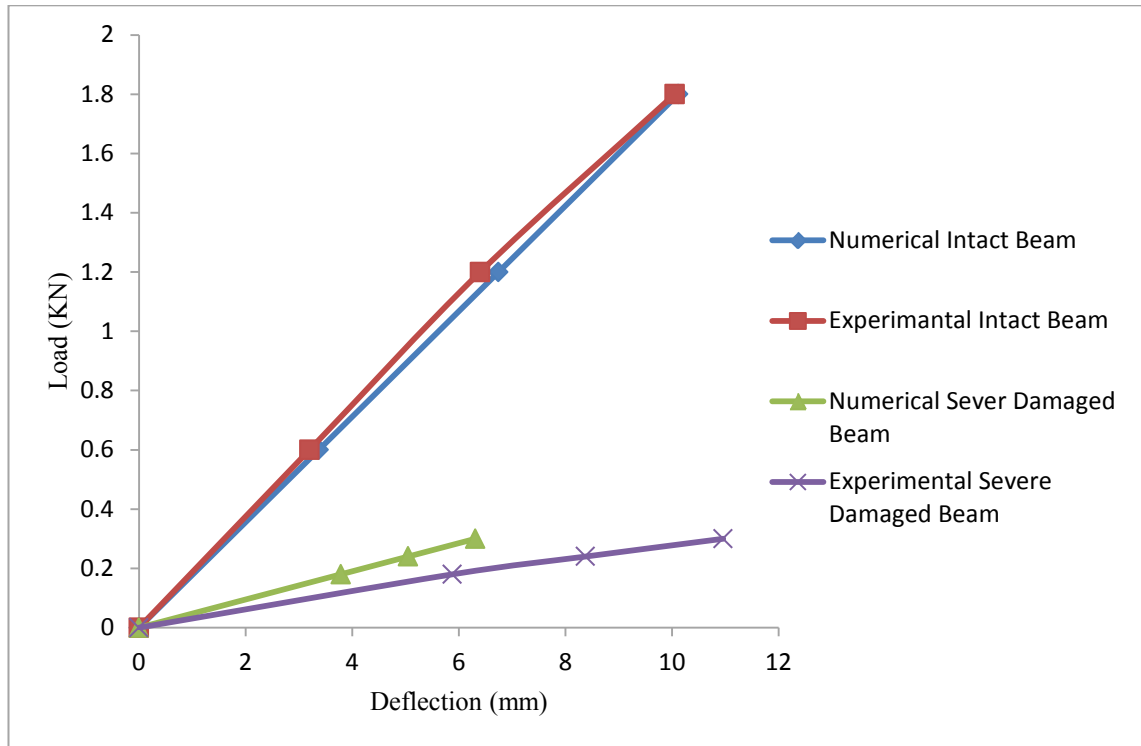
Figure 4.9 Load-Deflection comparison between numerical and experimental results

between numerical damaged beam results and intact beam results is smaller than experimental results. This comparison presents that the damage inflicted in numerical FE model is not as severe as in experimental case. The reason of leading this situation is described as follow. Firstly, the damage introducing is produced by saw-cut which is performed by hand. Unlike using machine, the boundary of damaged part is not as perfect as the numerical FE model. There is a small over cutting along the longitudinal direction and horizontal direction as shown in Figure 4.10. These small cuts results in the stiffness decrease in the around area. Secondly, timber can have natural growth characteristics which mean that the properties may not be uniform throughout while the FE model assumes that the property is isotropic. Whilst this will be much less for LVL, compared to sawn timber, such characteristic in the LVL beams still exists. This difference will affect both the intact and damaged beam results. Lastly, timber fibres may not be perfectly oriented in the longitudinal direction and inter-winding of fibres is quite common. This means that cutting a notch of depth say 75% of the beam depth may actually results in cutting more than 75% fibres of vice versa, depending upon how straight the fibres are. With the FE, however, this effect of inter-winding fibres cannot be accurately modelled, and besides each piece of timber (or LVL) will be different. This effect would be more prominent when the damage is severe one. However, this property of severe damage cannot be reflected in the FE model. Therefore, to solve the difference between the numerical and experimental results, the material property of the elements in FE model located at the pointed out area shown in Figure 4.10 required to be changed

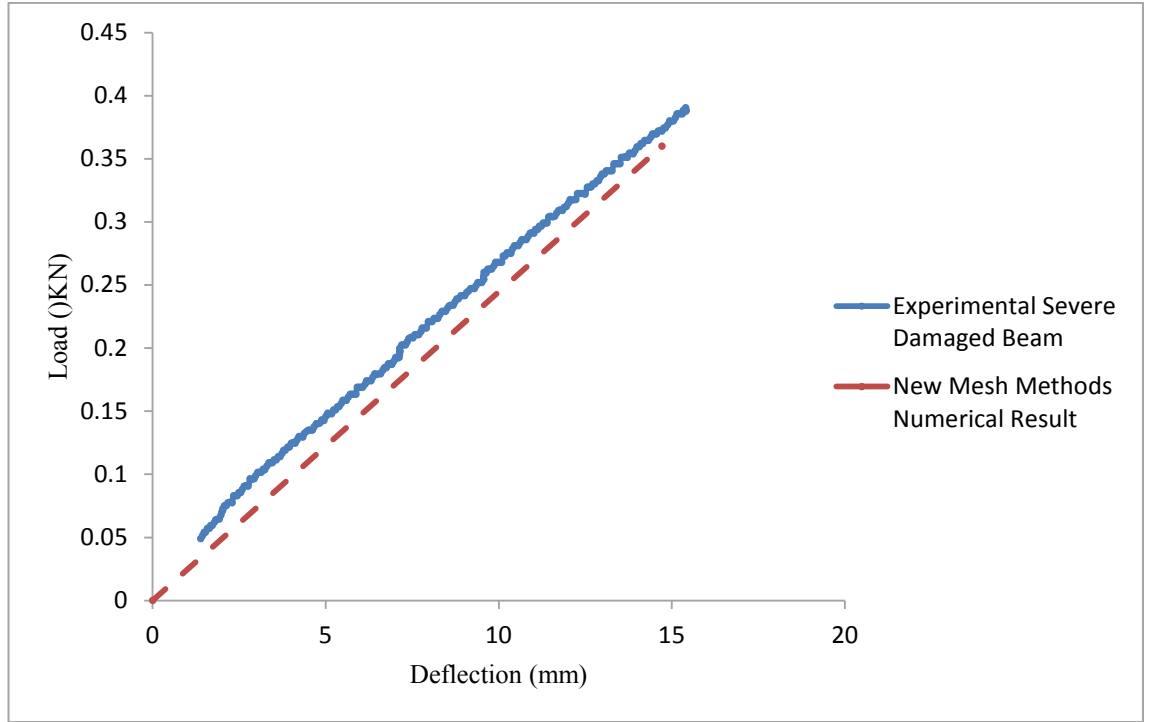
Figure 4.11 Load-deflection curve comparison
