Radiation Damage
Effects within Materials

A Thesis Submitted for the degree of
Master of Science by Research

University of Technology, Sydney

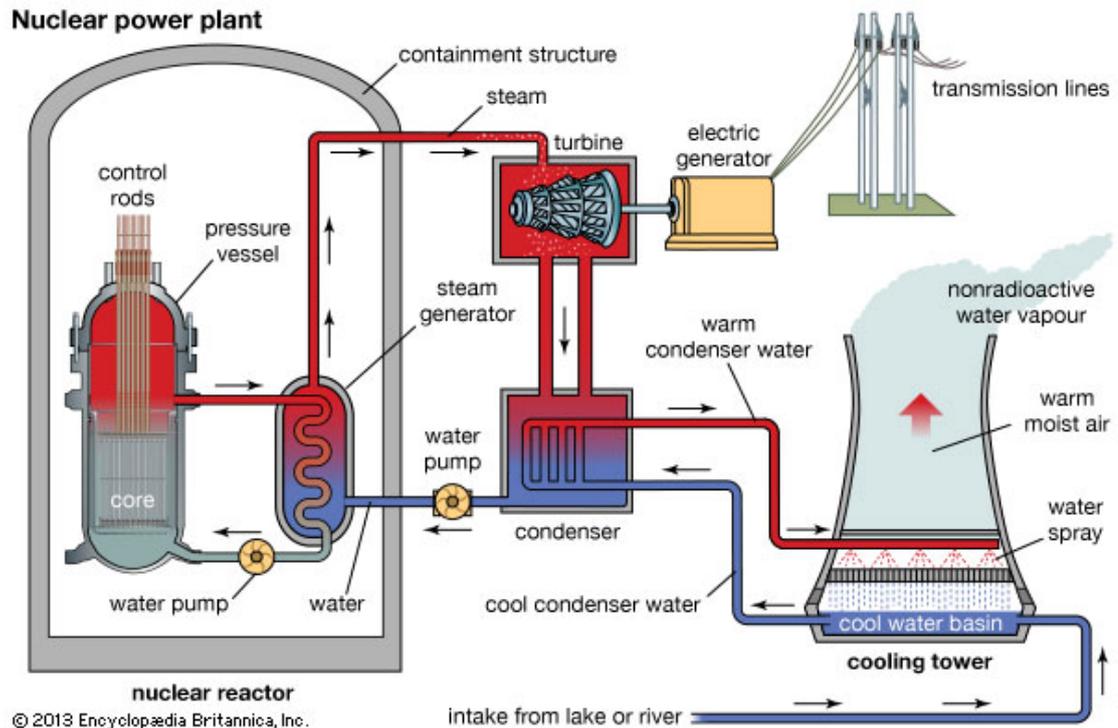
Figure 2-1: Schematic diagram of a nuclear power plant using a pressurised-water reactor, the most common commercially used type of fission power reactor. [Encyclopædia Britannica Inc.]

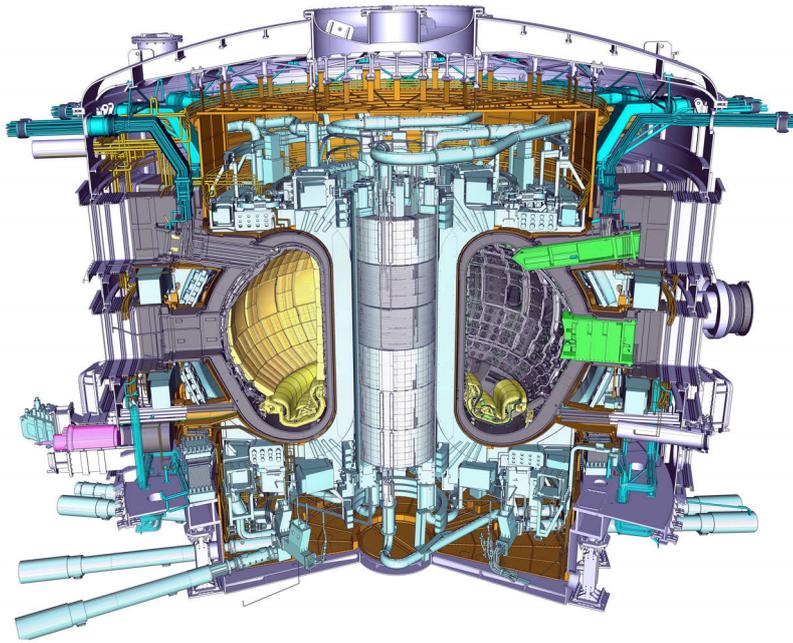
Figure 2-2: The ITER tokamak reactor design. The fuel is contained in a doughnut-shaped vessel and heated to 10 times the temperature of the sun's core, forming a plasma. [iter.org]

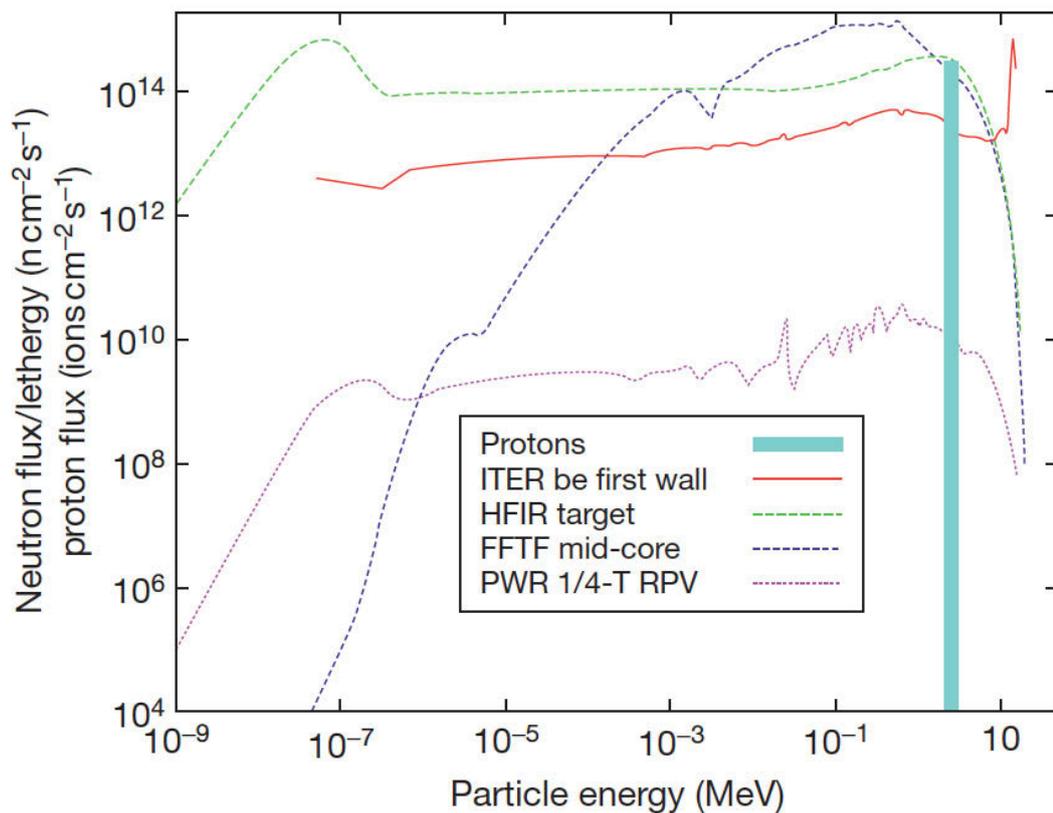
Figure 3-1: The energy spectrum for neutrons taken from a variety of reactor types and a monoenergetic proton beam. Reproduced from Stoller, R. E.; Greenwood, L. R. J. Nucl. Mater. 1999, 271–272, 57–62.

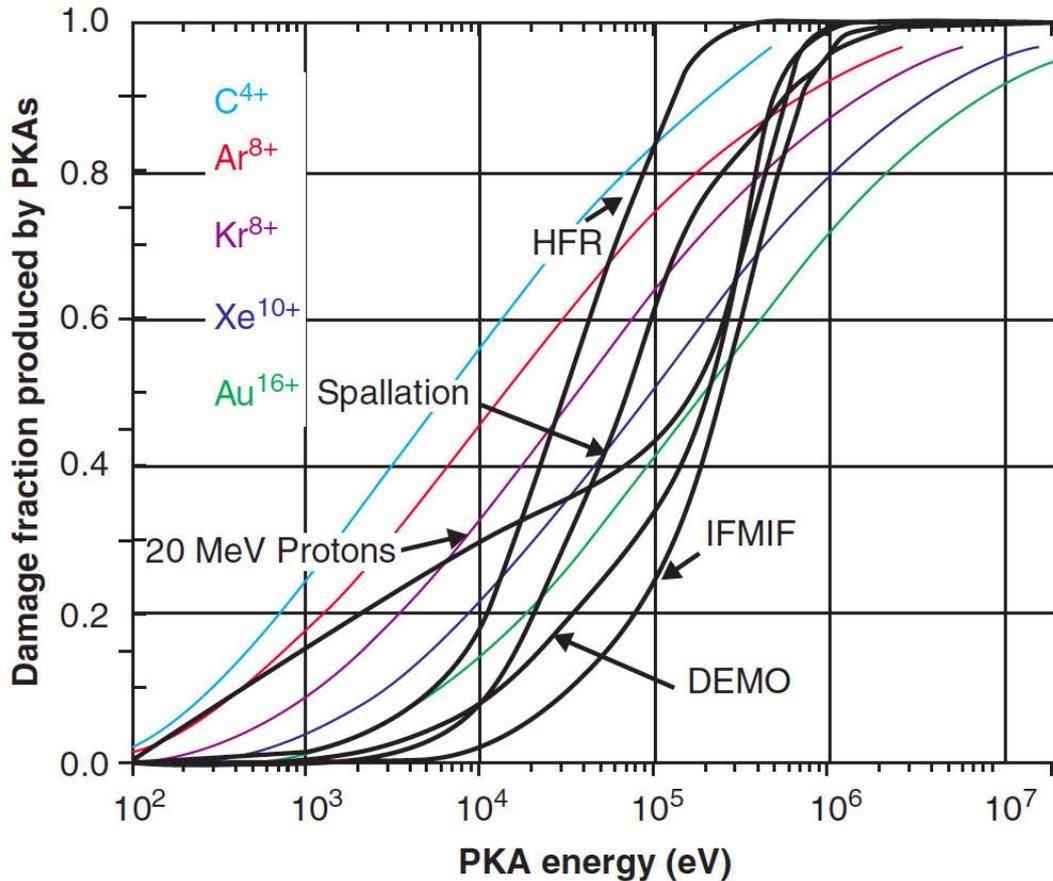
Figure 3-2: Primary knock-on atom (PKA) damage fraction produced as a function of PKA energy for three neutron spectra (DEMO, IFMIF, and HFR) compared with ion-beams (20MeV and 10MeV heavy ions). Serruys et al. (2008) [38].

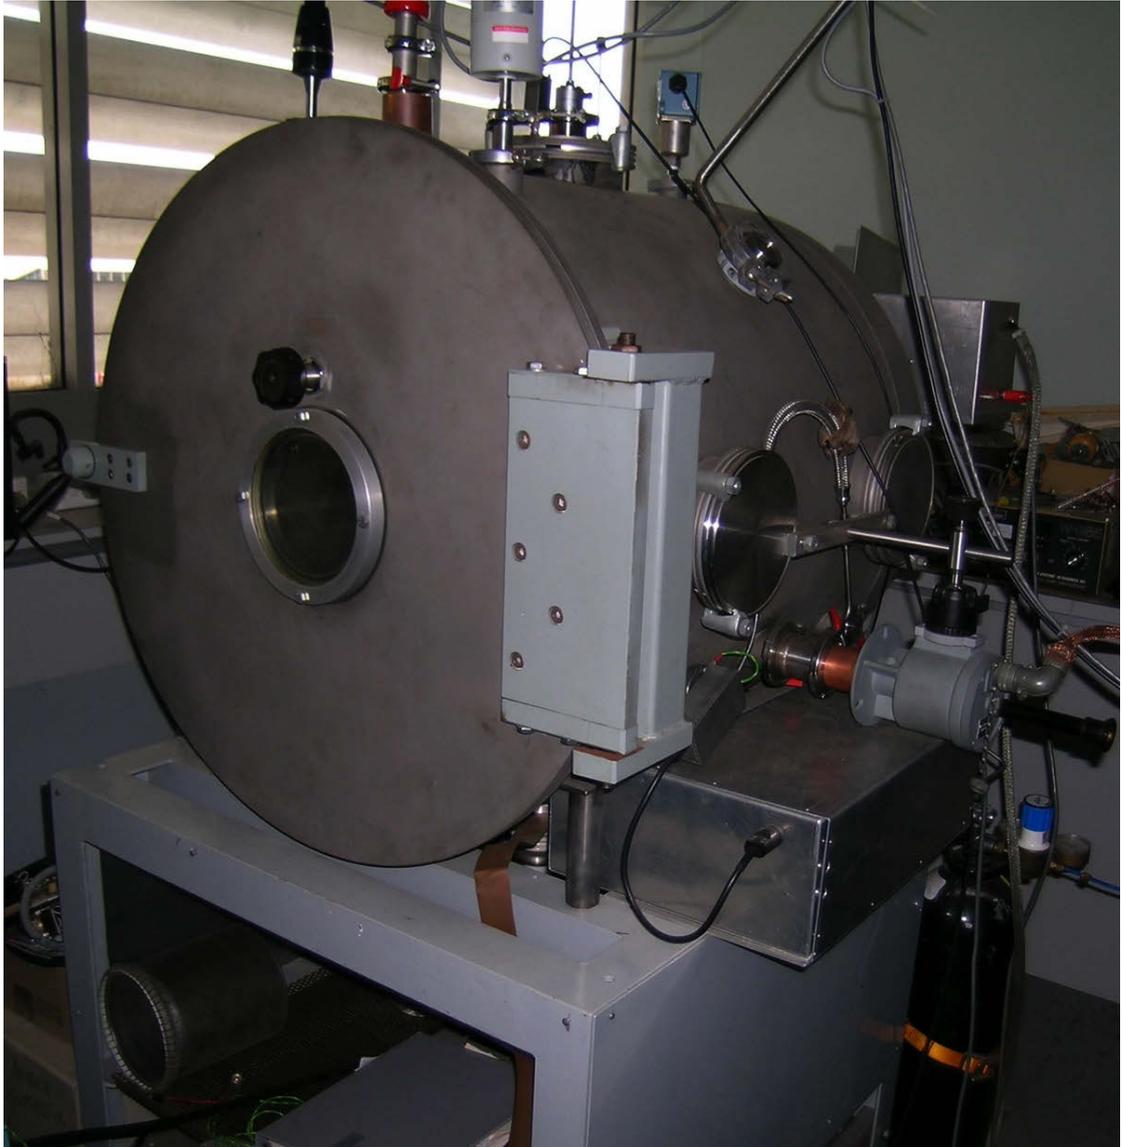
Figure 4-1: Plasma immersion ion implantation (PI³) instrument used for this project, which is housed at the Institute of Materials Engineering, ANSTO.

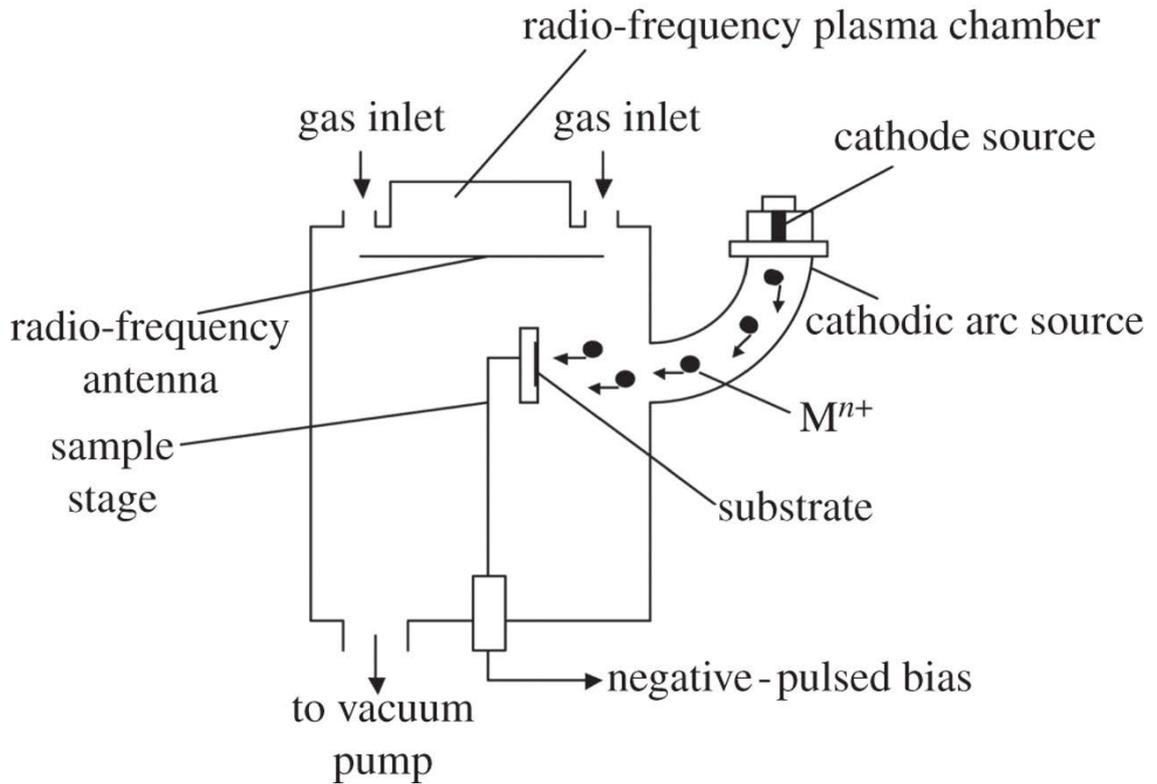
Figure 4-2: Schematic diagram showing the plasma immersion ion implantation (PI³) process [54].

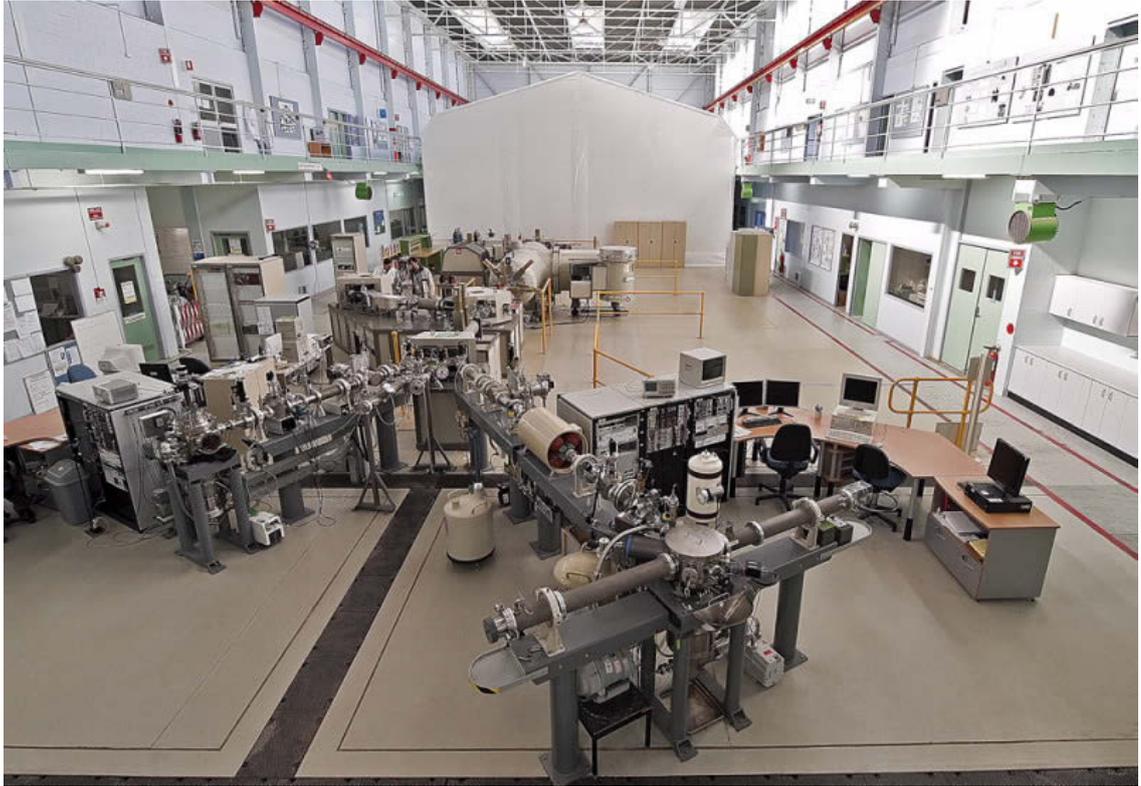
Figure 4-3: The STAR accelerator used for this project, which is housed at the Centre for Accelerator Science, ANSTO.

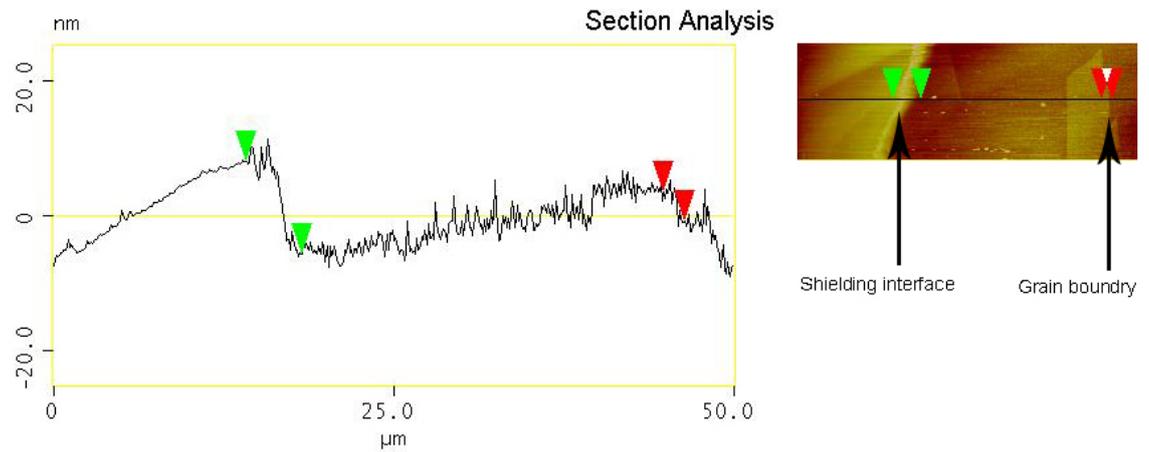
Figure 6-1: Atomic Force Microscopy (AFM) showing some evidence (13 nm) of sputtering and surface degradation was measured when using argon ions.

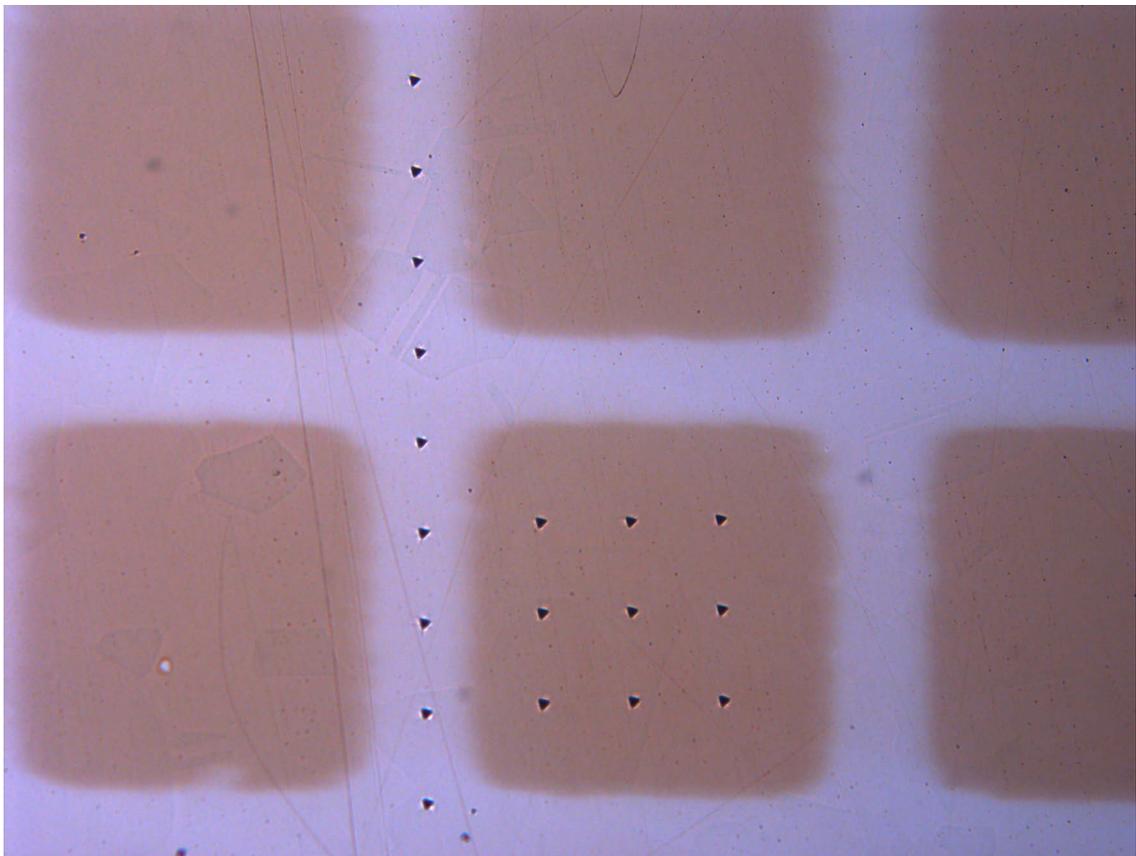
Figure 6-2: Optical image showing the regions where instrumented indentation was performed in the shielded and irradiated regions.

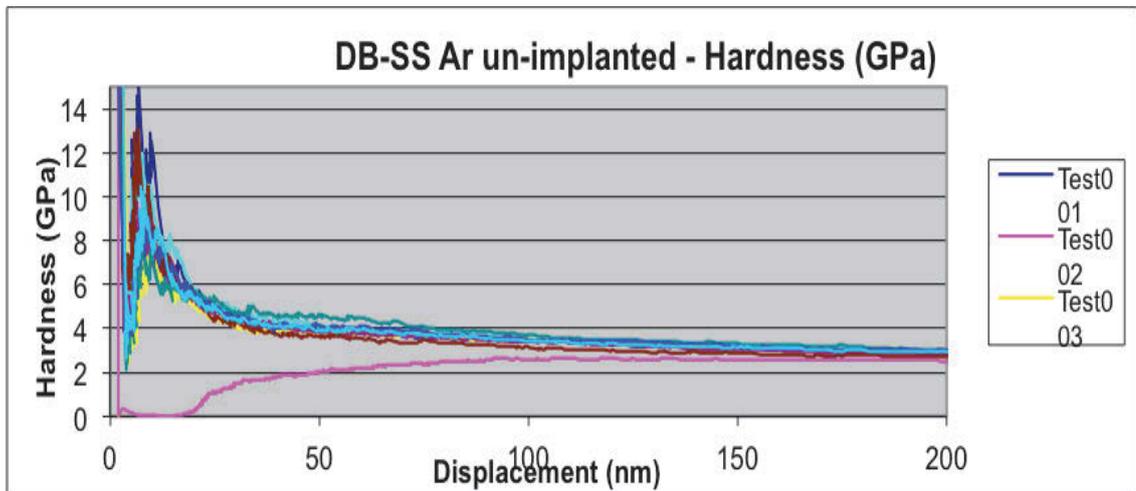
Figure 6-3: Results from the instrumented indentation to a maximum load of 250 mN as performed on the shielded region of the argon implanted steel.

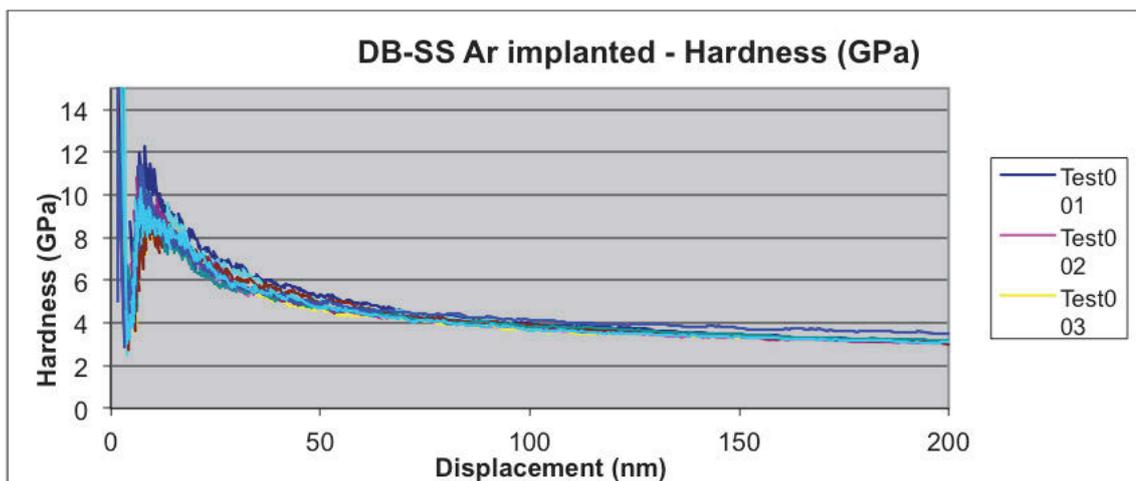
Figure 6-4: Results from the instrumented indentation to a maximum load of 250 mN as performed on the unshielded region of the argon implanted steel.

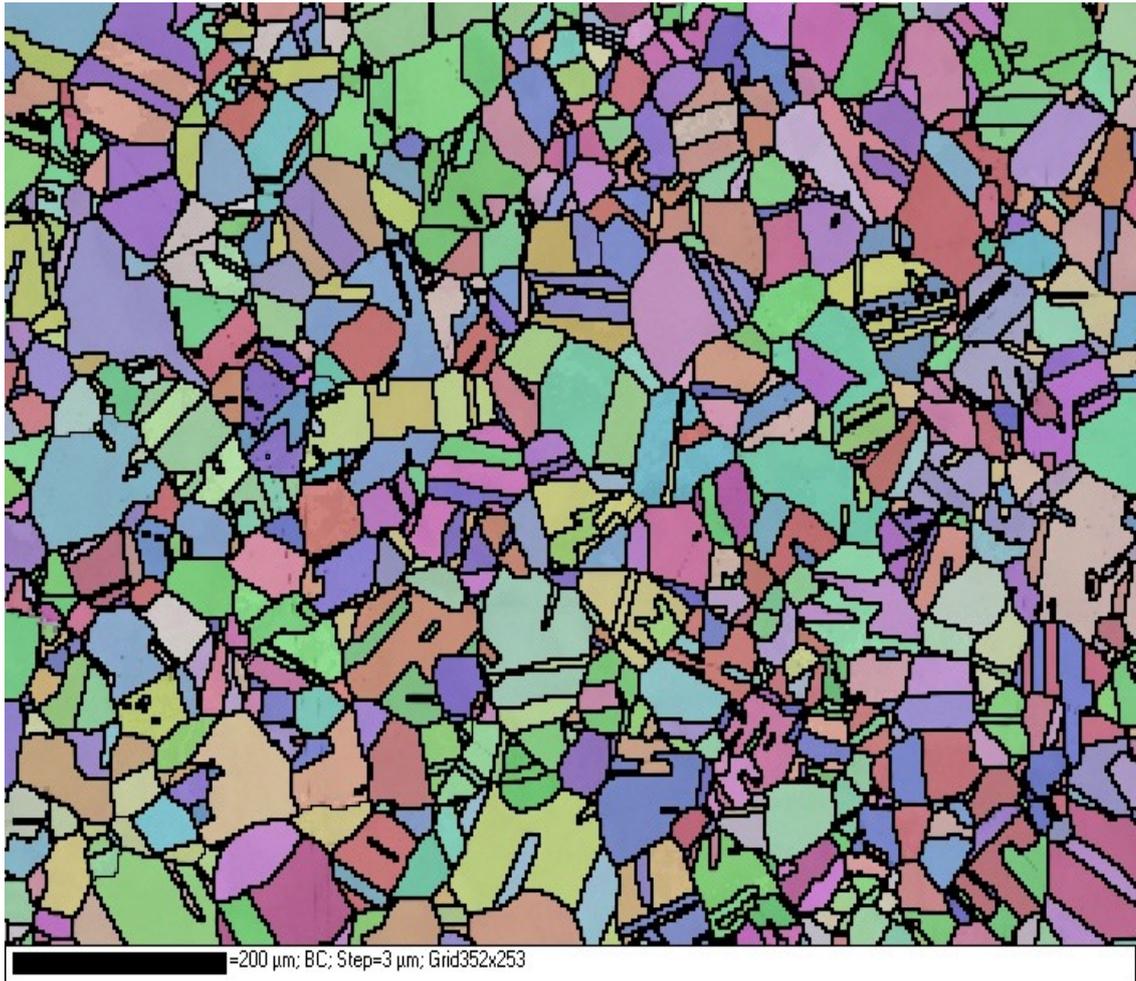
Figure 6-5: EBSD Map of 316 stainless steel before ion implantation. Map shows euler angle colouring with a very high pattern indexing rate.

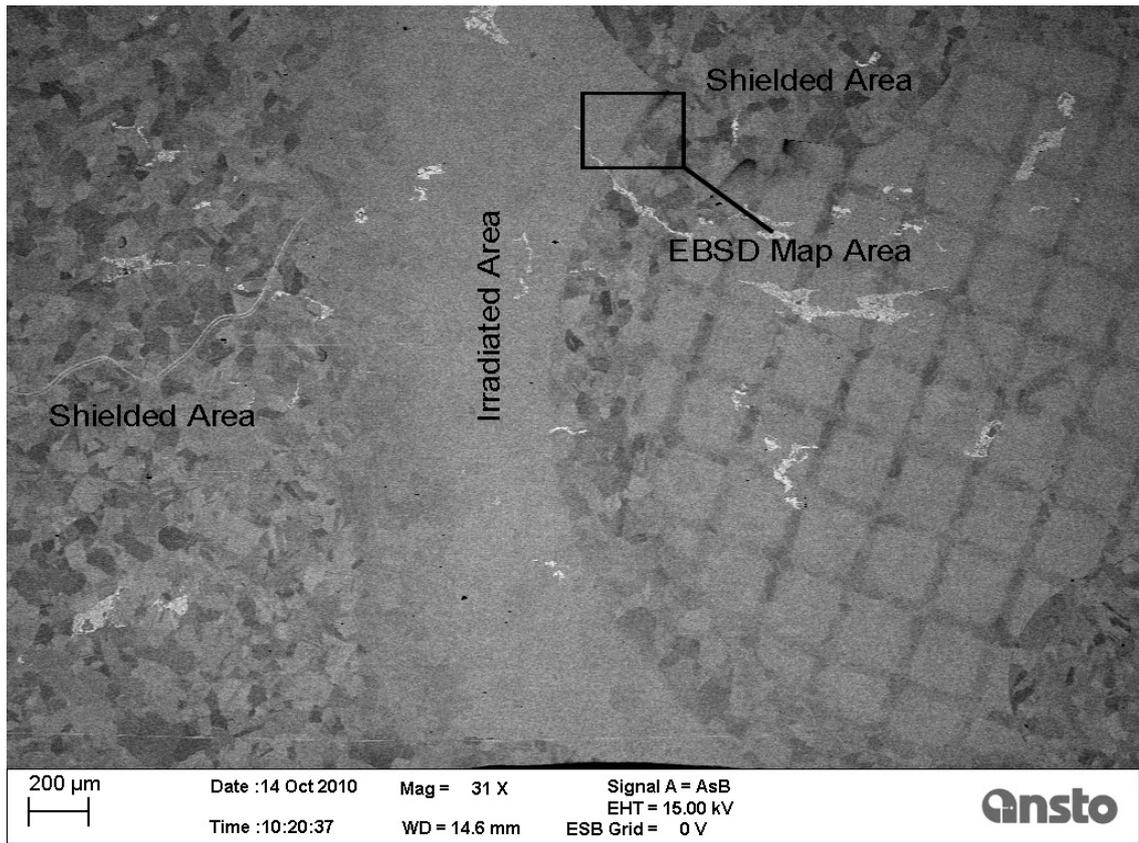
Figure 6-6: Backscattered electron image showing the irradiated and shielded regions and also the region where the EBSD map was taken from on the polished stainless steel surface. Argon ions were used for implantation.

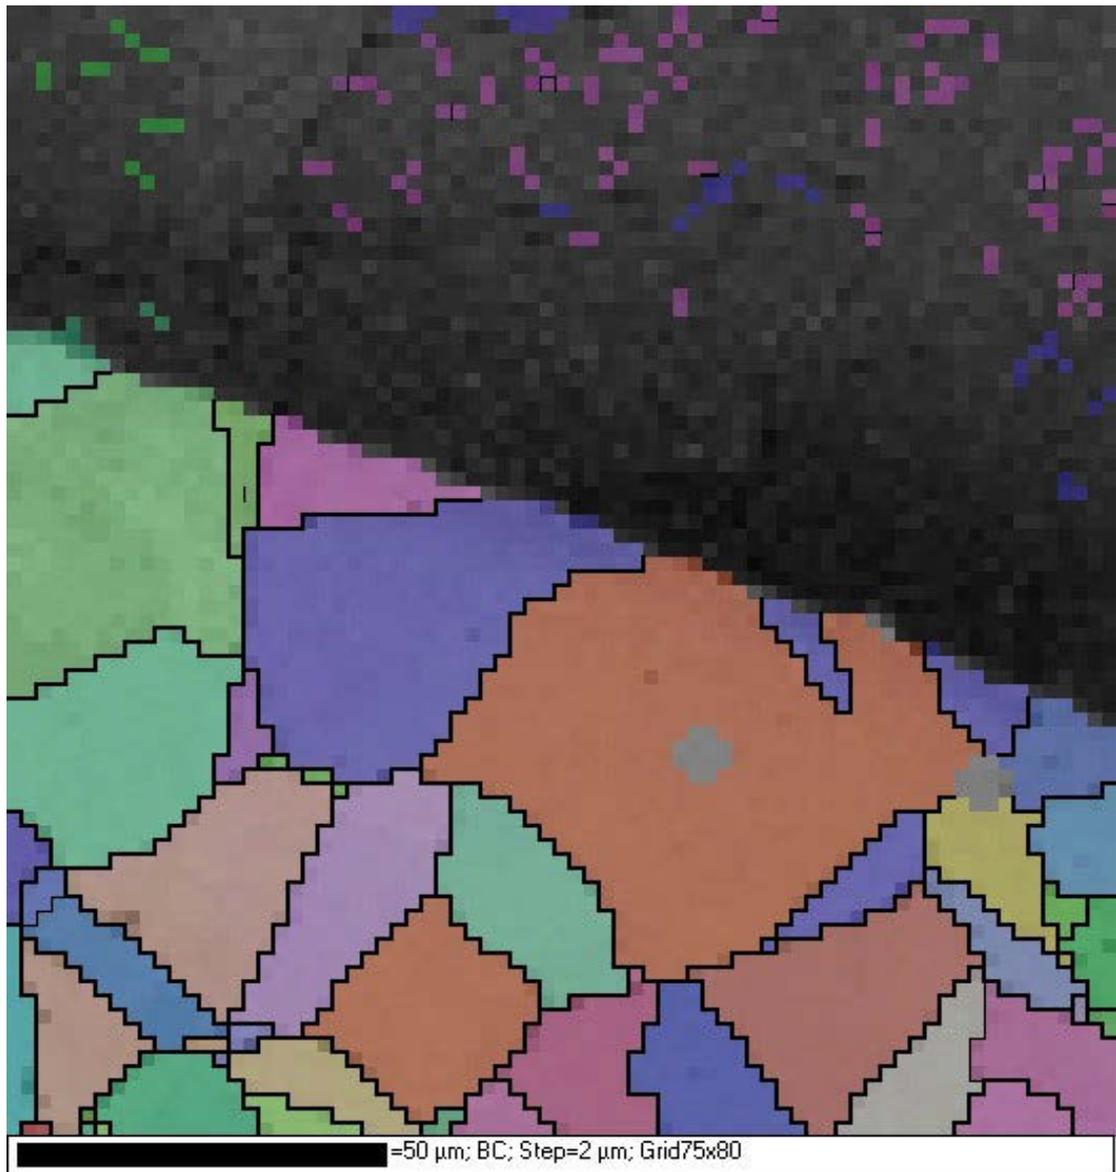
Figure 6-7: Corresponding EBSD map showing the loss of EBSD pattern indexing in the irradiated region (top of map).

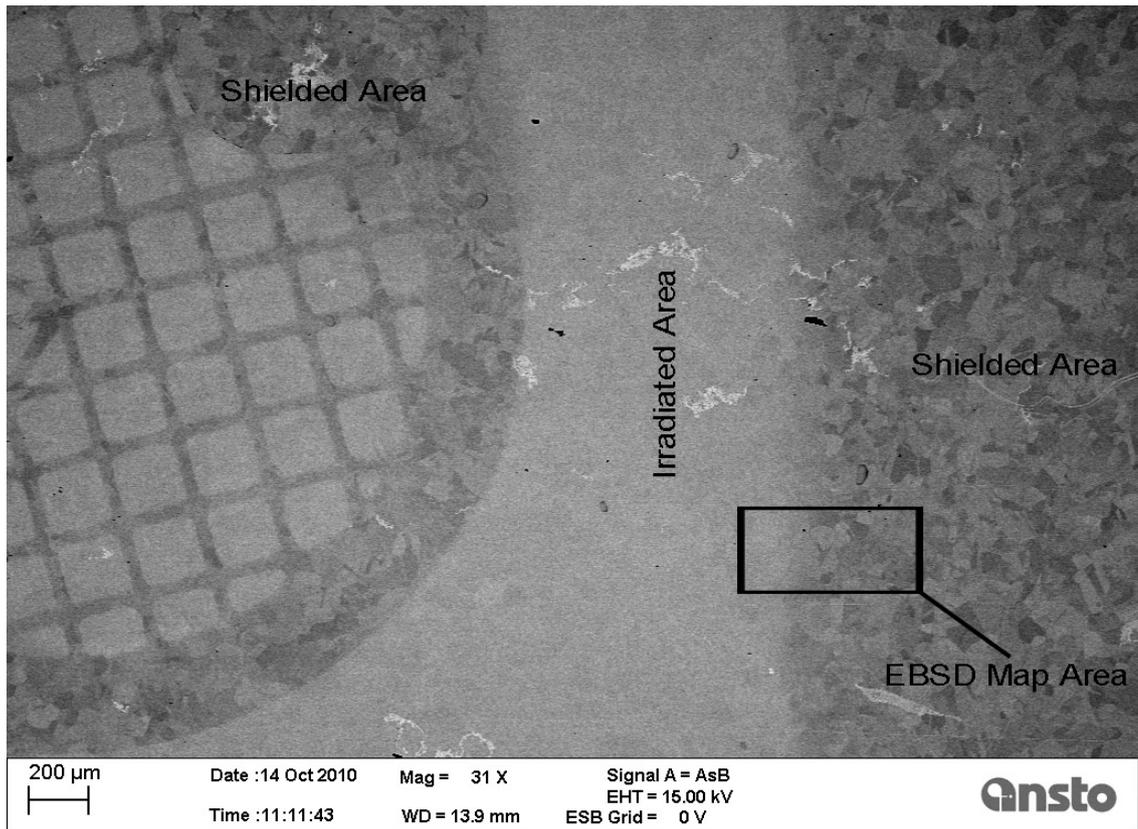
Figure 6-8: Backscattered electron image showing the irradiated and shielded regions and also the region where the EBSD map was taken from on the polished stainless steel surface. Helium ions were used for implantation.

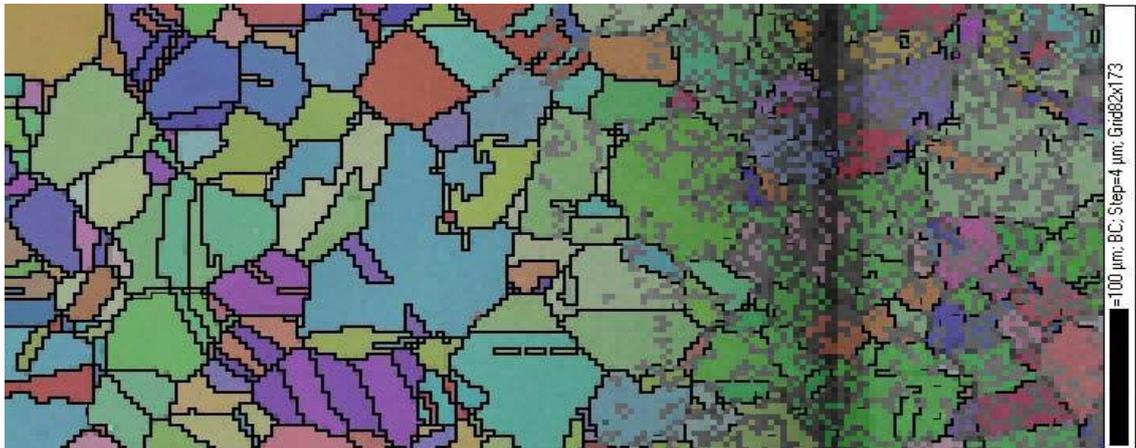
Figure 6-9: Corresponding EBSD map showing the loss of EBSD pattern in the irradiated region (right hand side of the map). Note the area mapped was shielded using a silicon wafer and gave a gradient of damage across the mapped region unlike the hard edge given by the TEM grid used in figure 6.8.

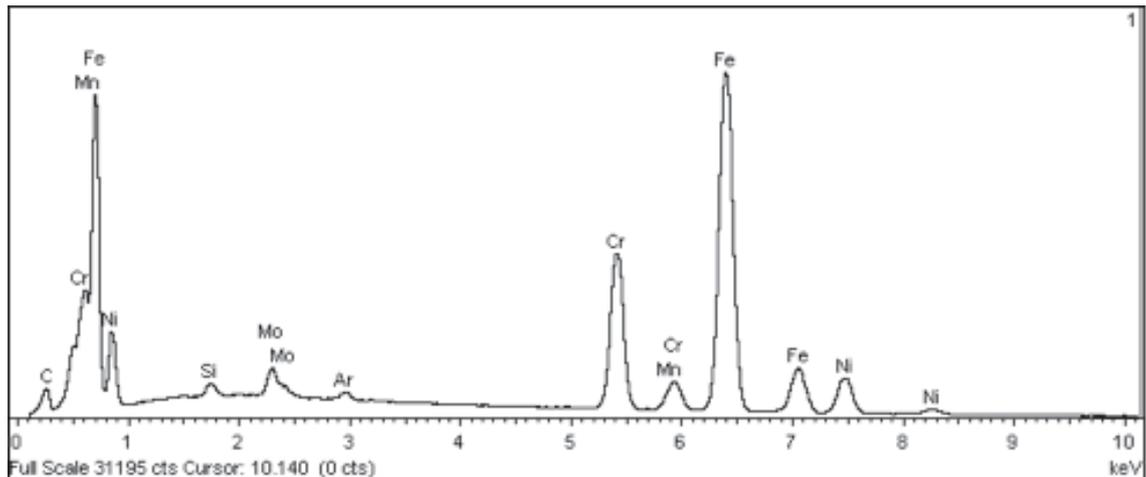
Figure 6-10: EDS spectrum showing argon present in the stainless steel ~0.2 weight % was found. However, this may not be considered representative of the true concentration as the interaction volume of X-ray generation will be predominantly below the region of deposited argon into the surface of the steel. As a result the fraction of argon present may be higher.

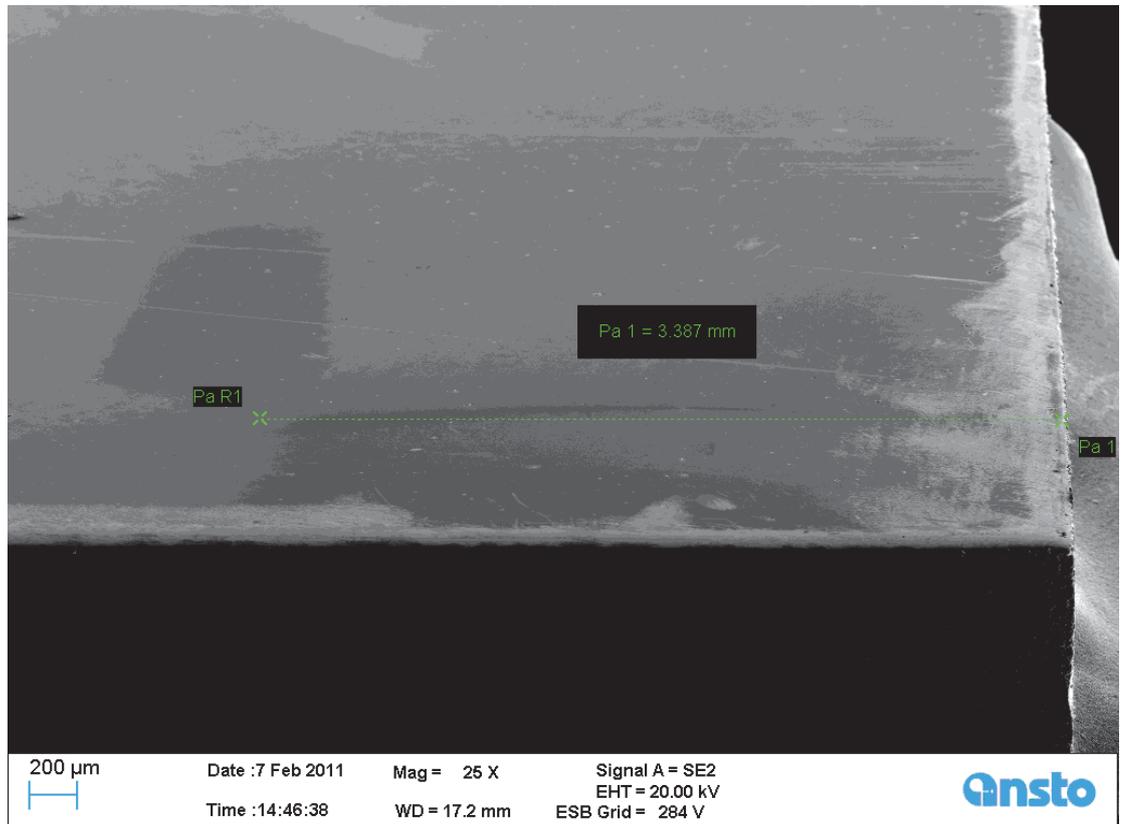
Figure 6-11: Secondary electron image showing the irradiated region.

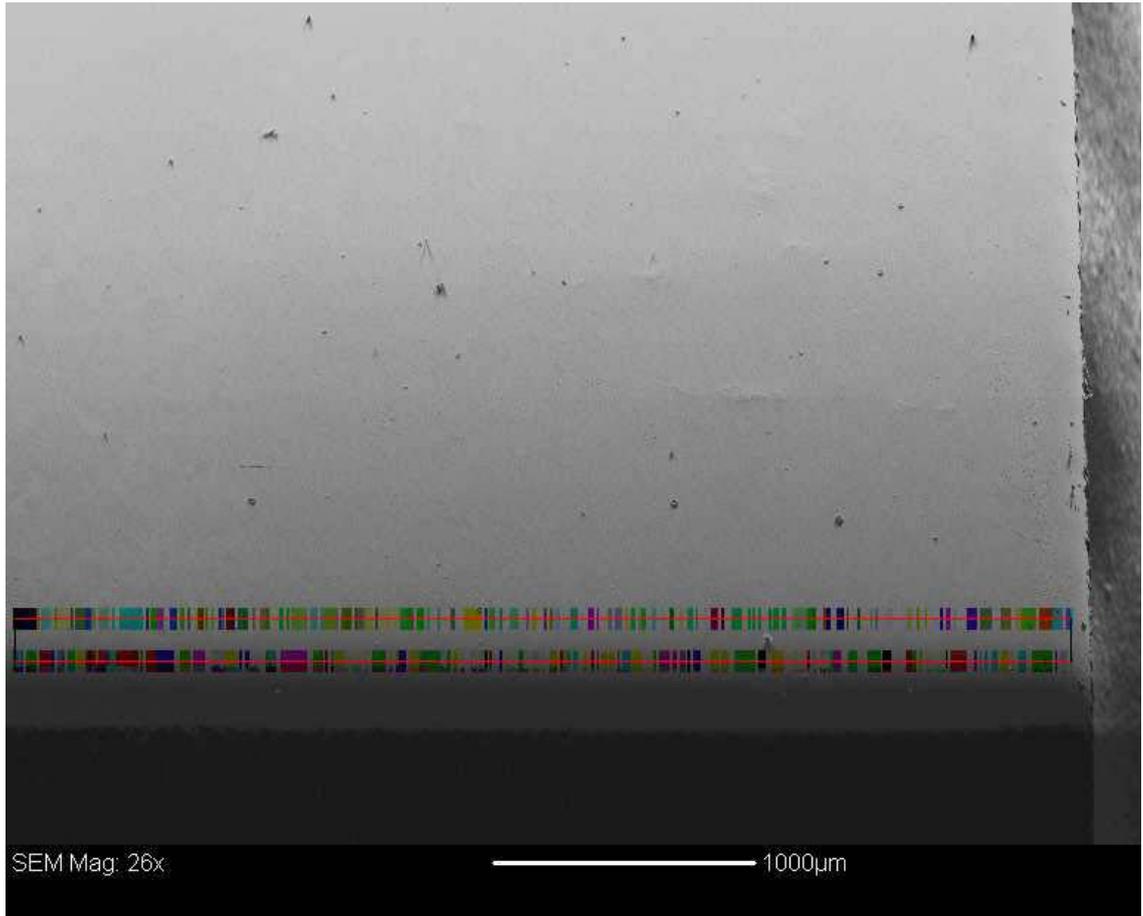
Figure 6-12: Corresponding EBSD line scans showing the EBSD pattern is still present in the irradiated region.

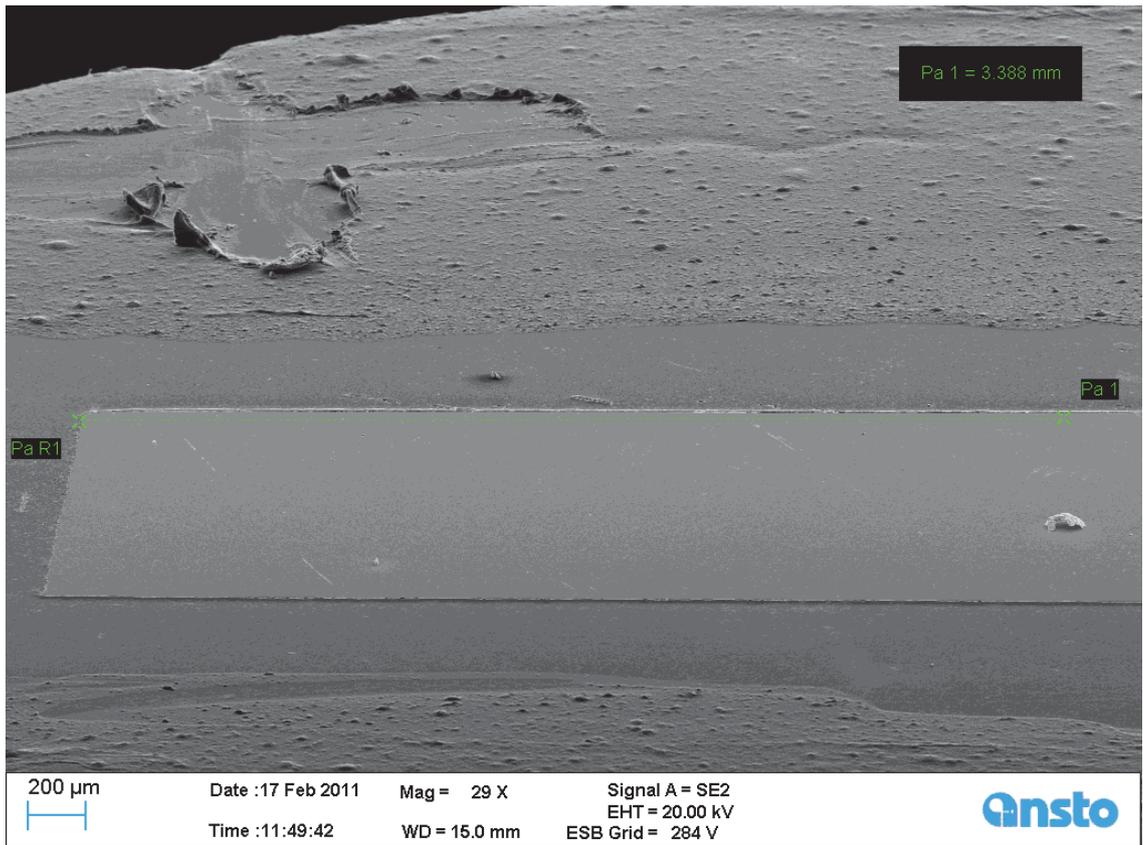
Figure 6-13: Secondary electron image showing the cross-section of the irradiated region mounted in epoxy resin and polished to a 1 micron diamond finish. Figure 6-14 below shows this region in high magnification.

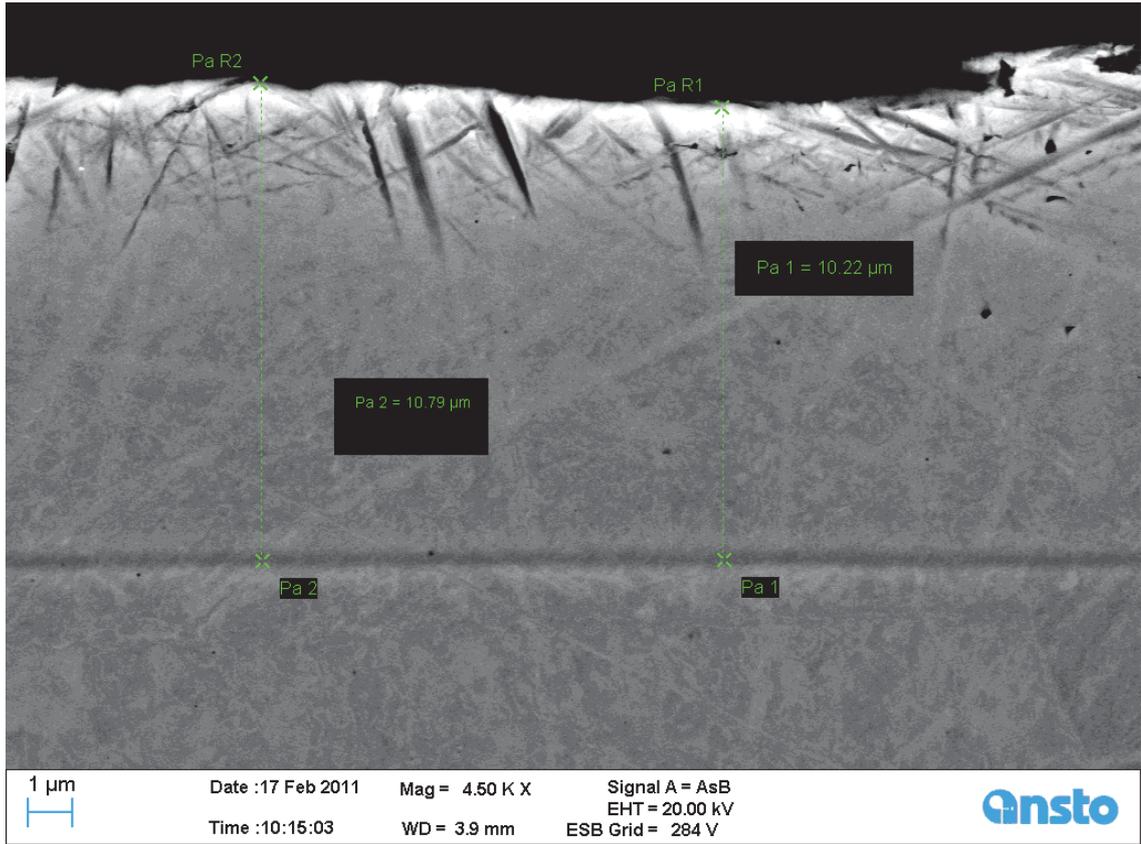
Figure 6-14: Backscattered electron channeling contrast image showing the cross-section of the irradiated region and a line of radiation damage caused by the helium ions approximately $10\mu\text{m}$ under the surface. Scratches remain in the top edge of the cross section due to edge rounding during mechanical polishing.

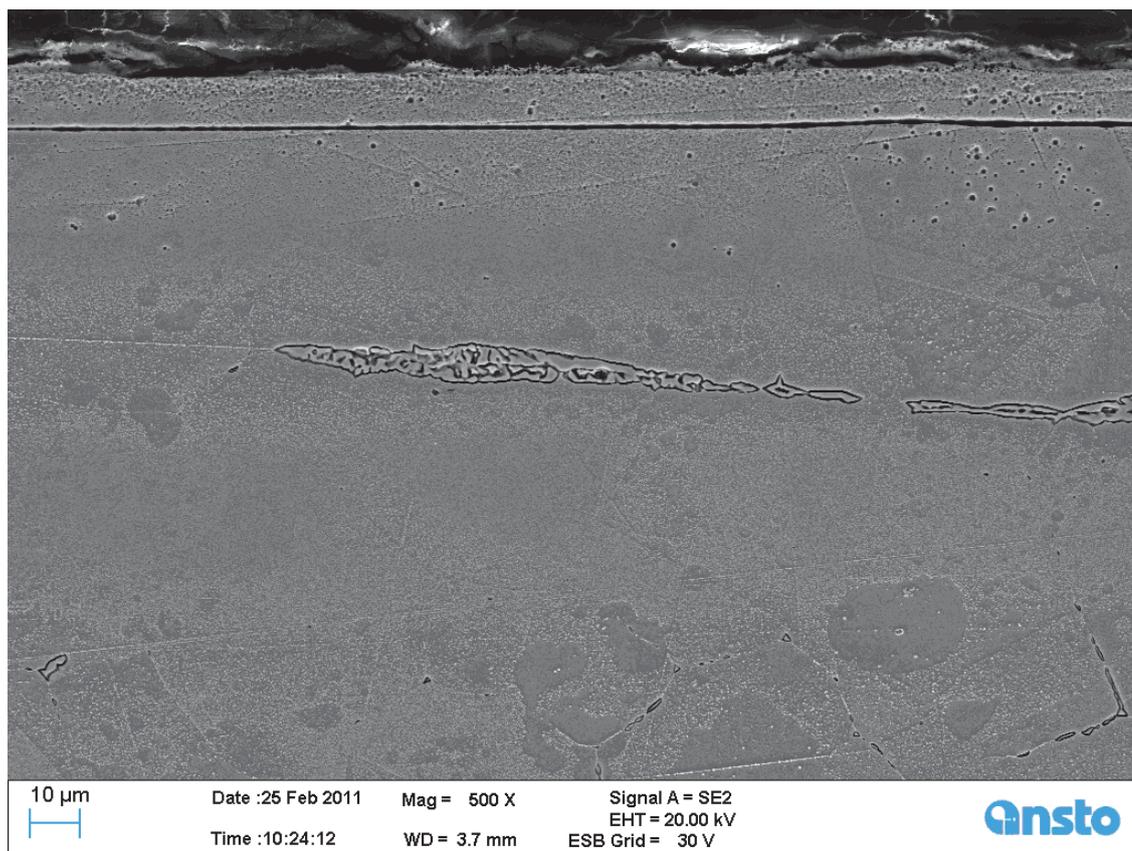
Figure 6-15: Secondary electron image showing the cross-section of the irradiated sample after heavy etching. The line of radiation damage caused by the helium ions approximately $10\mu\text{m}$ under the surface has been completely etched away.

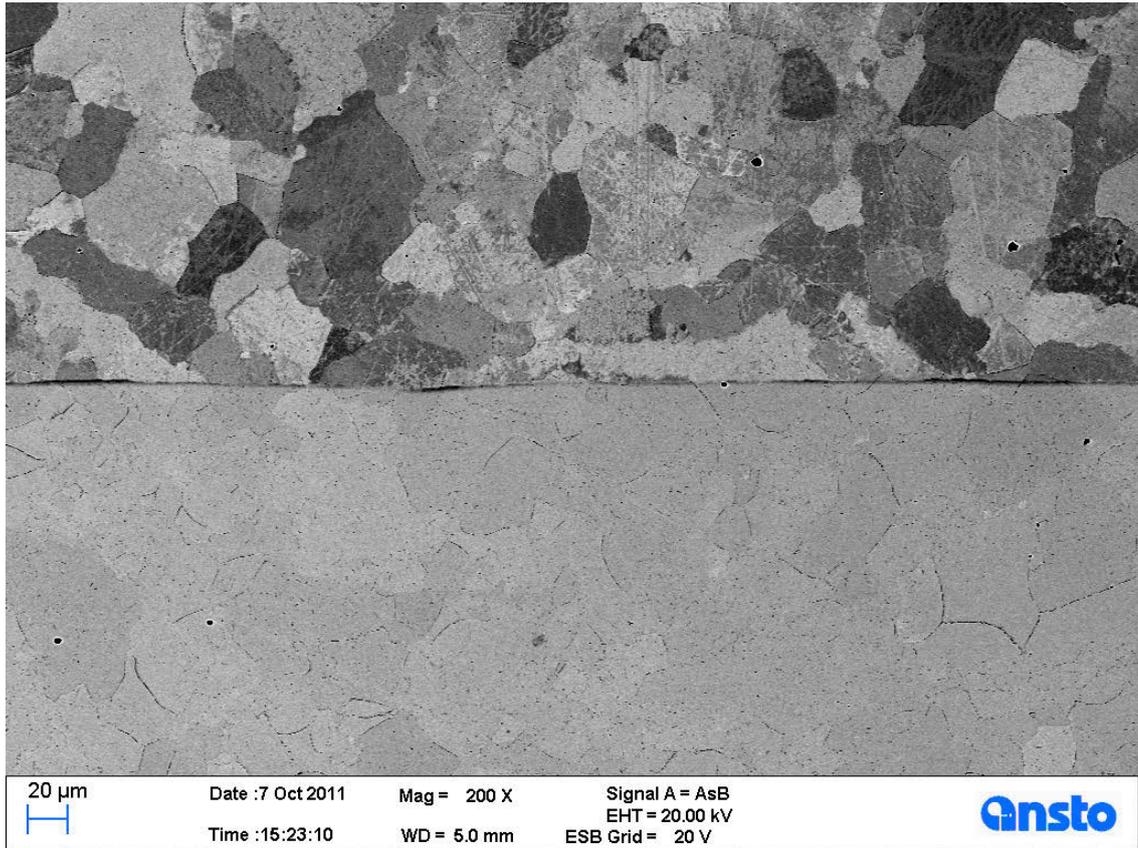
Figure 6-16: Backscattered electron channeling contrast image showing the irradiated and shielded regions of the 430 grade stainless steel. The region where the EBSD map was taken from on the polished stainless steel surface is also shown. Helium ions were used for implantation.

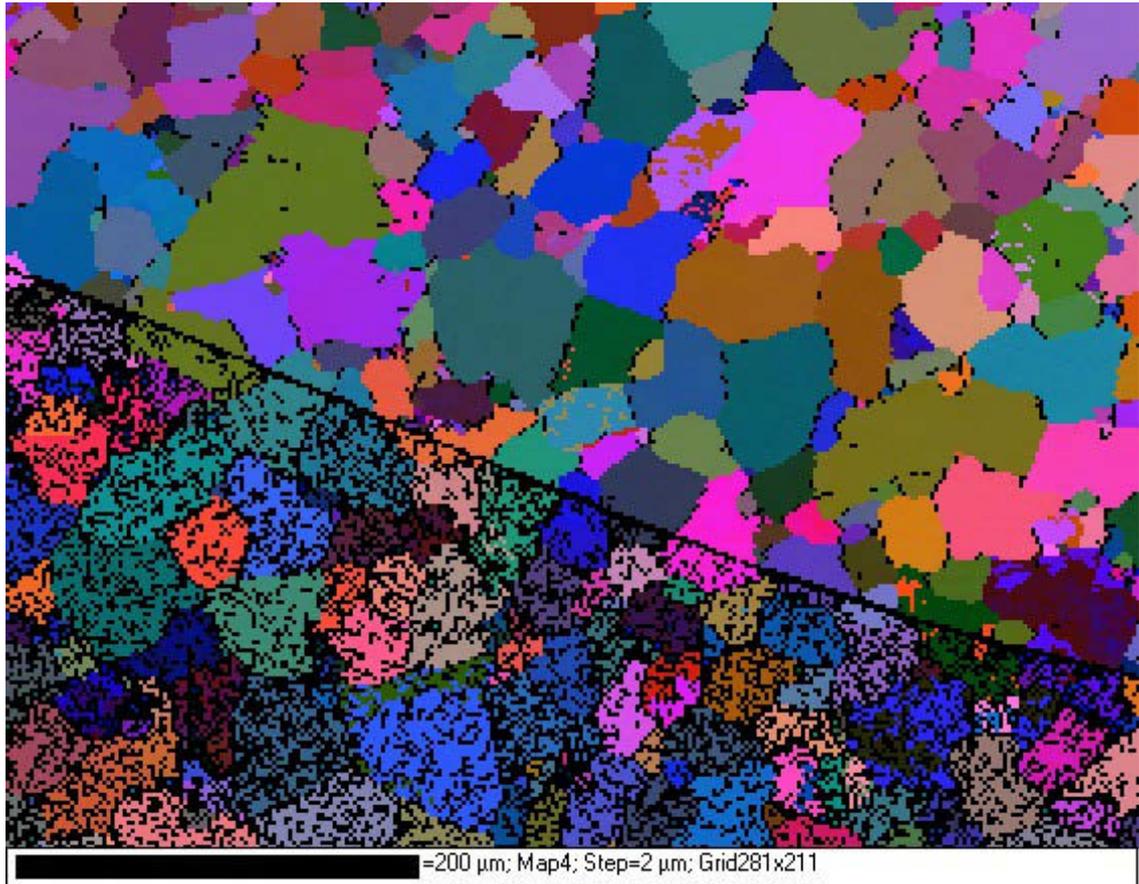
Figure 6-17: EBSD orientation map showing the partial indexing of the EBSD pattern in the non-shielded irradiated region (lower half) of the 430 grade stainless steel.

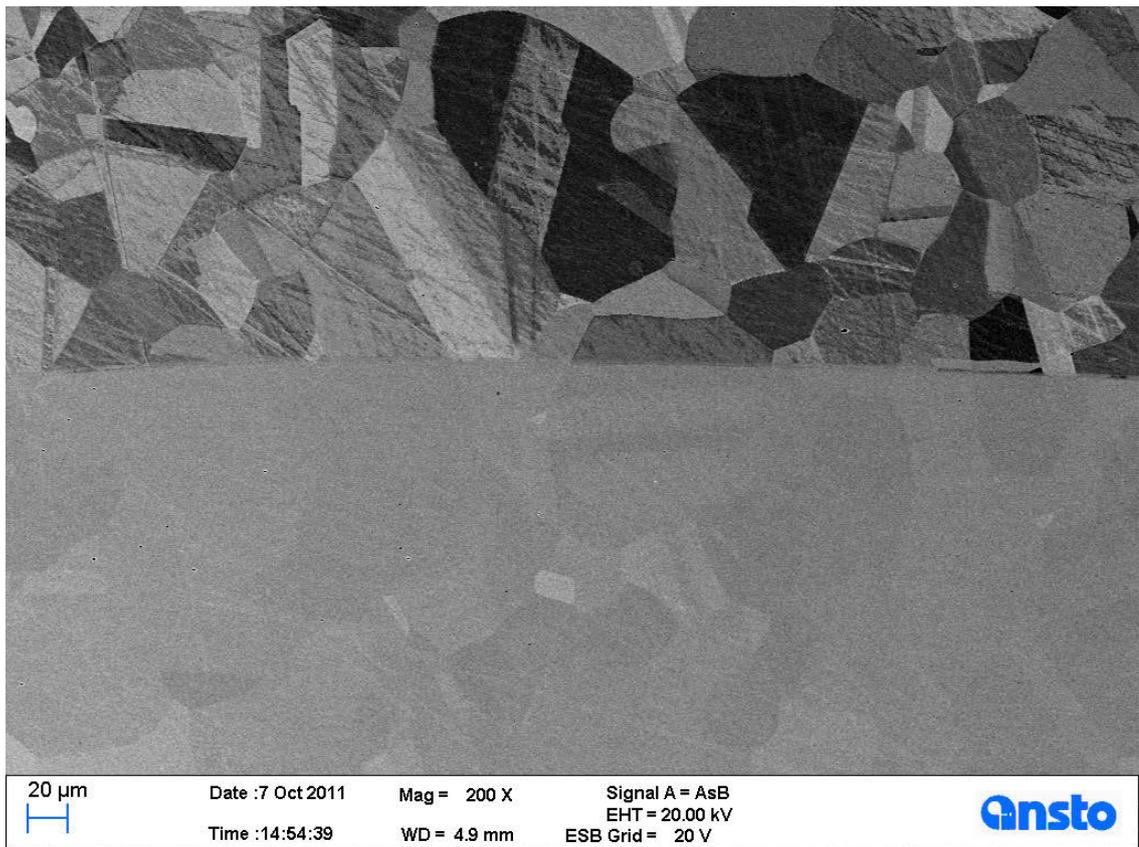
Figure 6-18: Backscattered electron channelling contrast image showing the irradiated (lower) and shielded region (upper) of the 304 grade stainless steel. Helium ions were used for implantation.
