Radiation Damage
Effects within Materials

A Thesis Submitted for the degree of
Master of Science by Research

University of Technology, Sydney

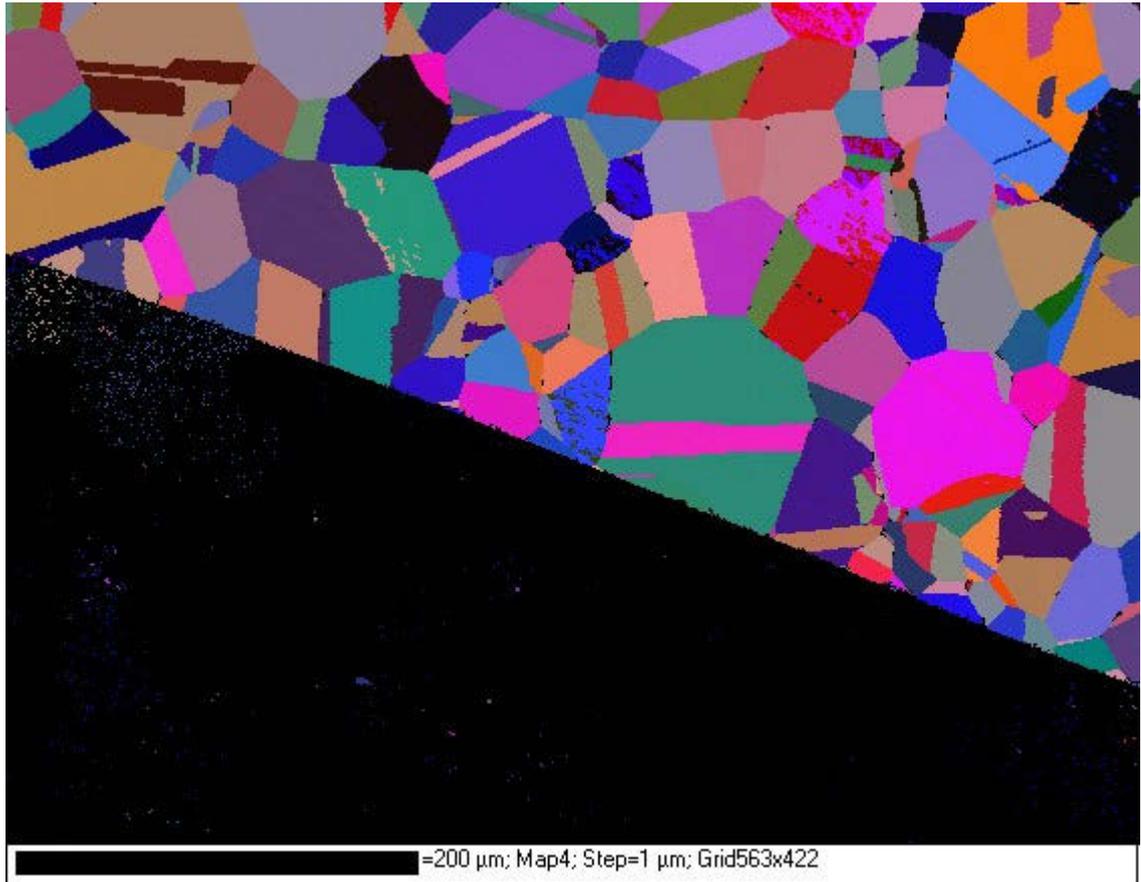
Figure 6-19: EBSD orientation map showing the complete loss of indexing of the EBSD pattern in the irradiated region (lower half) of the 304 grade stainless steel.

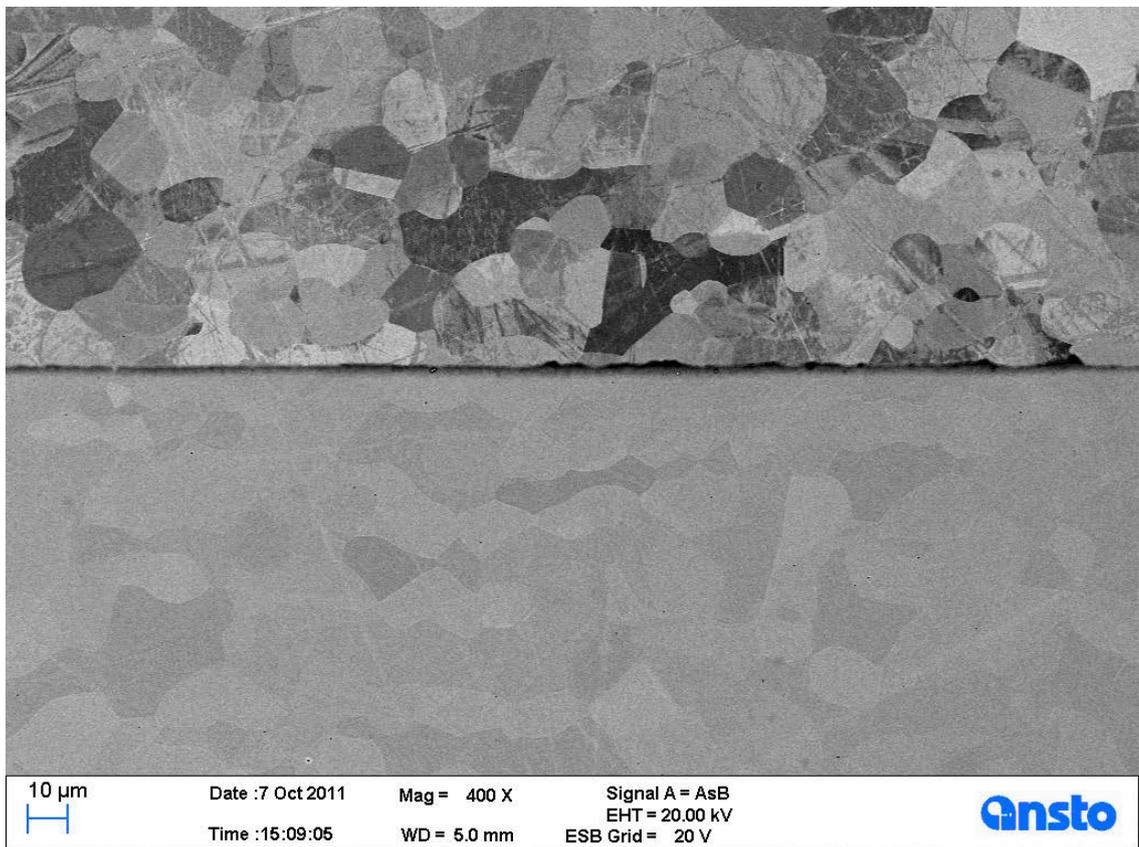
Figure 6-20: Backscattered electron channeling contrast image showing the irradiated and shielded regions of the 2205 grade stainless steel. The region where the EBSD map was taken from on the polished stainless steel surface is also shown. Helium ions were used for implantation.

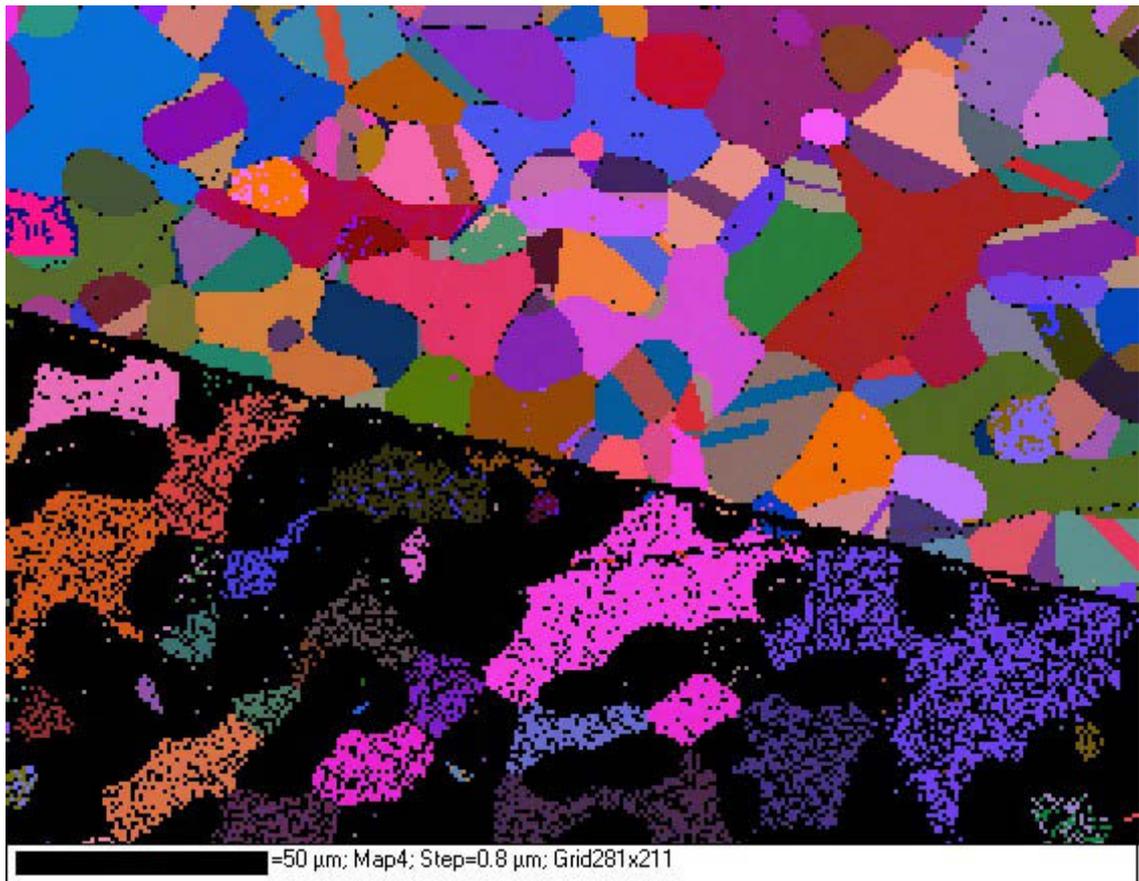
Figure 6-21: EBSD orientation map showing the partial or complete loss of pattern indexing from the grains in the irradiated region (lower half) of the 2205 grade steel.

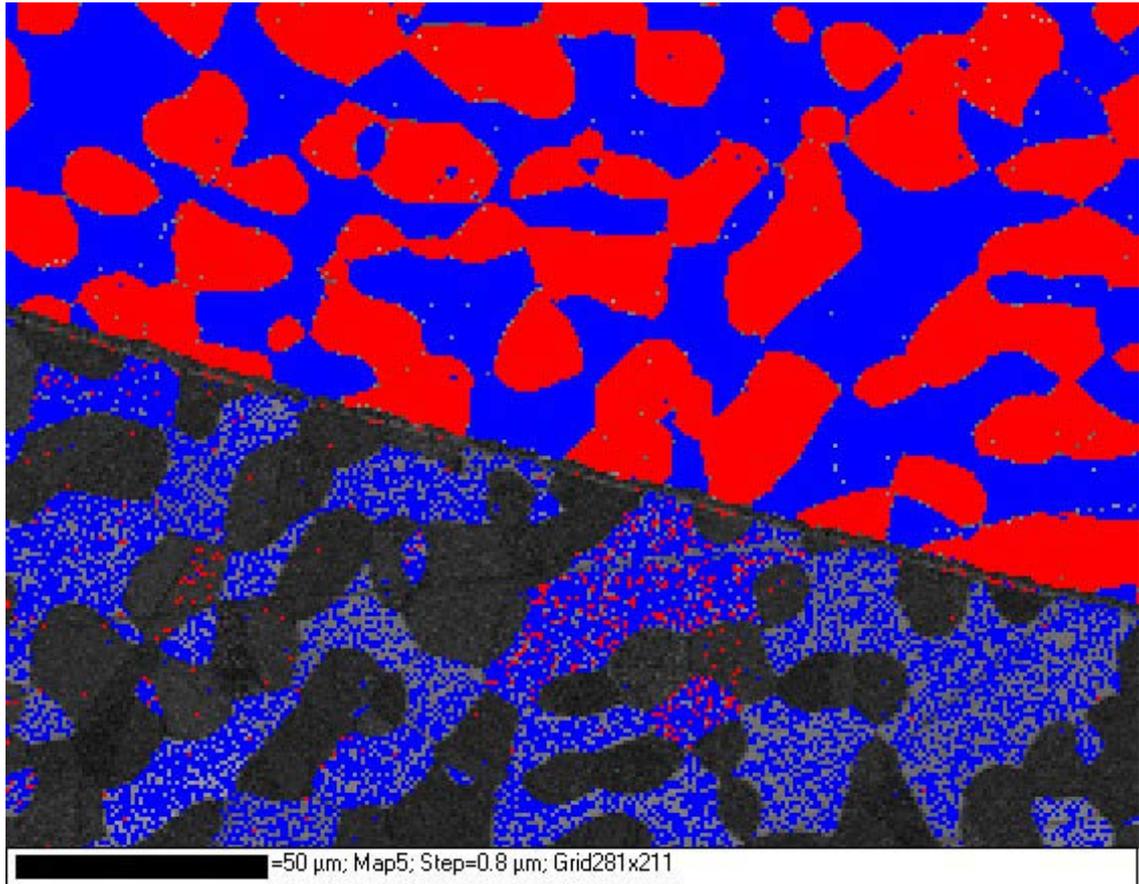
Figure 6-22: EBSD phase map showing the irradiated region (lower half) of the 2205 grade steel. The red colour is the FCC phase and the blue colour is the BCC phase. We can see that in the irradiated region (lower half) that the FCC phase was not able to be indexed however the BCC phase still shows partial indexing.

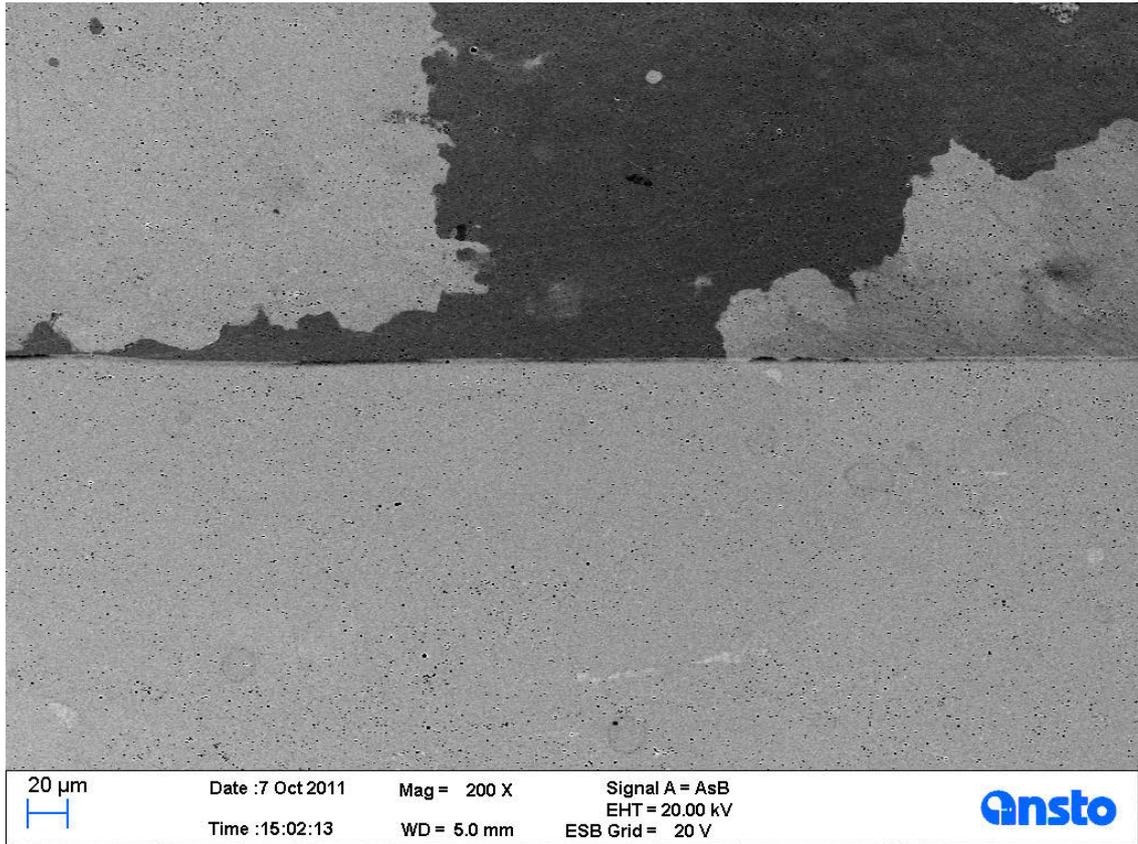
Figure 6-23: Backscattered electron channeling contrast image showing the irradiated (lower) and shielded region (upper) of the MA956 grade stainless steel. Helium ions were used for implantation.

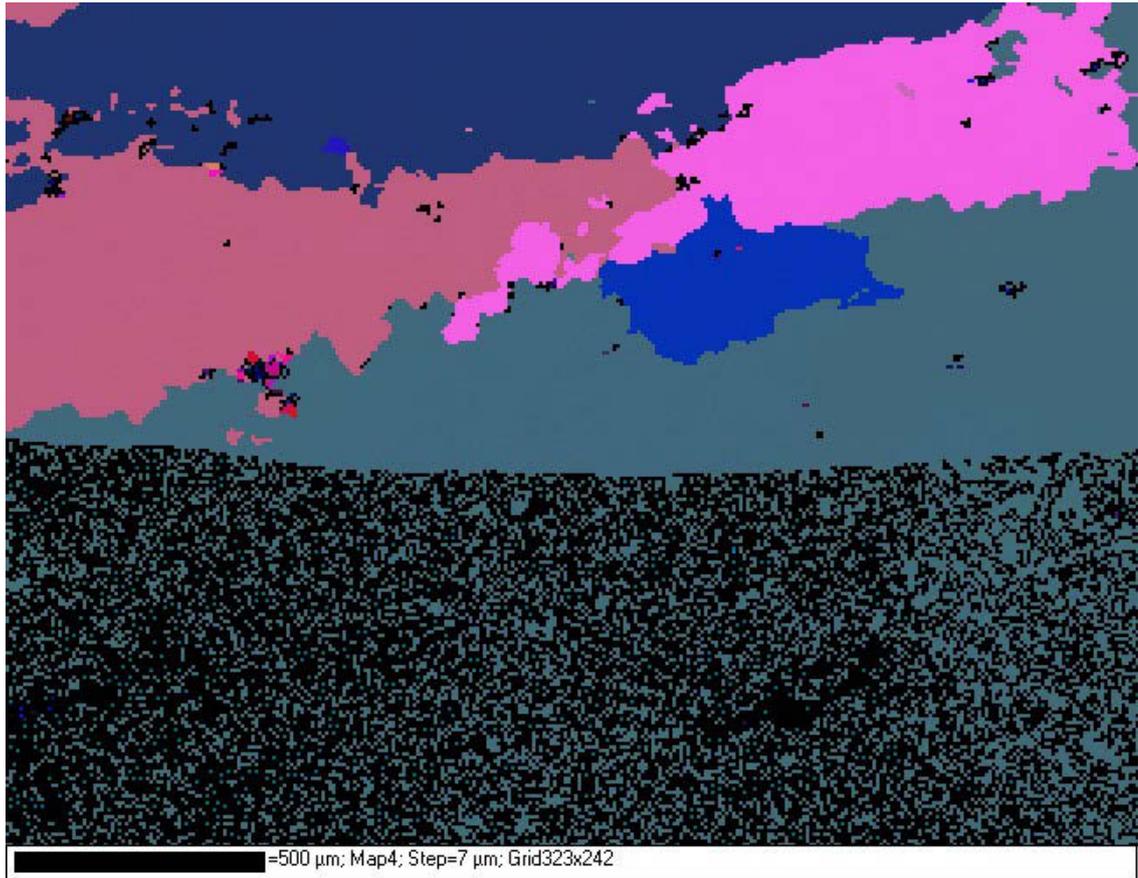
Figure 6-24: EBSD orientation map showing the partial indexing of the EBSD pattern in the irradiated region (lower half) of the MA956 grade stainless steel.

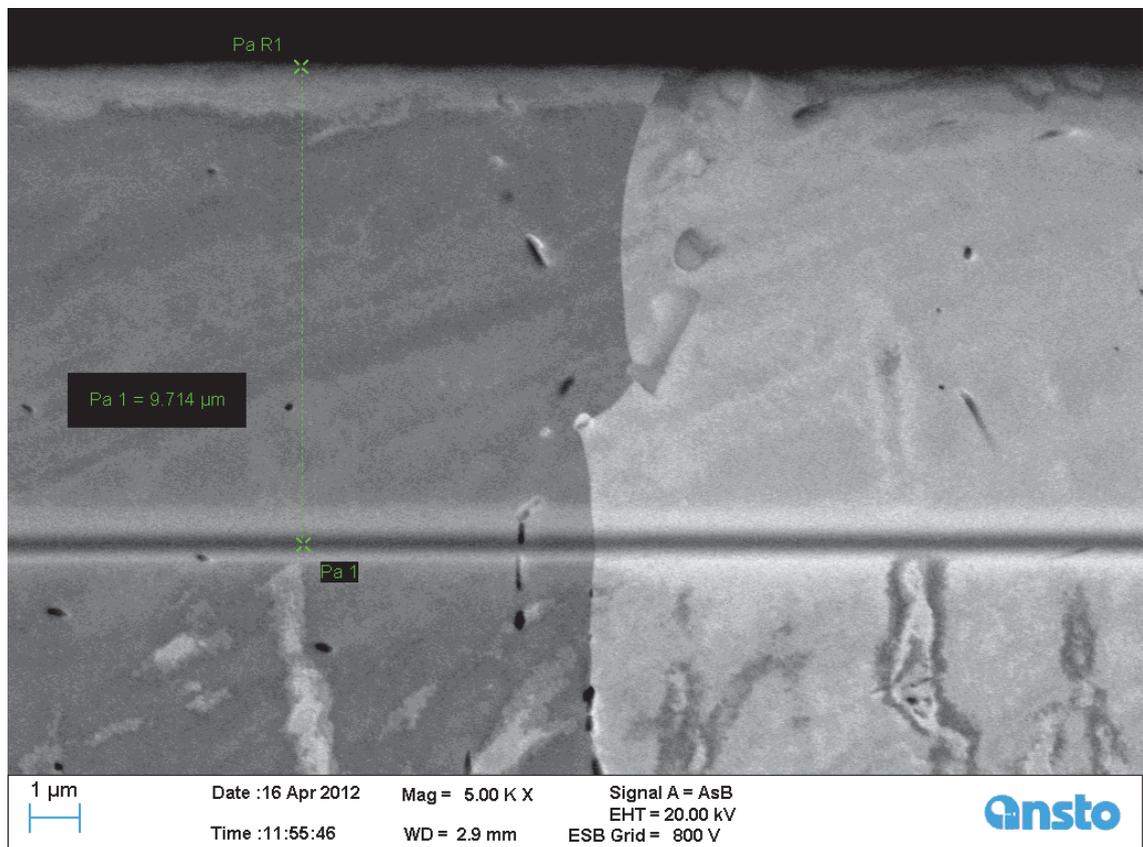
Figure 6-25: Backscattered electron channeling contrast image of the 430 grade steel showing the cross-section of the irradiated region and a line of radiation damage caused by the helium ions approximately 9.7 μm under the surface.

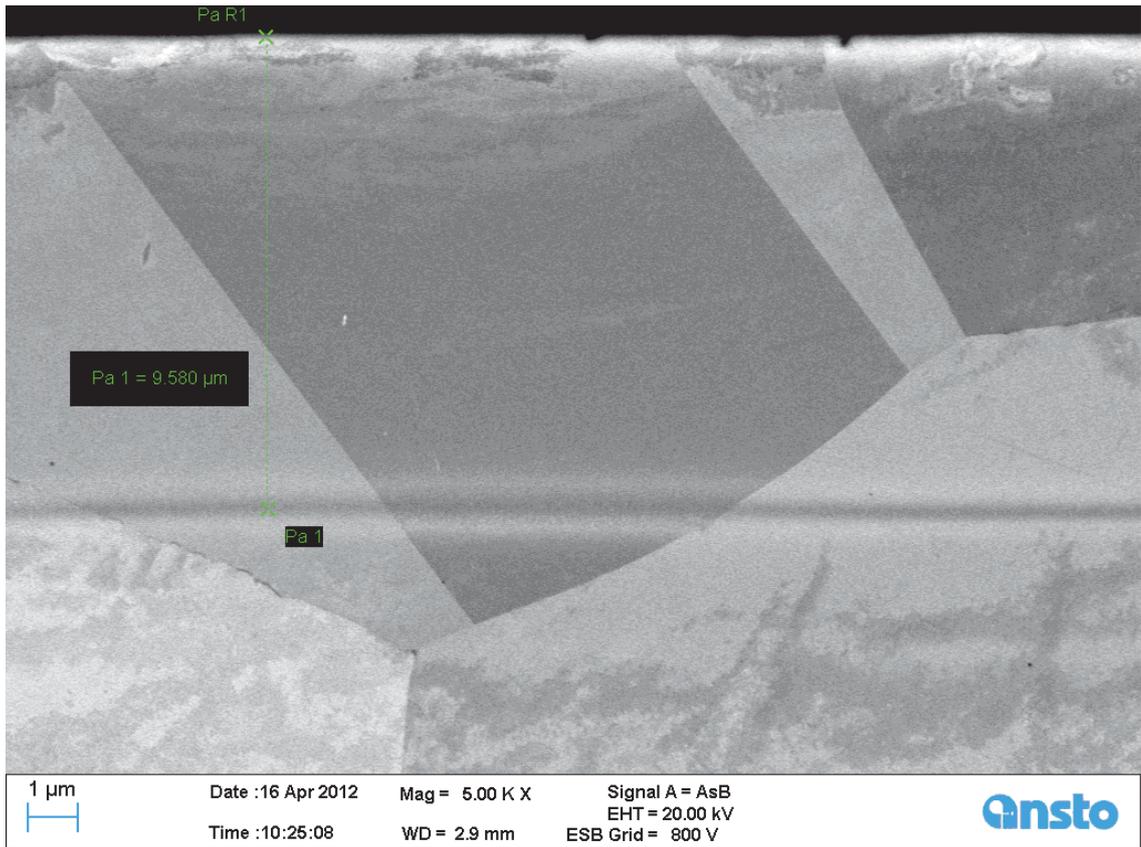
Figure 6-26: Backscattered electron channeling contrast image of the 304 grade steel showing the cross-section of the irradiated region and a line of radiation damage caused by the helium ions approximately 9.6 μm under the surface.

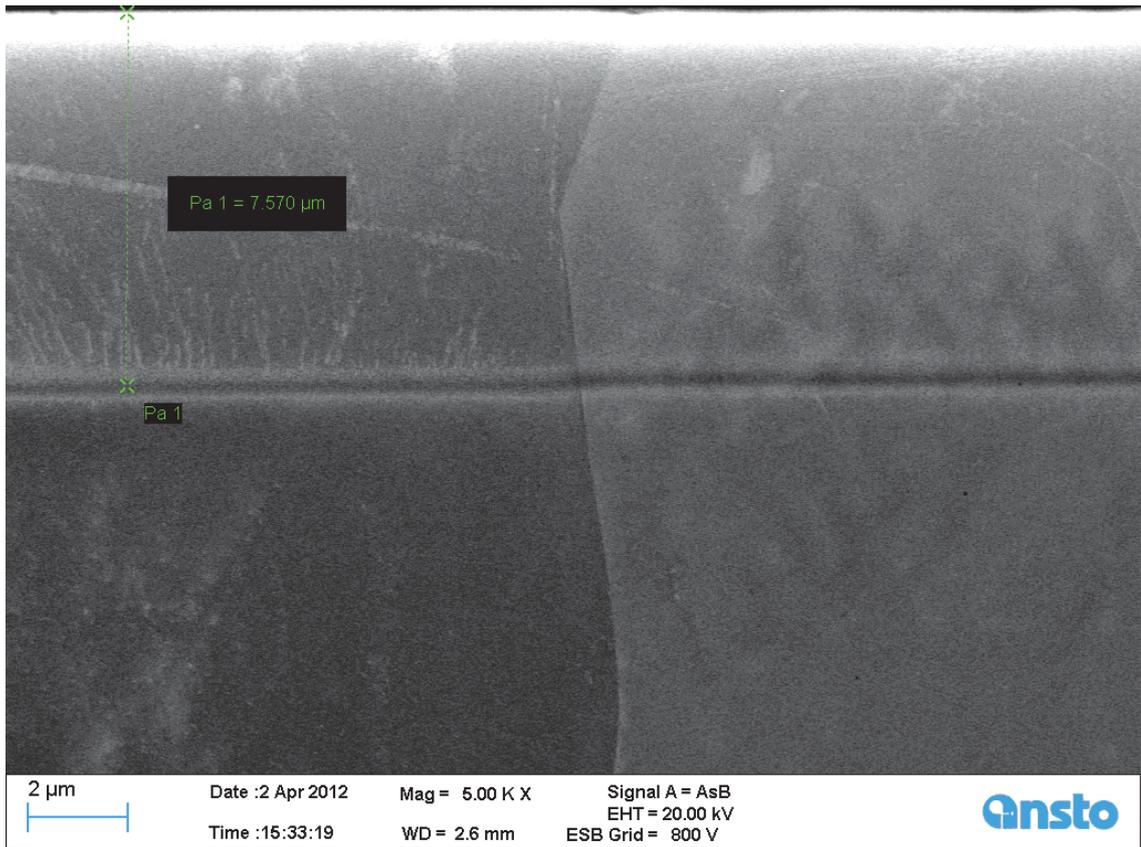
Figure 6-27: Backscattered electron channeling contrast image of the 2205 grade duplex steel showing the cross-section of the irradiated region and a line of radiation damage caused by the helium ions approximately 7.6 μm under the surface.

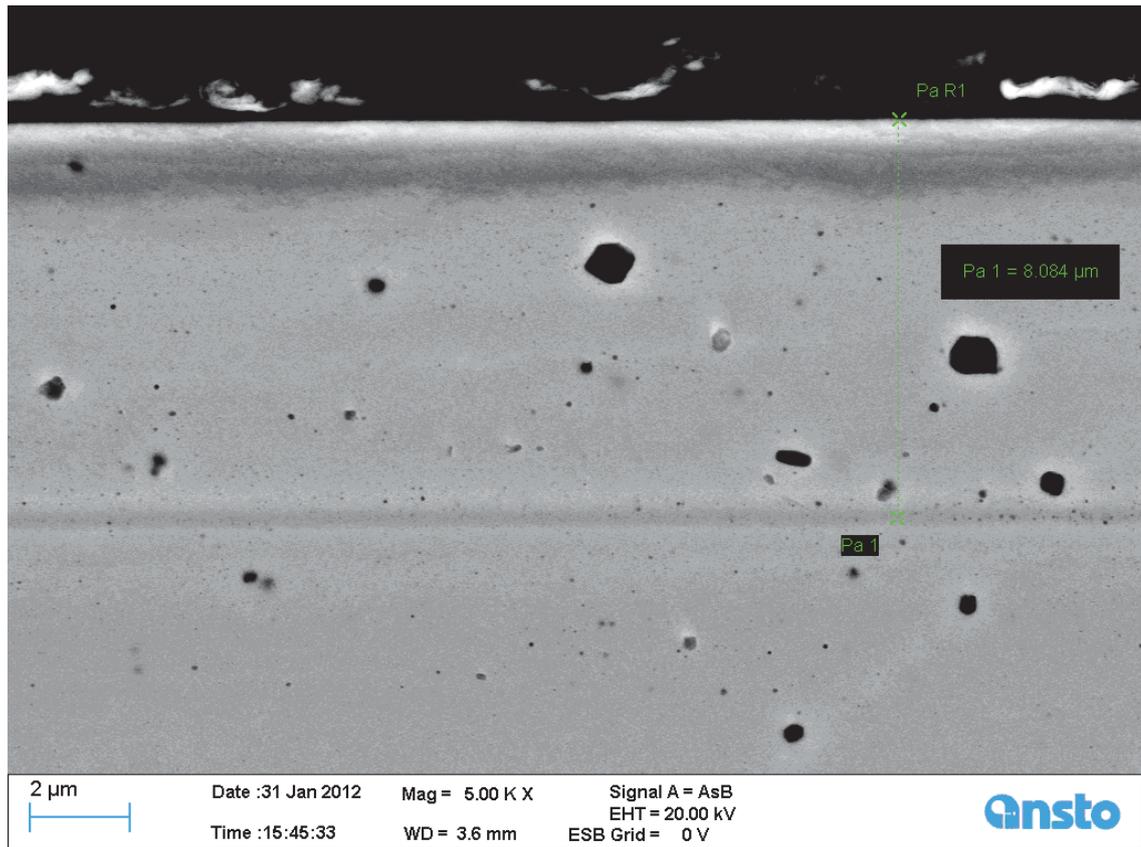
Figure 6-28: Backscattered electron channeling contrast image of the MA956 grade ODS steel showing the cross-section of the irradiated region and a line of radiation damage caused by the helium ions approximately 8 μm under the surface.

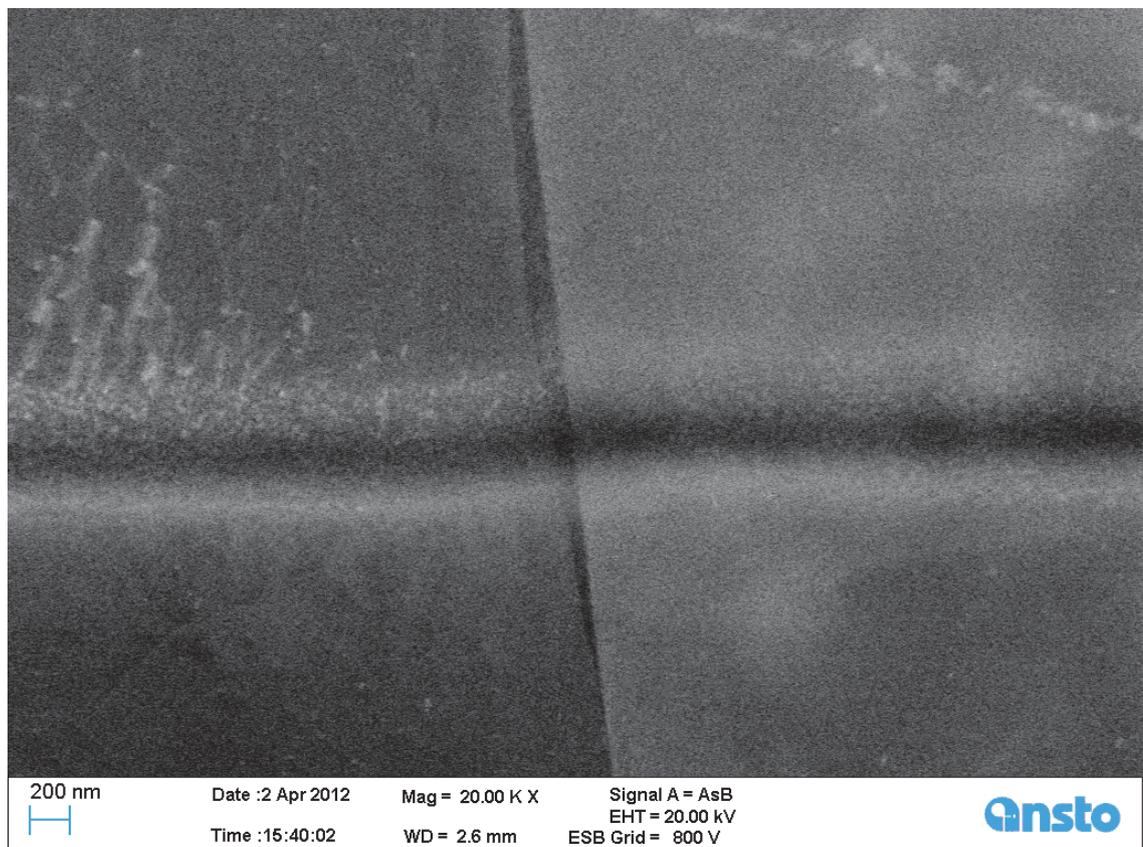
Figure 6-29: Backscattered electron channeling contrast image of the 2205 grade duplex steel at high magnification showing the damage region caused by the helium ions at a grain boundary.

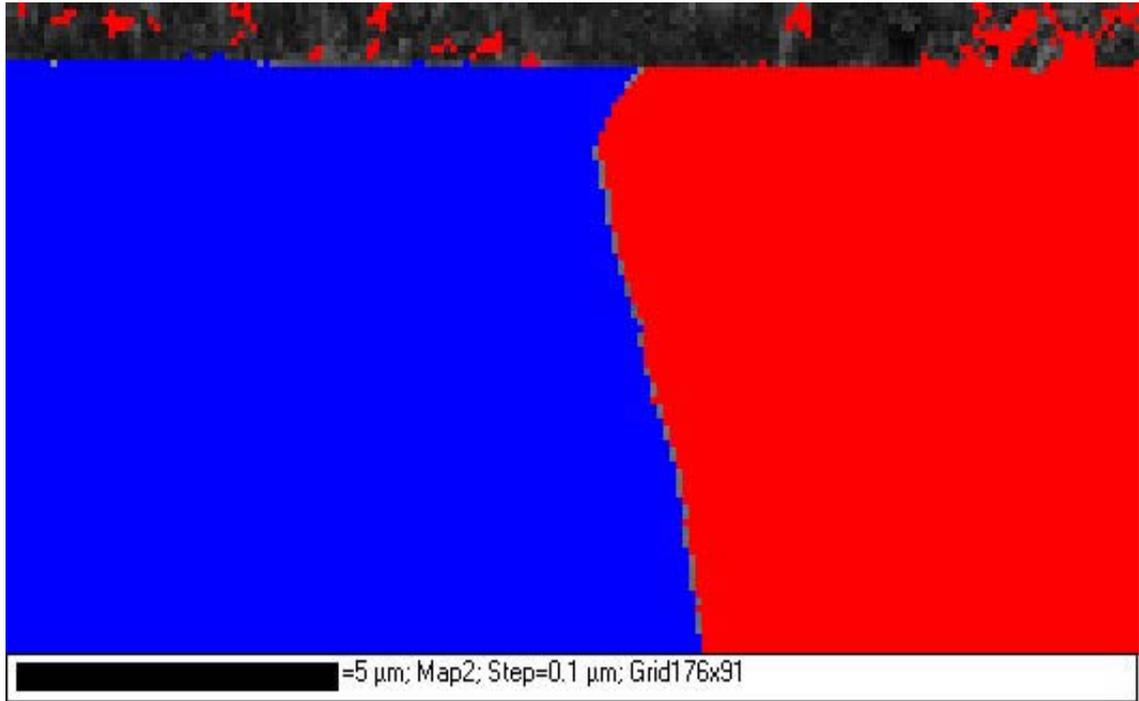
Figure 6-30: EBSD phase map of the cross section of the 2205 grade duplex steel grain boundary region showing the BCC phase in blue on the left grain and the FCC phase in red on the right grain.

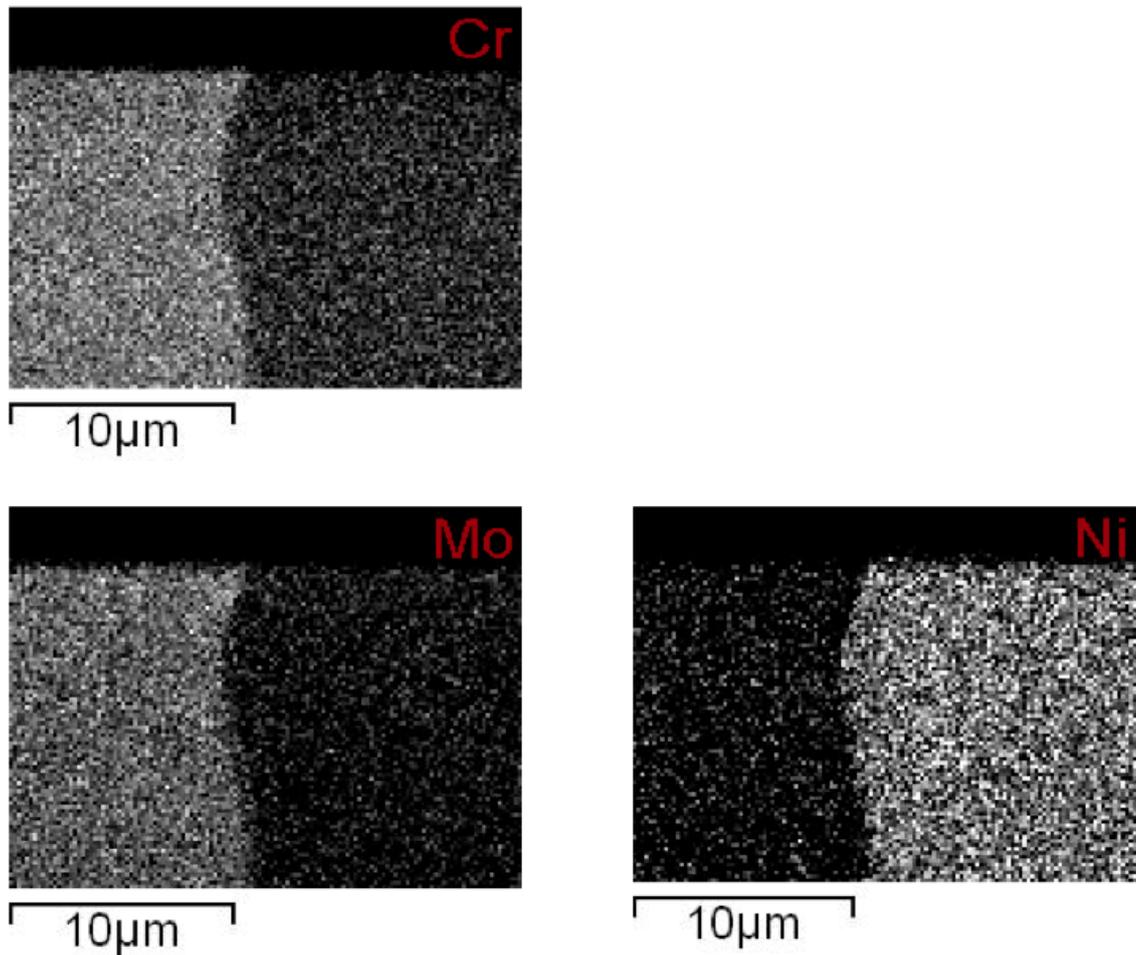
Figure 6-31: X-ray mapping of the cross section of the 2205 grade duplex stainless steel showing the corresponding grains as seen in figure 6.30. The X-ray mapping shows which elements are specific to the BCC and FCC phases.

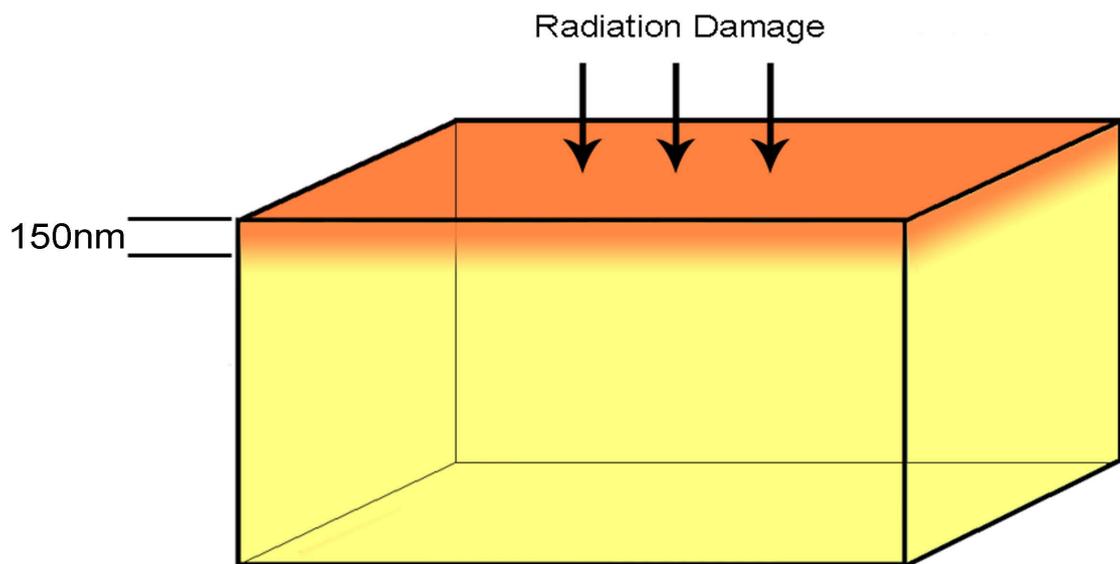
Figure 6-32: Illustration demonstrating the Stopping Range of Ions in Matter (SRIM) calculations put the expected peak damage layer at a depth of ~ 150 nm for 316 stainless steel.

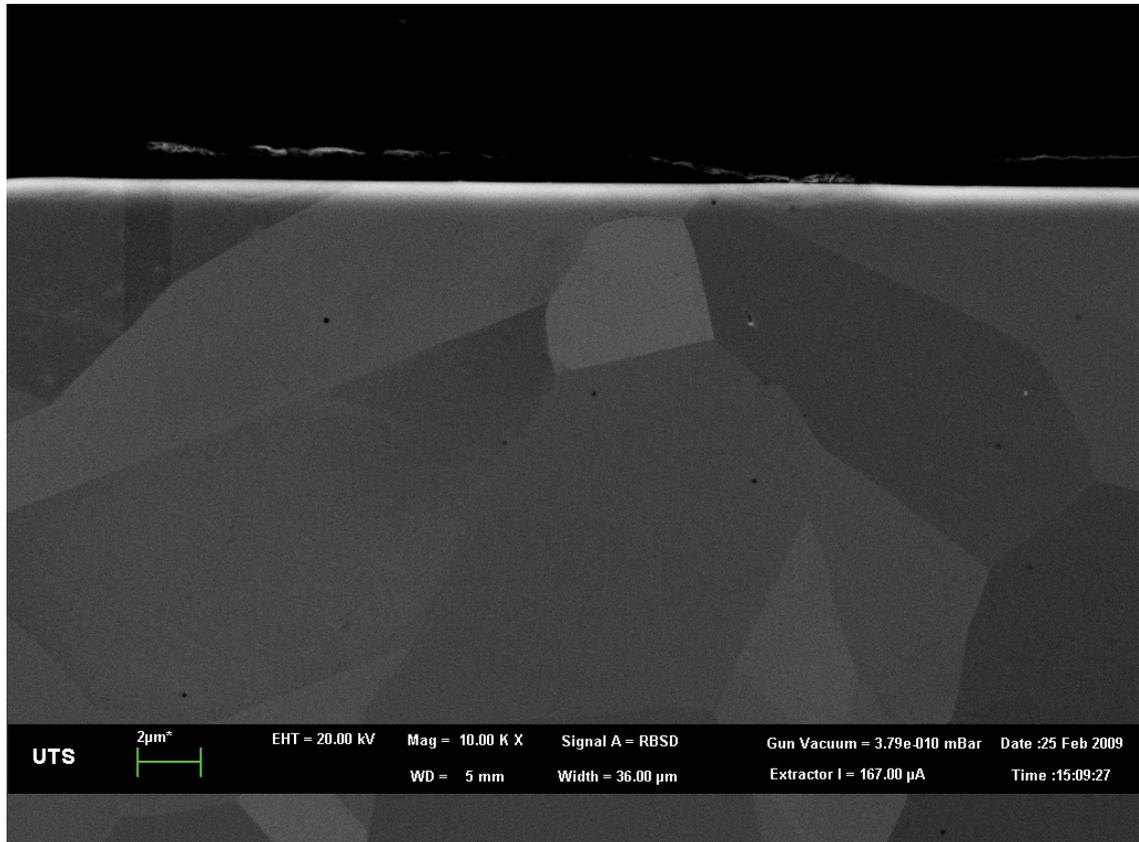
Figure 6-33: The result of mechanical polishing of the cross sectioned stainless steel samples showing edge rounding well beyond the 100nm below surface area of interest. The area above the steel is an epoxy resin which is much softer and allows for the polishing rate to differ causing the rounding of the stainless steel edge.

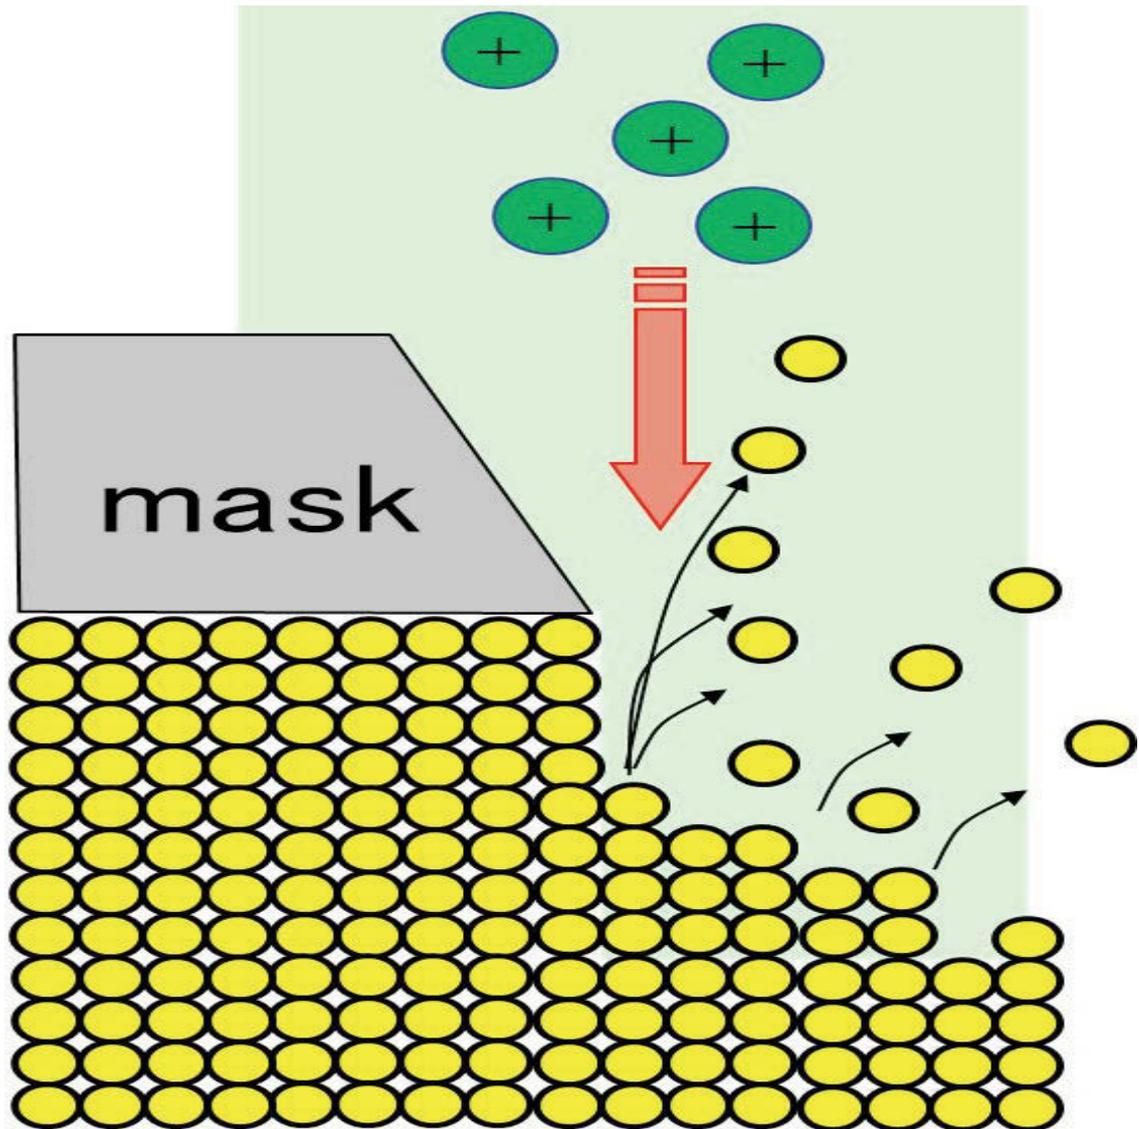
Figure 6-34: Schematic diagram showing the method of polishing performed in the large scale ion beam cross sectional polisher. [Hitachi High Technologies America, Inc. 2015]

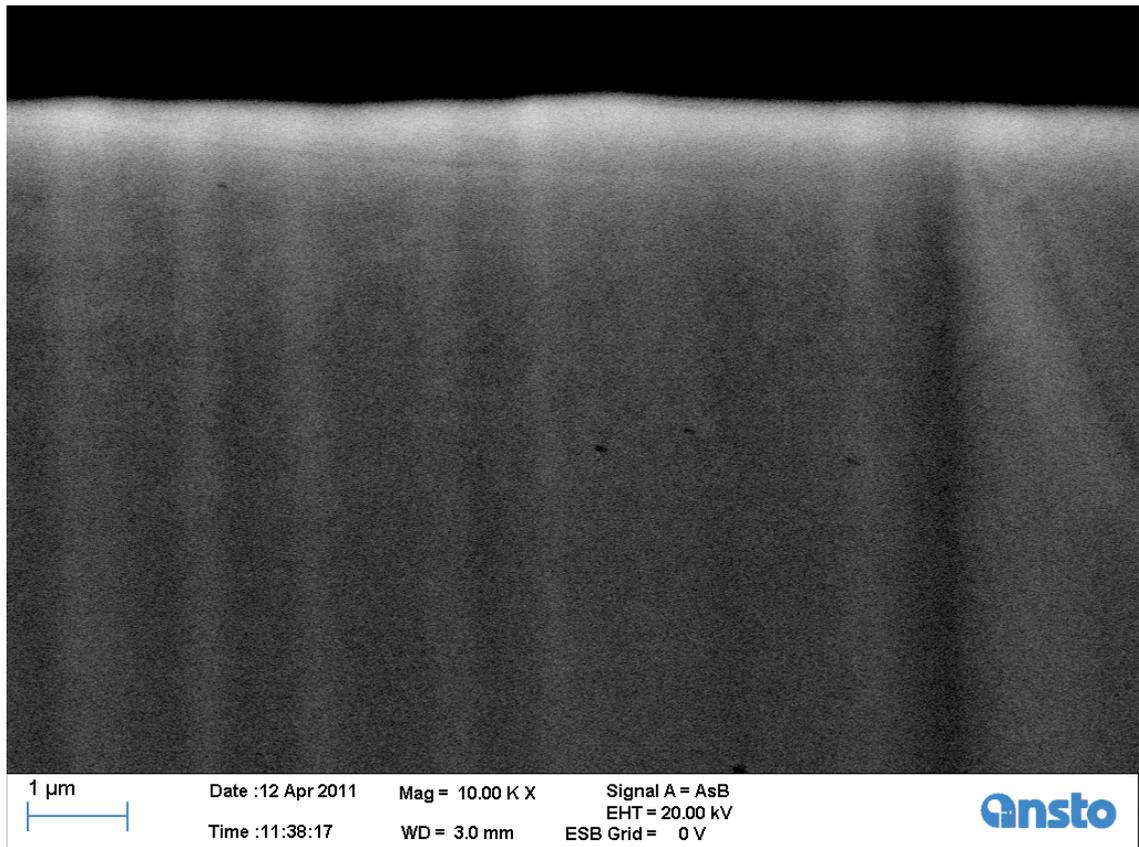
Figure 6-35: Blank stainless steel sample prepared using the JEOL cross sectional polisher with edge retention in the sub 100nm region.

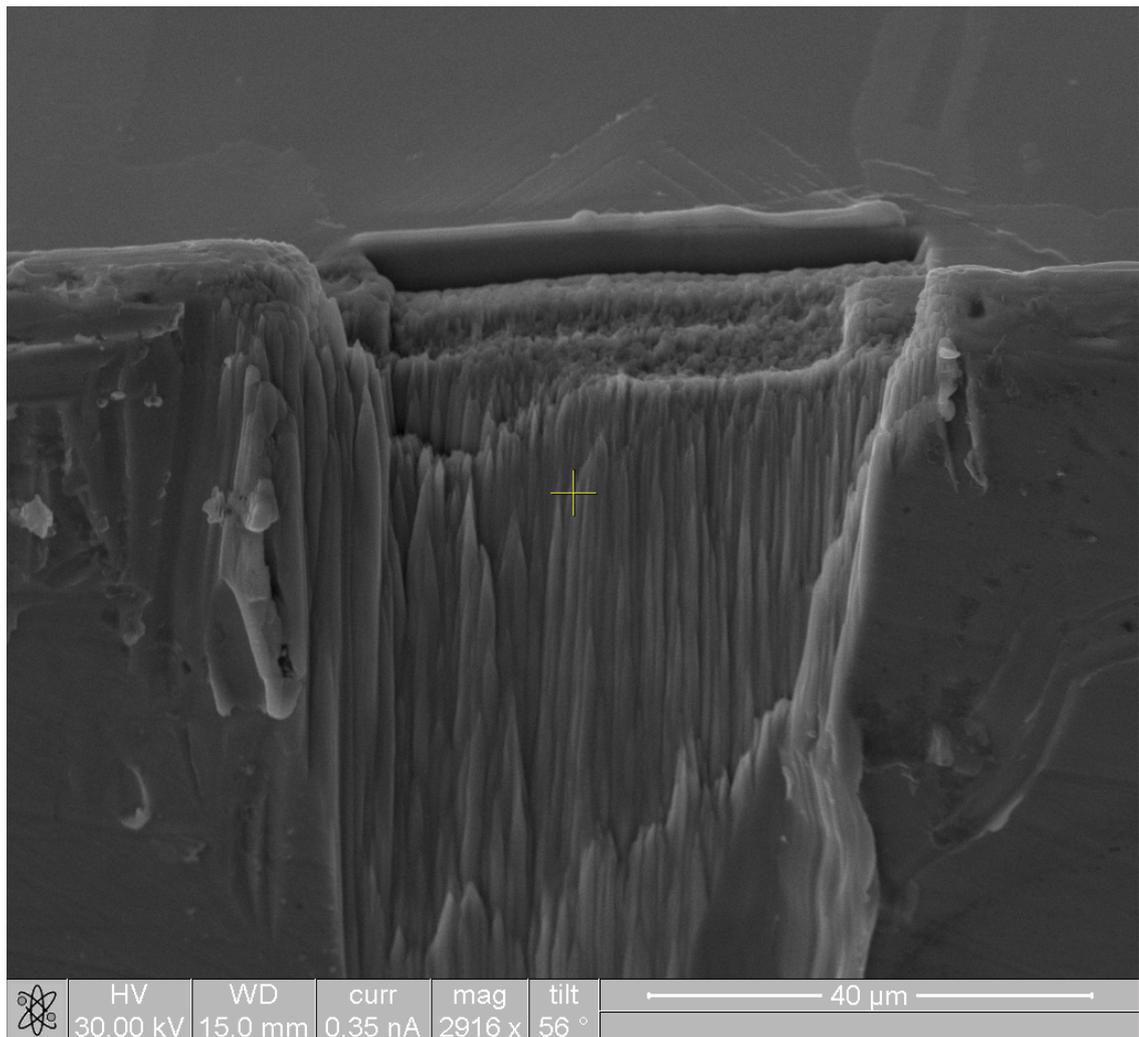
Figure 6-36: SEM image of the partially milled cross section using the focused ion beam.

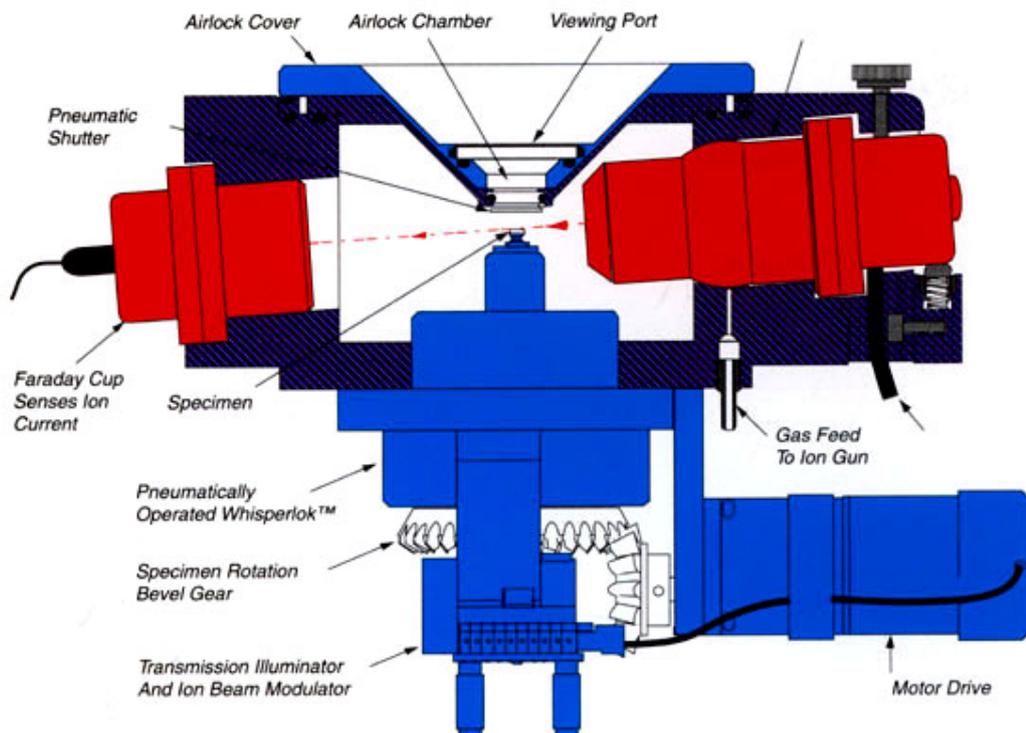
Figure 6-37: Schematic diagram of the PIPS instrument [Gatan Inc.]

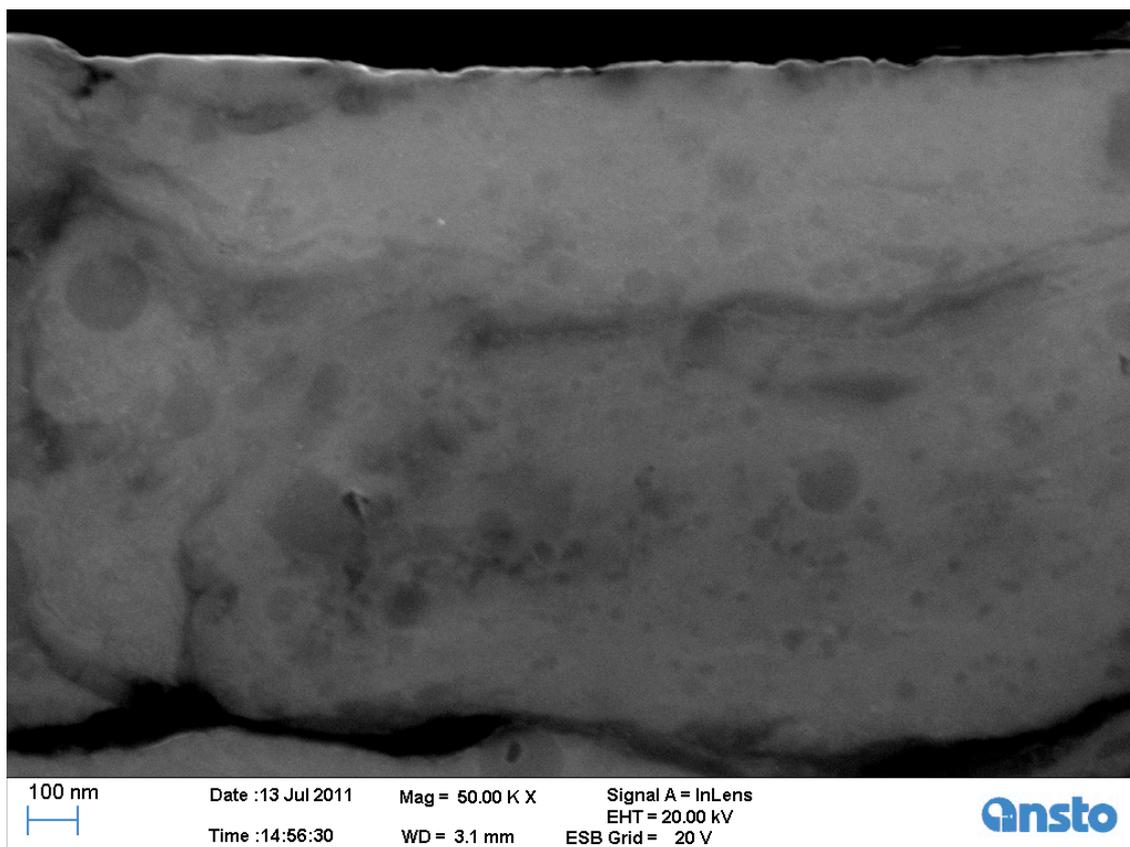
Figure 6-38: Precision ion beam polished cross section of the 316 stainless steel un-irradiated test sample showing excellent edge retention in the sub 150nm region.

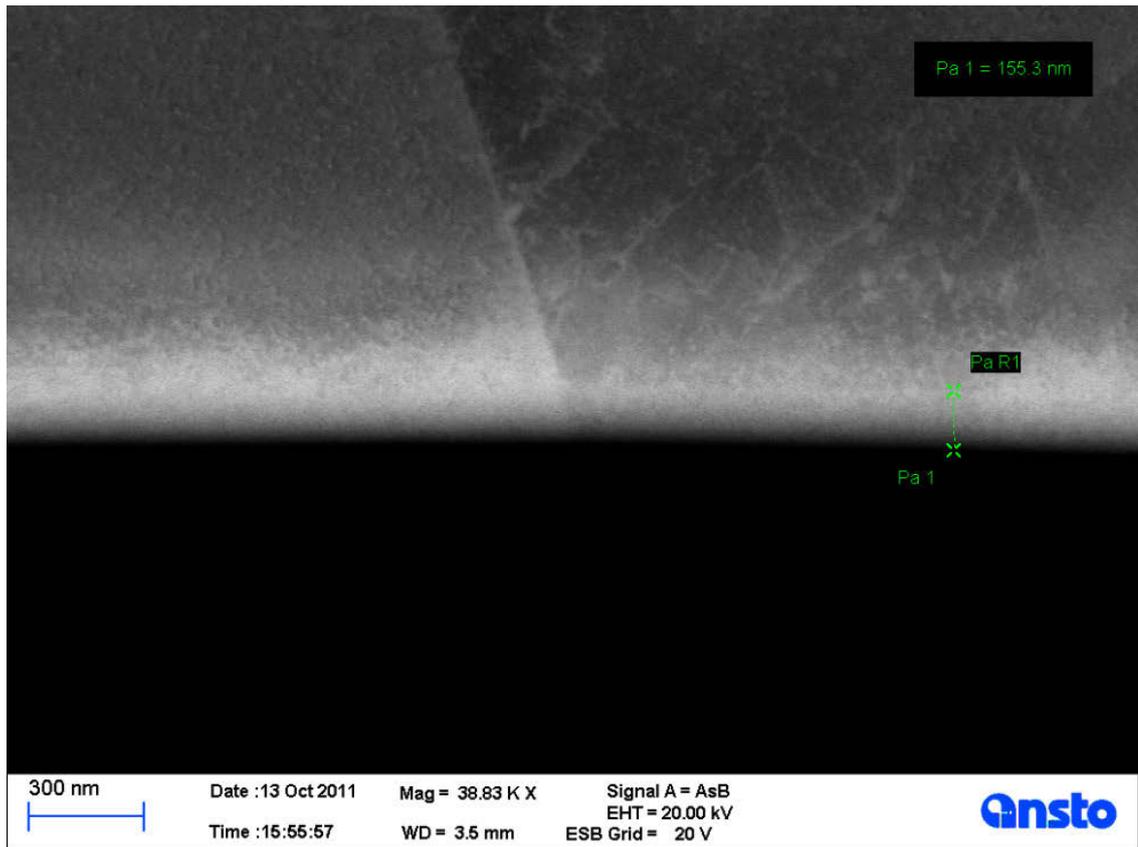
Figure 6-39: Backscattered electron channelling contrast image showing the helium ion implantation damage layer in the PIPS prepared cross section with a depth that agrees with SRIM calculations.

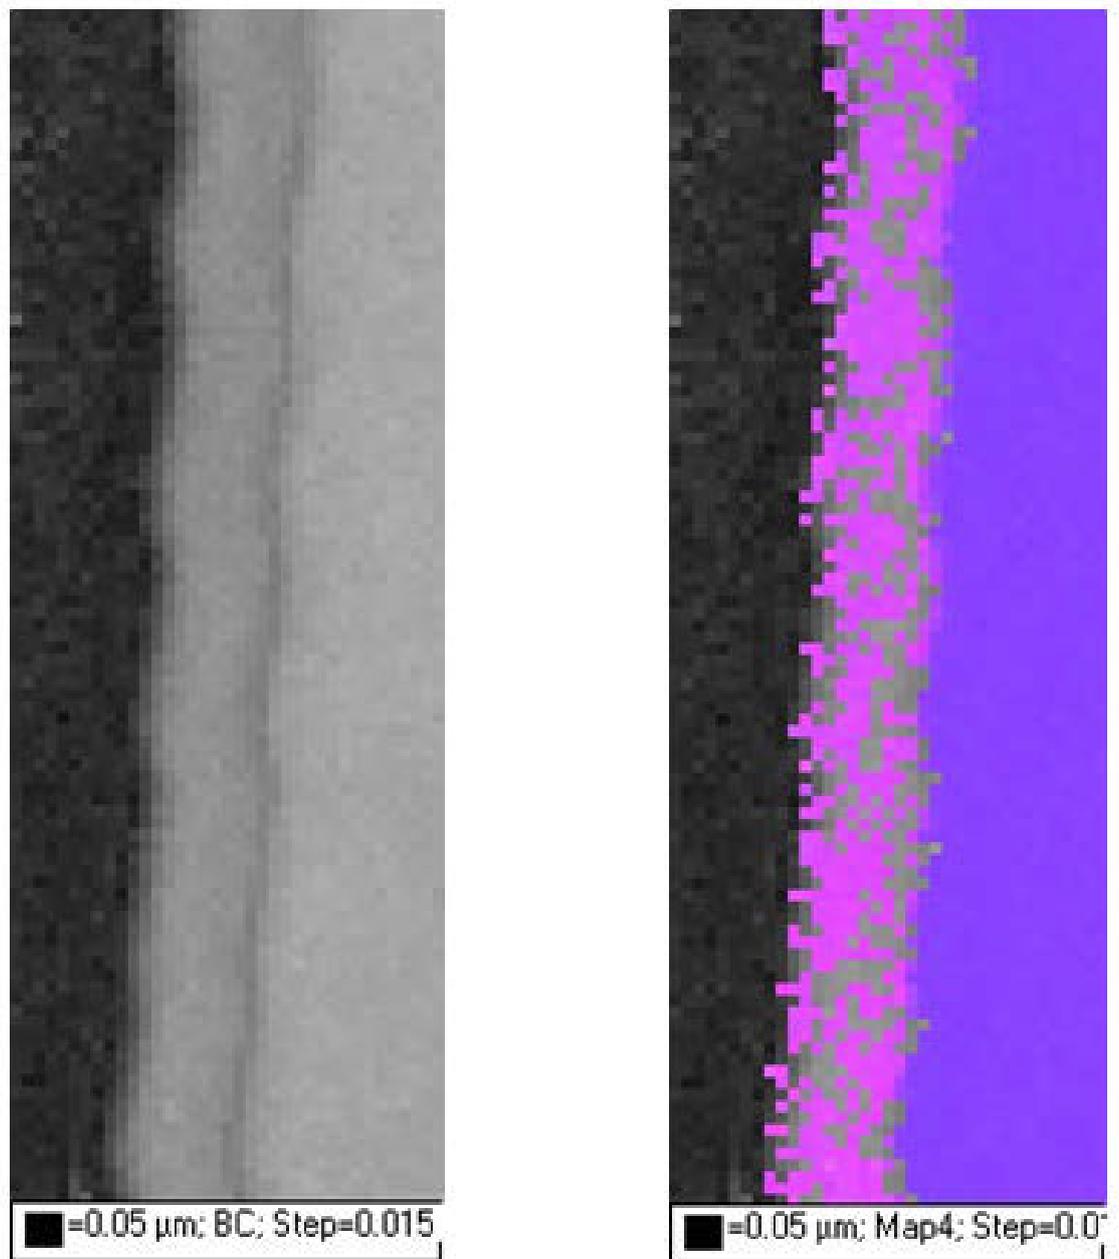
Figure 6-40: EBSD band contrast map (left) and orientation map (right) of the cross section showing a partial loss of indexing in the damage region.
