Radiation Damage
Effects within Materials

A Thesis Submitted for the degree of
Master of Science by Research

University of Technology, Sydney

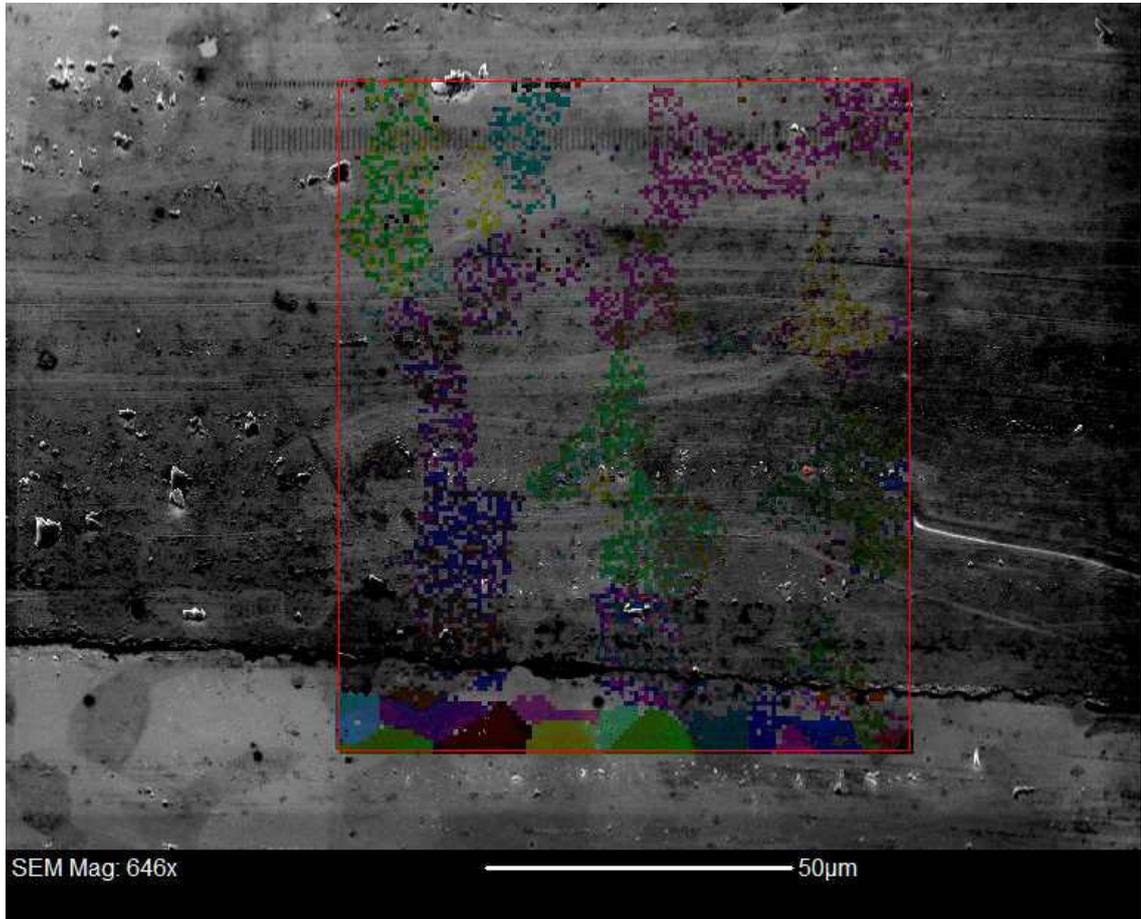
Figure 6-41: EBSD map of the area in the irradiated region to determine the grain boundary of interest prior to FIB milling.

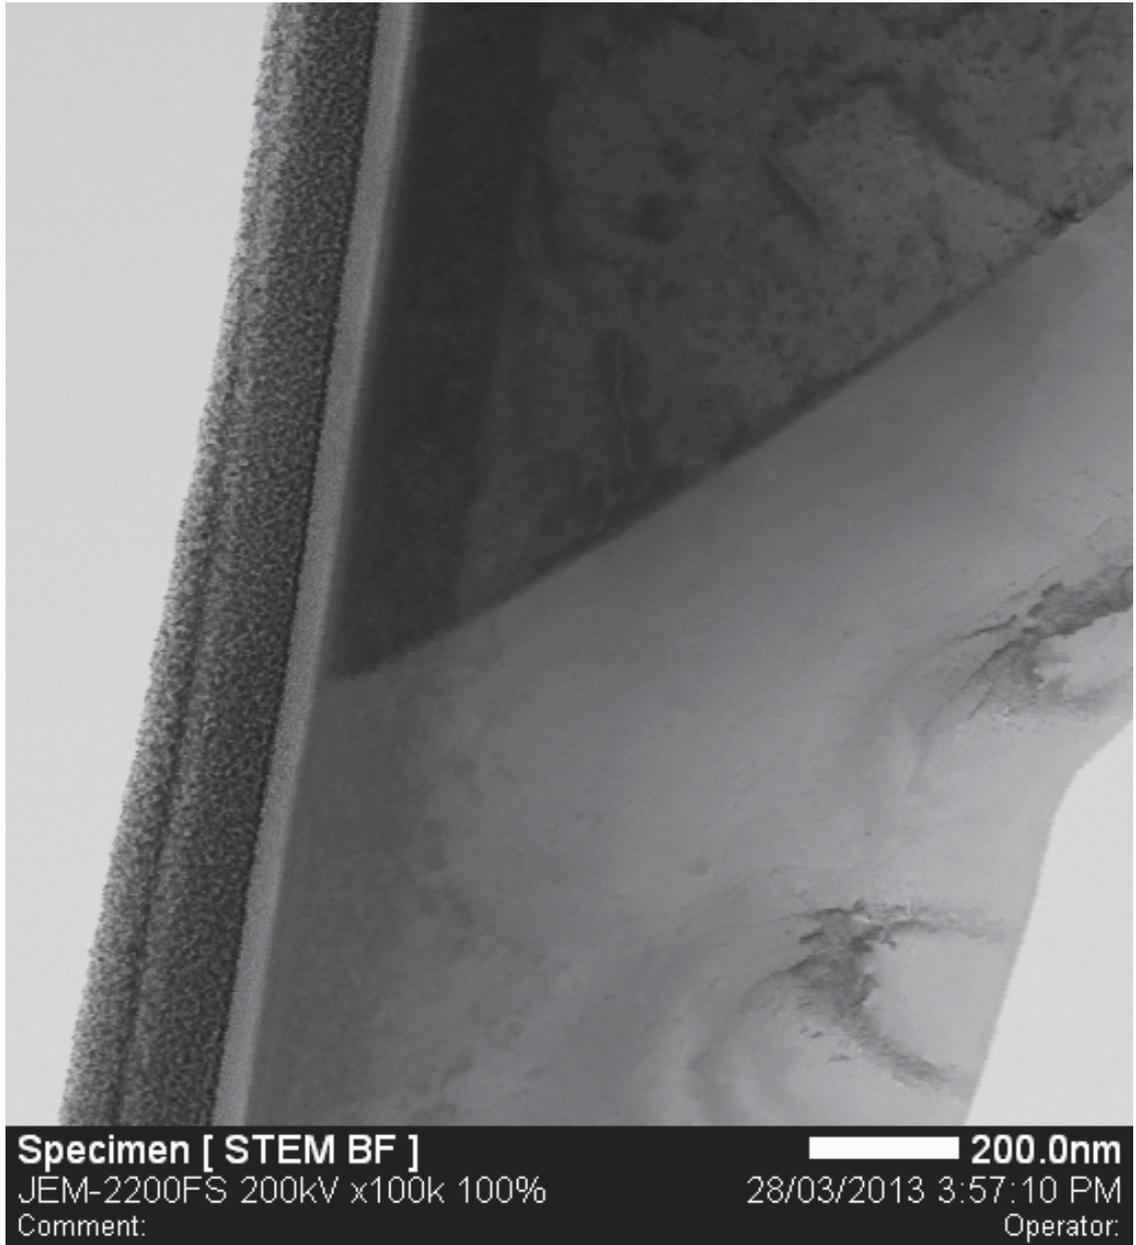
Figure 6-42: Low magnification STEM image of the FIB prepared cross section showing the grain boundary of the helium implanted duplex stainless steel. BCC phase is the lower region; FCC phase is the upper region.

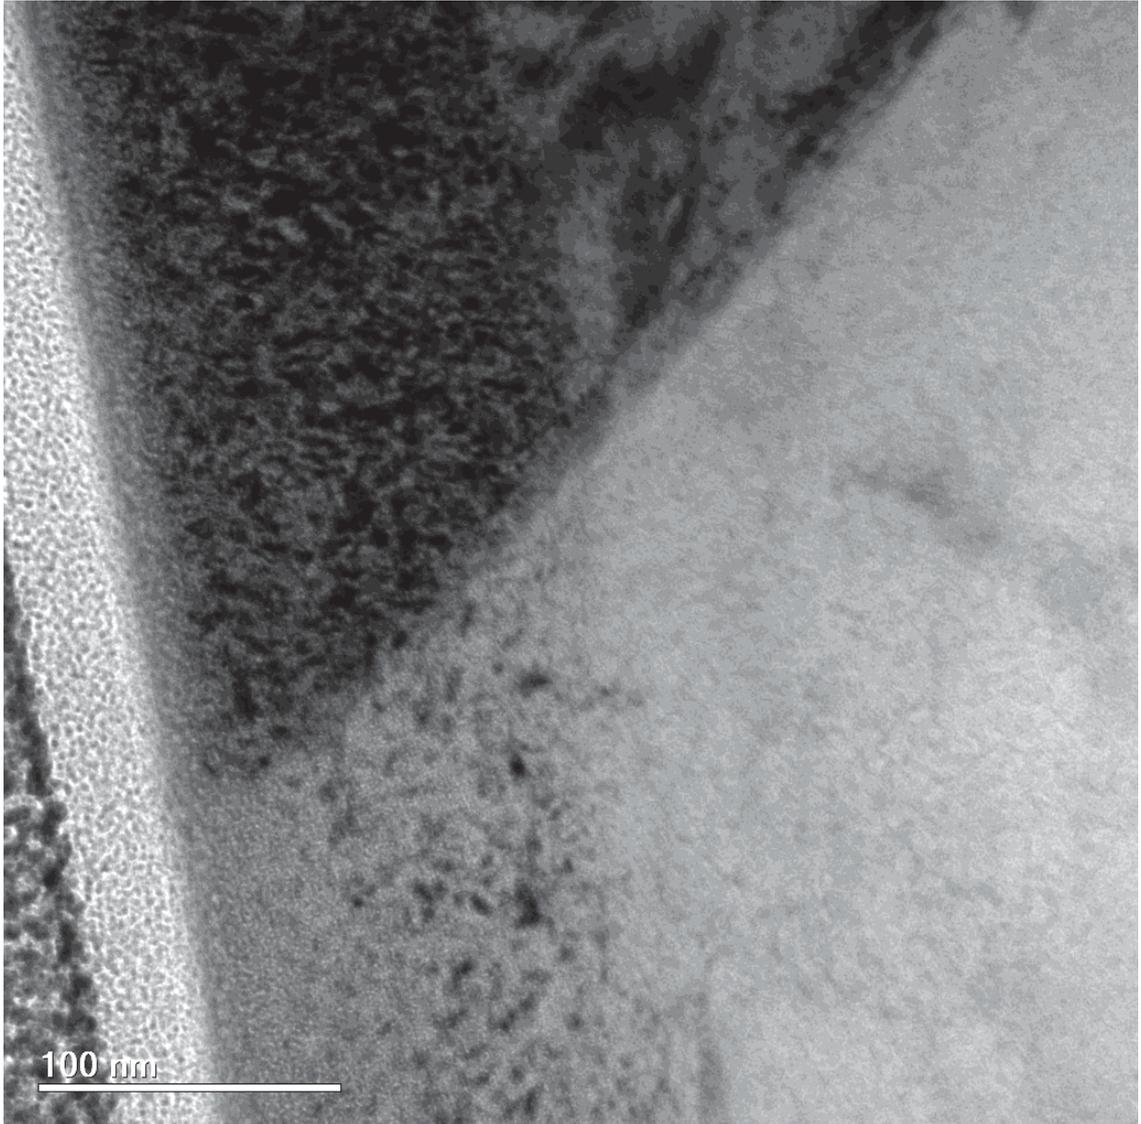
Figure 6-43: High magnification TEM image showing the grain boundary between the two phases. We can see in this image the significant increase in the amount of defects in the FCC phase compared to the BCC phase.

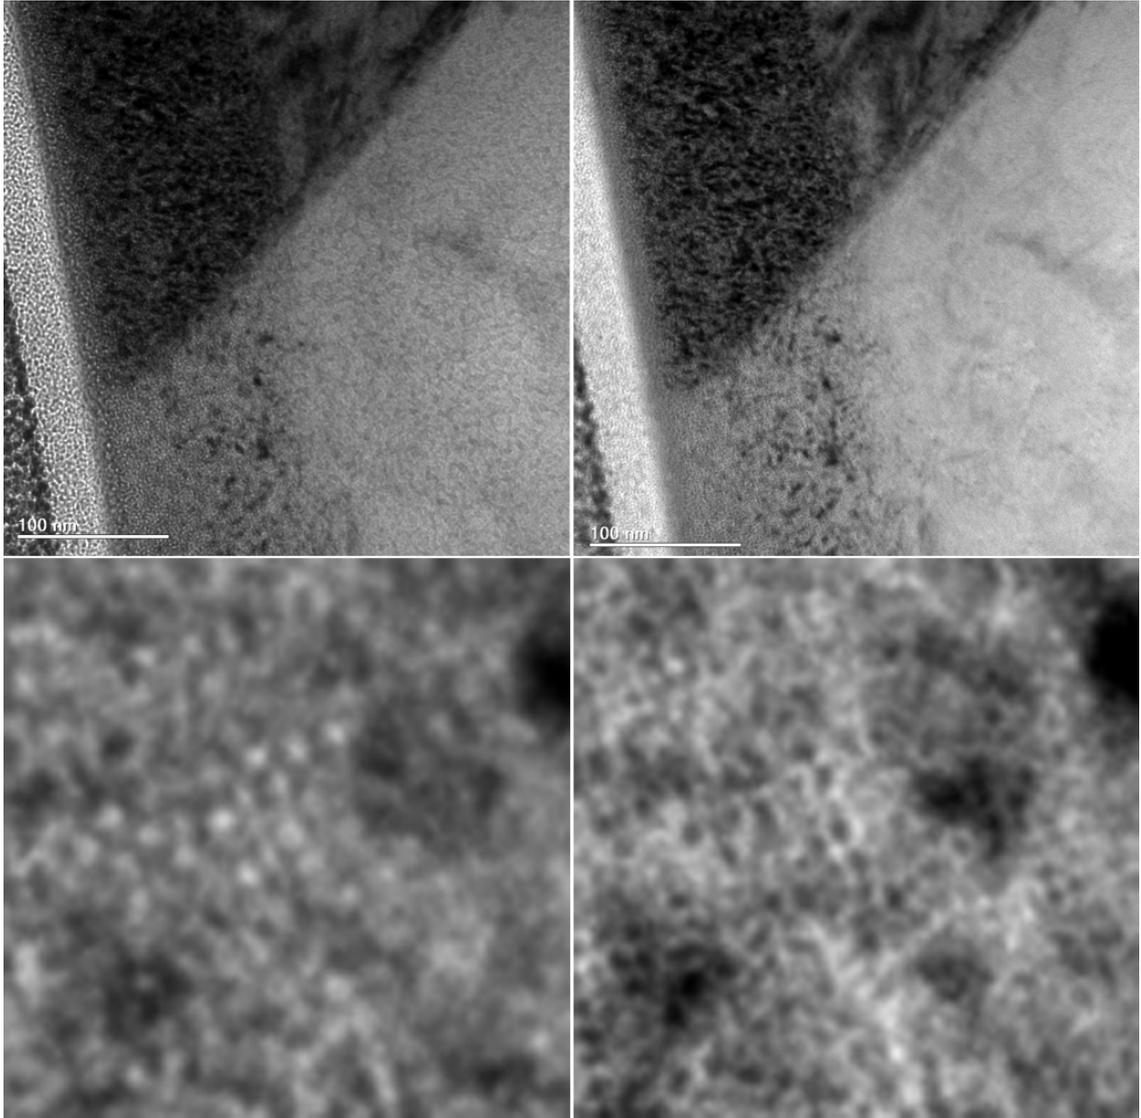
Figure 6-44: TEM images of the grain boundary between phases shown in under-focus (left) and over-focus (right) condition. The lower images are digitally blown up regions of the corresponding images above for ease of viewing. Fresnel-contrast imaging is used to reveal the voids and point defects in the damage layer.

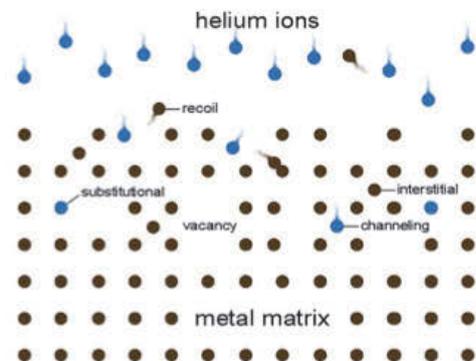
Fig. 1. Schematic representation of the initial formation of point defects created in the metal matrix as a result of helium ion implantation.

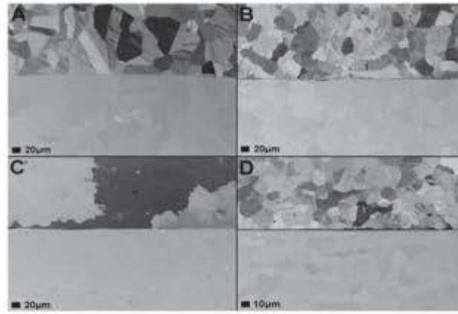
Fig. 2. BSE channeling contrast images of the shielded to unshielded interface in plan view of (a) 304 grade stainless steel, (b) 430 grade stainless steel, (c) MA956 oxide dispersed strengthened (ODS) steel and (d) 2205 duplex stainless steel, implanted with helium ions at 30 kV and a fluence of $\sim 1 \times 10^{17}$ ions cm^{-2} .

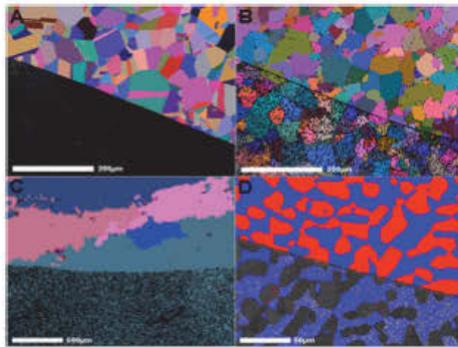
Fig. 3. EBSD orientation maps of the shielded to unshielded interface in plan view of (a) 304 grade stainless steel, 100 \times magnification, 280 \times 210, 4 μm step size (b) 430 grade stainless steel, 200 \times magnification, 187 \times 140, 3 μm step size (c) MA956 oxide dispersed strengthened (ODS) steel, 50 \times magnification, 283 \times 212, 8 μm step size and (d) a phase map of the 2205 duplex stainless steel, 200 \times magnification, 281 \times 211, 2 μm step size. In this map we have assigned the FCC iron phase with a red colour and the BCC iron phase with a blue colour. All samples were implanted with helium ions at 30 kV and a fluence of $\sim 1 \times 10^{17}$ ions cm^{-2} . (For interpretation of the references to colour in this figure legend, the reader is referred to the web version of this article.)

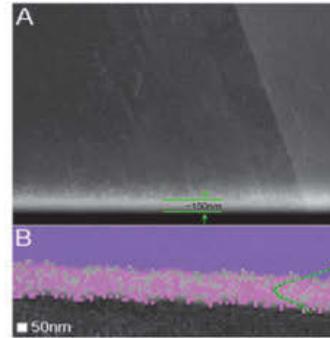
Fig. 4. (a) BSE channeling contrast image of an irradiated 316 stainless steel cross-section showing a ~ 150 nm band with a distinct change in contrast in the expected damage region. (b) Corresponding EBSD map of this region showing the loss of EBSD pattern in the damage region, a misorientation of between 3 and 5 degrees is also observed between the damage layer and parent metal in this EBSD map. The SRIM depth distribution curve is also shown.

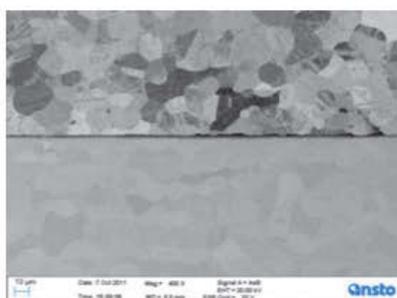
Fig. 1. AsB images of the 2205 duplex stainless steel implanted with helium ions at 30 kV accelerating voltage and to a fluence of $\sim 1 \times 10^{17}$ ions cm^2 . This image shows the loss of crystallographic contrast in the lower unshielded region.

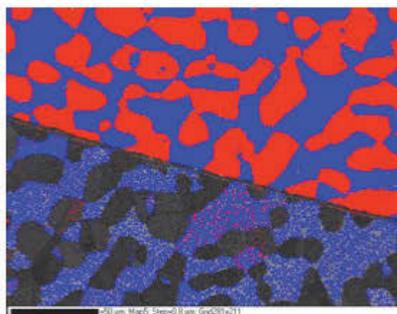
Fig. 2. EBSD phase map of the 2205 duplex stainless steel implanted with helium ions at 30 kV accelerating voltage and to a fluence of $\sim 1 \times 10^{17}$ ions cm^2 . The red colour is assigned to the FCC iron phase and the blue colour is assigned to the BCC iron phase. The top half of the map is the shielded region and the lower half has been exposed. We see a loss of indexing of the FCC phase.

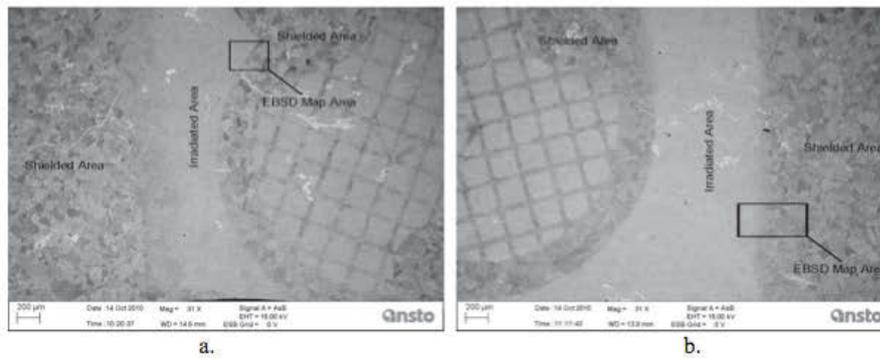
Figure 1. Backscattered electron image showing the irradiated and shielded regions and also the region where the EBSD map was taken from on the polished stainless steel surface. a) Argon ions were used for implantation and b) Helium ions were used for implantation.

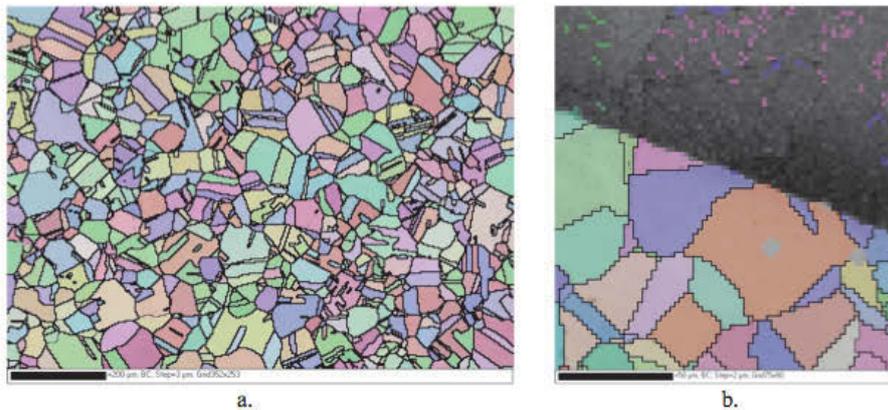
Fig. 2. EBSD map showing the loss of EBSD pattern in the irradiated region (top of map).
