ADVANCES IN LEAK PREVENTION TO MINIMISE UNACCOUNTED WATER

Rebeka Nikoloska¹, Dammika Vitanage¹ Lili Bykerk², Jaime Valls Miro², Bin Liang², Jack Xu², Yang Wang² 1. Sydney Water, Sydney, NSW, Australia

2. University of Technology Sydney, Sydney, NSW, Australia

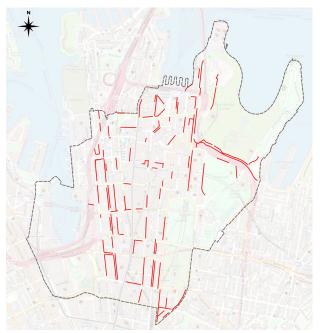
Figure 1: Priority map of Sydney CBD based on pipe failure prediction

For the deployment of acoustic sensors, a water pipe failure prediction tool is used to identify high risk pipes, and the acoustic sensors are installed around the prioritised high-risk pipes in the selected areas.

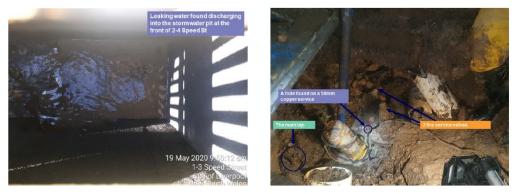
Figure 8: Leak in Liverpool discharging into the stormwater pit, caused by a hole on a 50mm copper service

Faults detected by the sensors have included leaking hydrants, main taps, service lines, stop valves, dividing valves, main breaks, meter taps and meter couplings of varying leak rates. Most of these leaks and breaks had water running into the ground and not surfacing or appearing as runoff in drains. One leak detected by sensors in Liverpool (audio signals shown in Figure 5, leak shown in Figure 10) was previously undetected and not reported to Sydney Water, despite water discharging into a nearby stormwater pit at an estimated rate of 3 L/s.
