The effectiveness of FRP strips in repairing moderately and severely damaged RC beam–column connections

Rijun Shrestha

Scott T. Smith

Bijan Samali

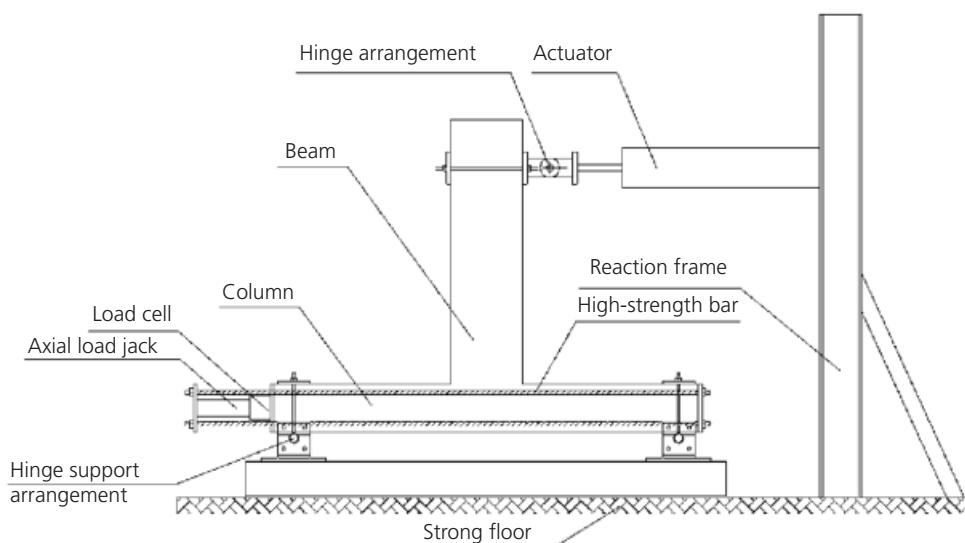
Figure 3. Test set-up

end of the vertically orientated beam. The connection was mounted on a stiff test frame with hinge supports at both ends of the column as shown in Figure 3. An axial load of 180 kN (equal to 8% of the gross axial load capacity of the column and representative of a typical floor load) was applied to the column using a hydraulic jack embedded in a self-reacting frame of high strength Macalloy bars anchored to both ends of the column.

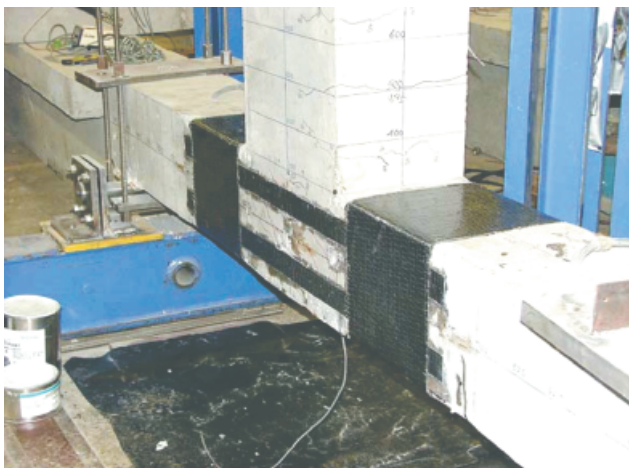
Figure 4. Column strip repair: moderately damaged connection: (a) pre-repair (UM1); (b) post-application of FRP repair (RM1); (c) close-up view of RM1 after repair

considerable shear cracking in the joint region, although, the damage was not excessive, as shown in Figure 4(a) (see diagonal cracks in the boxed area) and Figure 5. This connection is herein referred to as 'moderately damaged' and distinction is made in Figure 5 between major cracks (cracks of large width) and minor cracks (cracks of small width). Prior to application of the FRP, the loose concrete in the cracked joint region was removed and the surfaces cleaned by spraying with compressed air; however, it should be noted from Figure 4(a) that little or no concrete cover in the joint region had fallen off, thus indicating the less severe nature of the damage. Voids left after removal of damaged concrete were filled with an epoxy adhesive, known as Megapoxy PF, prior to application of the FRP repair. According to the manufacturer's specification, the epoxy adhesive had a setting time of seven minutes and attained more than half of its ultimate strength within 15 min of mixing. As the extent of damage and the size of the major cracks were not excessive, repair adhesive, as opposed to repair mortar, was deemed suitable to patch up the damaged region sufficiently for the FRP repair to be adequately applied.

Figures 4(b) and 4(c) show connection RM1 which has been repaired with two two-layered column strips applied to both sides of the joint face, although no significant repair work is evident from these photographs. The ends of the column strips have been anchored by wrapping two layers of FRP around the perimeter of the column.

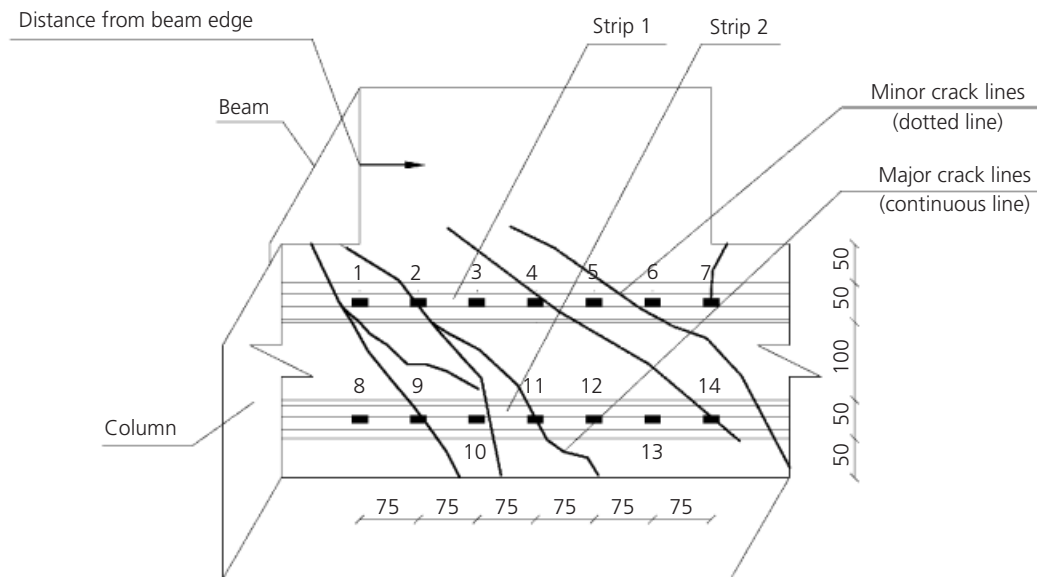
Figure 5. Column strip repair: extent of damage (and repair) and strain gauge layout of RM1 and SM1

Strain gauges of 5 mm gauge length were adhered to the FRP in identical positions for the strengthened and corresponding repaired specimens, with centre-to-centre distances relative to the beam or column edges shown in Figure 5 (specimens SM1 and RM1), Figures 7(a) (specimen SM2) and Figure 7(b) (specimen RM2). For connection RM2, three gauges were slightly repositioned from their original SM2 position to coincide with the intersection of the FRP passing over existing cracks. The repositioned gauges are indicated with an 'A' in Figure 7(b) (i.e. gauges 5A, 10A and 13A) and one additional gauge was added to RM2 (i.e. gauge 16 in Figure 7(b)). Strain gauges of 50 mm gauge length were adhered to the concrete surface (not shown) and strain gauges of 5 mm gauge length were adhered to the internal steel reinforcing bars (not shown). The details of these non-FRP strain gauges are provided in Shrestha (2009).

The distribution of strain along the length of strips 1 and 2 (refer to Figure 5 for strip and strain gauge location) on the front heavily instrumented face of the joint for the moderately damaged connection RM1 at different load levels are shown in Figures 10 and 11, respectively. Locations where the shear cracks in the joint regions intersected the FRP are also shown (shear cracks denoted by vertical dashed lines). High strains can be observed in the region adjacent to shear cracks indicating debonding of the FRP, while low FRP strain regions are those where the bond between FRP and concrete was not lost and full shear transfer between the two was maintained. Also, relatively

Finally, comparisons of the strain at identical locations for RM1 and SM1 for different levels of load are shown in Figure 14. These particular locations were chosen as they were closest to the cracks where the highest strain readings were observed (i.e. gauge 6 for strip 1 and gauge 11 for strip 2, as defined in Figure 5:

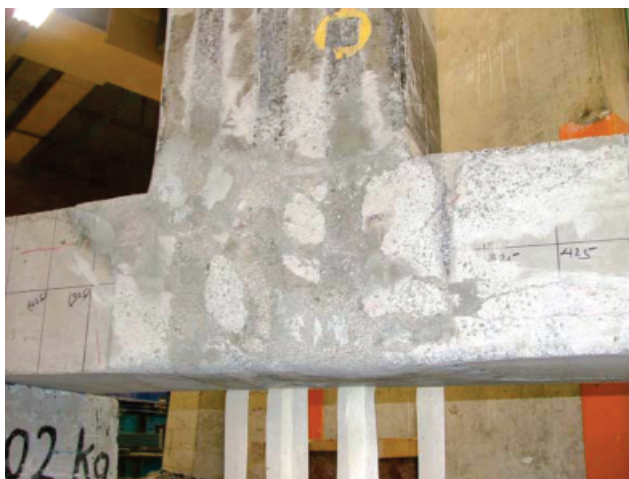
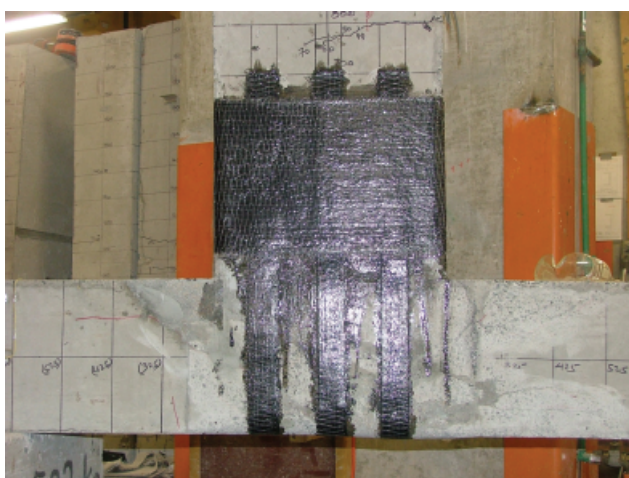
Figure 6. Beam strip repair: severely damaged connection: (a) pre-repair (SM2 after removal of beam strips); (b) post-application of repair mortar; (c) post-application of FRP repair (RM2)

To repair connection SM2 before being tested as connection RM2, all the loose and broken concrete was removed after the connection was unloaded and removed from the test frame. Owing to the severe level of damage, large voids remaining after removal of the damaged concrete were filled with repair mortar. Figure 6(a) shows the connection prior to the application of the repair mortar (heavily damaged areas circled with concrete cover removed), while Figure 7 is a detailed schematic of the cracking, damage and extent of repair mortar. After application of the mortar (Figure 6(b)), the connection was then repaired with FRP strips which were again oriented parallel to the beam (Figure 6(c)).

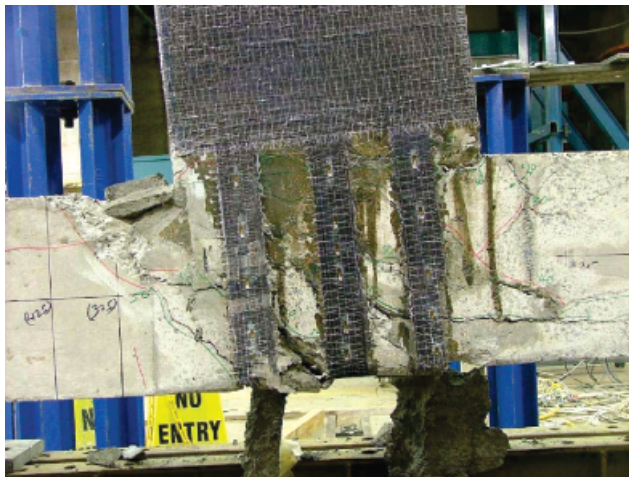
Figure 8. Photographs of failed repaired specimens: (a) RM1; (b) RM2

much lower load). A peak load of 106.6 kN was achieved at a displacement of 29.3 mm when complete debonding of FRP strip 1 on both faces of the connection between the end wraps occurred simultaneously, followed by the joint diagonal cracks opening widely, with spalling of the concrete at the column face adjacent to the beam. Failure can best be summarised as complete debonding of FRP strip 1 on both sides of the joint followed by joint shear failure. The test was stopped upon separation of the side cover on the beam at the beam-column interface. No clear debonding in strip 2 was observed and the final crack pattern is shown in Figure 8(a).

Separation of repair mortar was the primary mode of failure for repaired connection RM2, followed by FRP rupture and joint shear failure. Figure 8(b) shows the specimen post-test. No cracks were observed at the first load step; however, cracks started to appear at the beam column corner as the load was increased to 20 kN. Existing cracks re-opened as the load was increased to 40 kN and as no new cracks were observed the connection was then loaded continuously to failure. Repair mortar separated from the compressed beam-column corner at a load of 55 kN, upon which the load dropped but then started to increase again with no noticeable debonding of the FRP. A second peak load of 63.8 kN was reached when more of the repair mortar separated from the back side of the column. Rupture of FRP strip 1 followed shortly afterwards, owing to excessive rotation of the joint region. Further loading resulted in rupture of strip 3, after which the load-carrying capacity of the connection was significantly lost and severe cracking in the joint region could be seen.

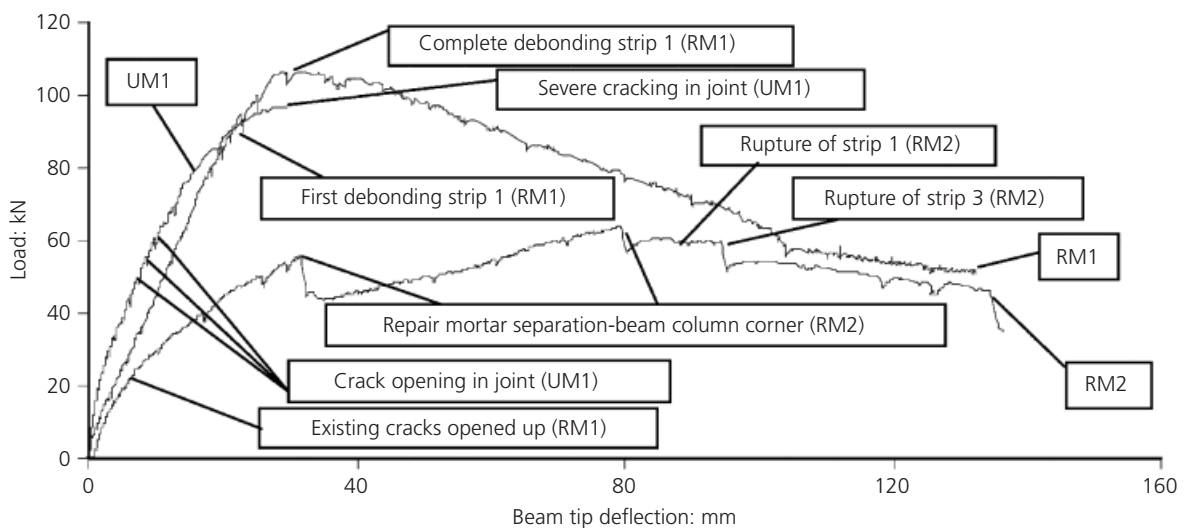
Figure 9. Load-deflection responses

The load-deflection plots for the two repaired connections (RM1 and RM2) are shown along with the control connection (UM1) in Figure 9, and a summary of the peak loads are presented in Table 2. Inspection of the load-deflection curve for RM1 reveals the FRP repair was able to restore not only the stiffness of the connection but also the load-carrying capacity. In fact, the load-carrying capacity was even enhanced by about 10%, although the effectiveness was limited by FRP debonding. Although the connection had significant cracking, especially in the joint region, owing to shear failure in its unstrengthened state, the FRP was able to maintain the integrity of the connection. Debonding of the FRP was, however, a real problem that required rectification. Some comments regarding prevention of debonding consist of (a) anchorage of the FRP (e.g. with FRP anchors; Kim and Smith, 2009, 2010; Smith *et al.*, 2011; Zhang *et al.*, 2011) in the joint region for two-dimensional connections, and (b) debonding will not be an issue in three-dimensional connections owing to the presence of the transverse beams. Unlike the moderately damaged connection RM1, FRP strengthening was less effective in the severely damaged connection RM2 even through the FRP strengthening delayed the failure following the separation of repair mortar. About 66% of the original connection strength was achieved, primarily owing to the FRP. The primary mode of

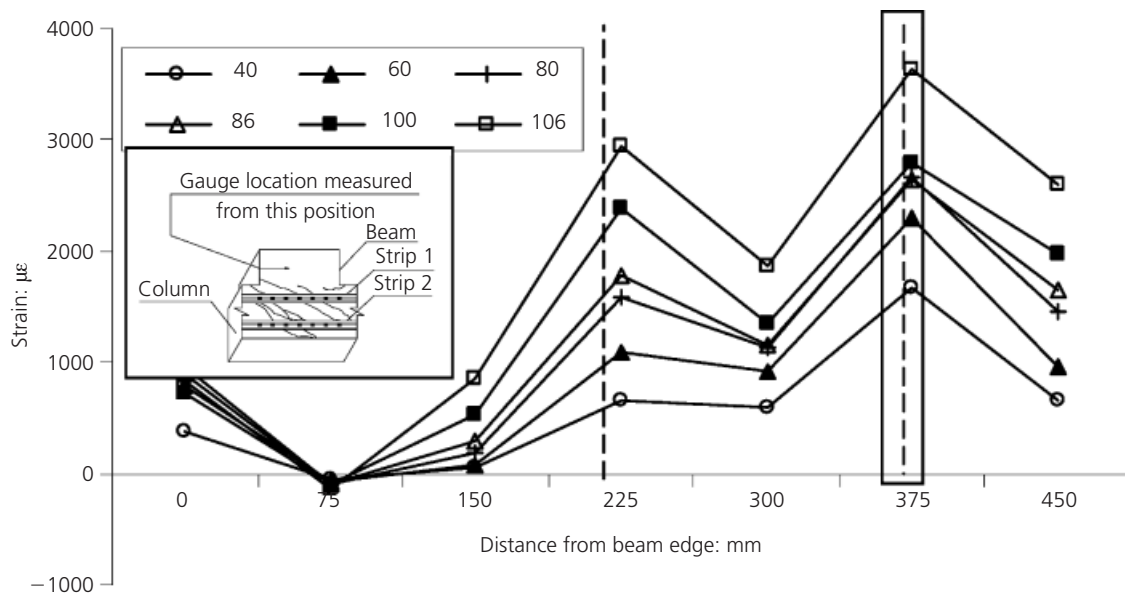
Figure 10. FRP strain distribution along strip 1: RM1

higher strain values were observed in strip 1 compared with strip 2, indicating that strip 1 was the main shear-resisting strip. On the whole, the peak strains (as measured by the strain gauges) are well below the 1.1% rupture strain limit of the FRP. Similar behaviour of the FRP strips on the back face of the connection was observed, although only a limited number of gauges were used on these FRP strips, and the results are not shown here.

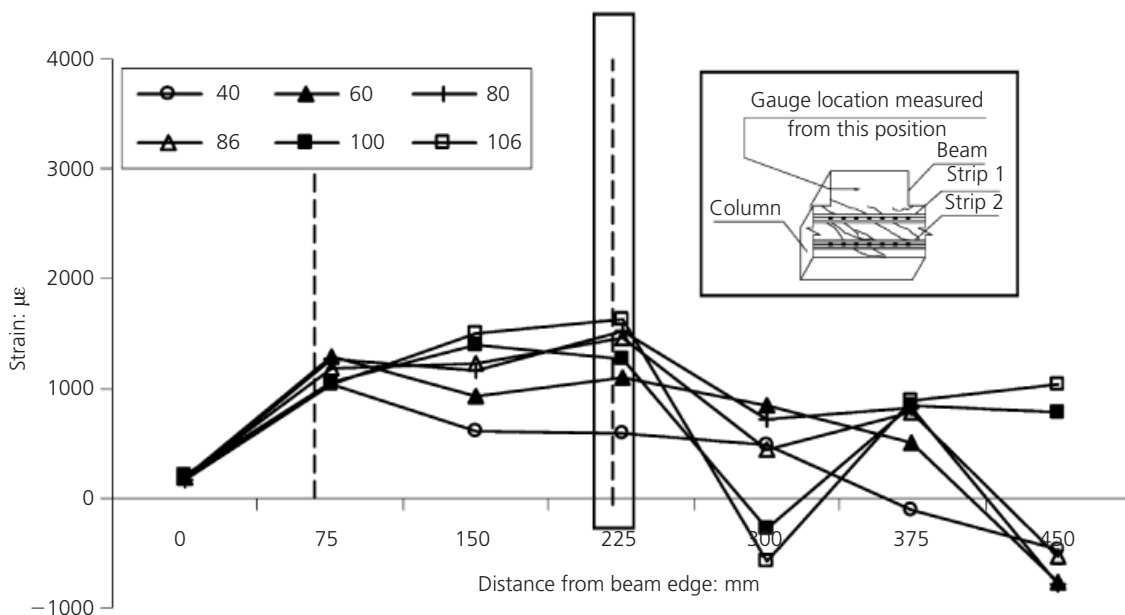
Figure 11. FRP strain distribution along strip 2: RM2

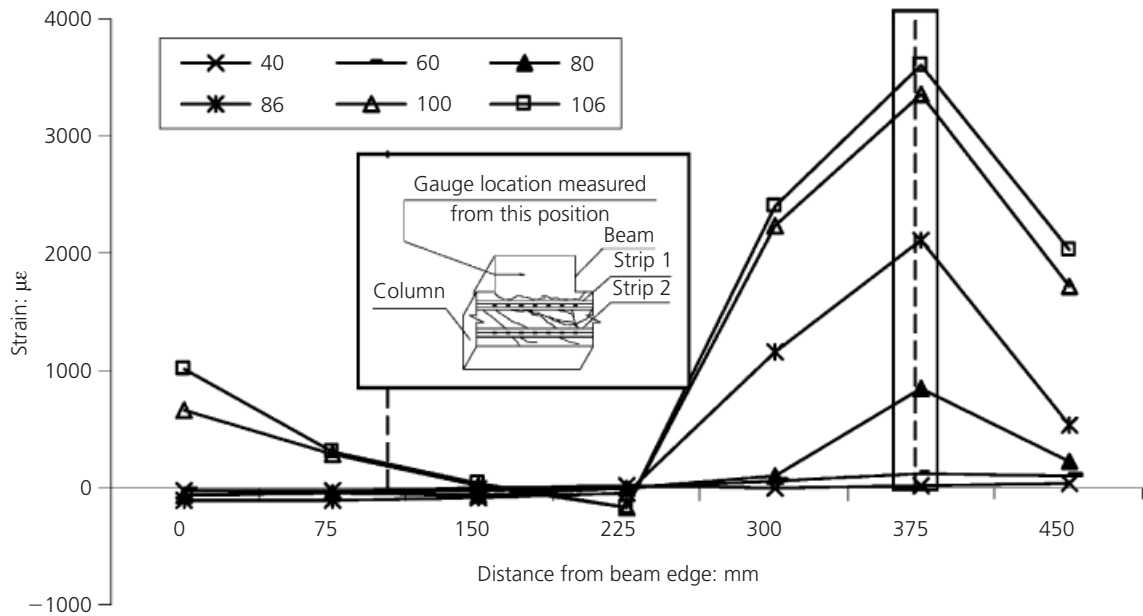
Figure 12. FRP strain distribution along strip 1: SM1

served in SM1, as shown in Figures 12 and 13, indicating that the behaviour of the FRP strips were similar in both repair and strengthening cases.

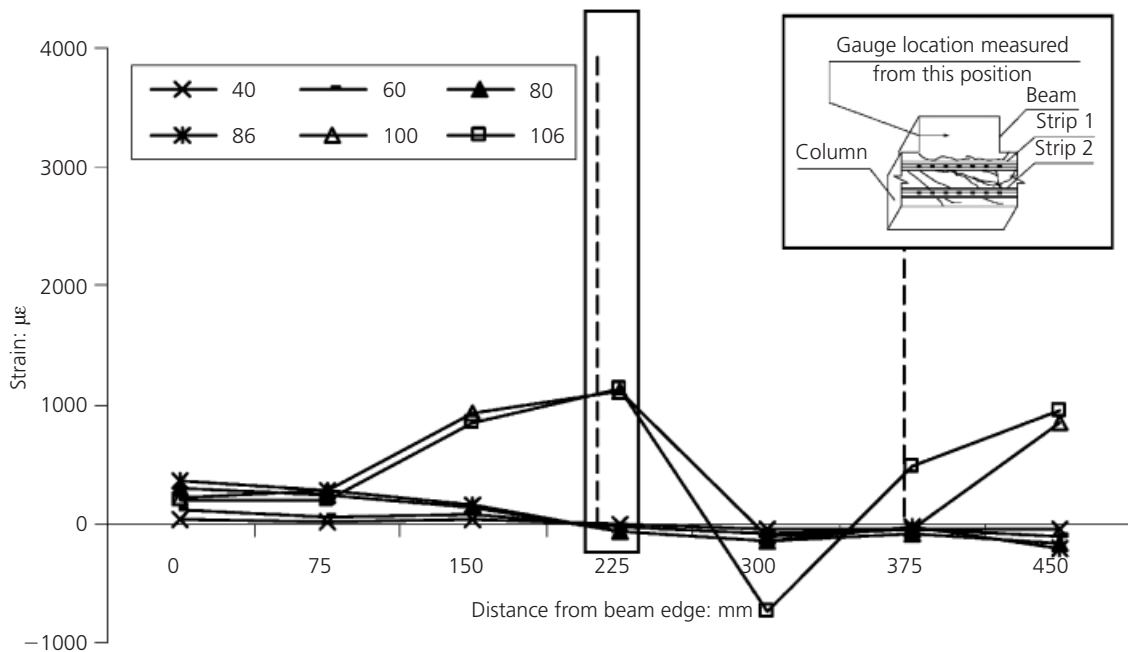
Figure 13. FRP strain distribution along strip 2: SM1

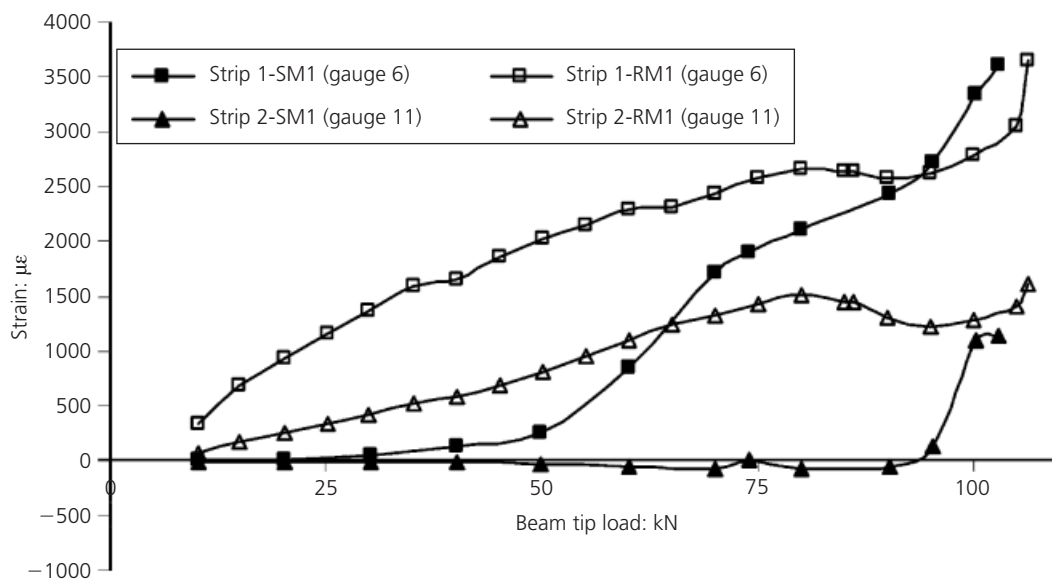
Figure 14. Comparison between RM1 and SM1 at identical locations

these gauges have also been defined on Figures 10 to 13 by vertically oriented rectangular boxes). Figure 14 shows that strip 1 carries significant load after about 50 kN in connection SM1, with the same strip carrying load from the onset of loading in RM1. Similar broad conclusions can be drawn for strip 2 in SM1

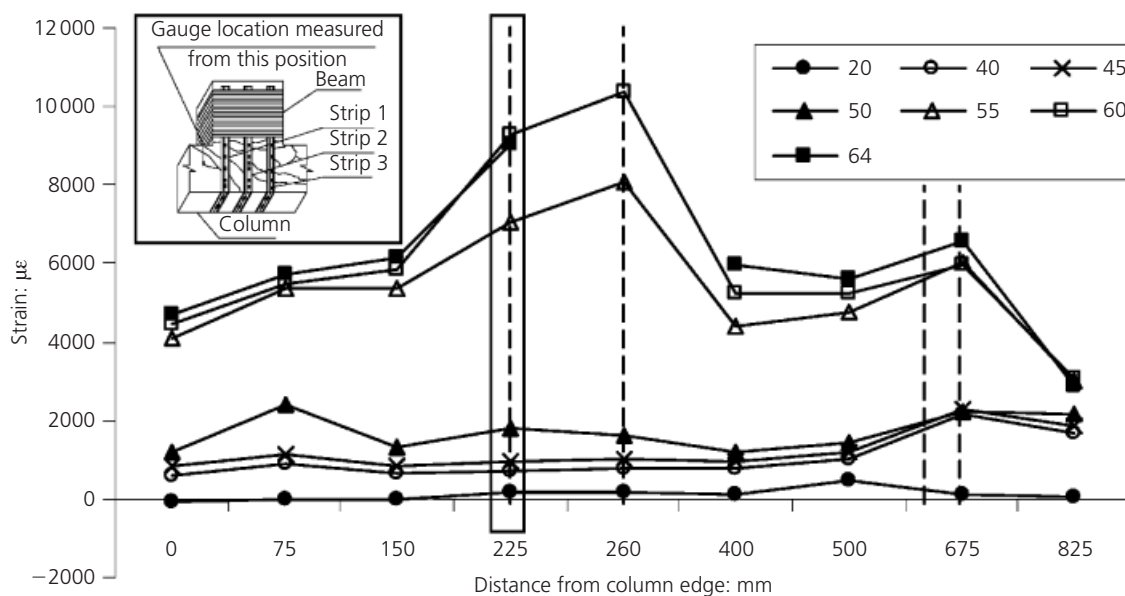
Figure 15. FRP strain distribution along strip 1: RM2

Distribution of strain along FRP strips 1, 2 and 3 for the severely damaged connection RM2 at different load levels are given in Figures 15, 16 and 17, respectively. Locations where the cracks intersect the FRP strips are also marked by vertical dashed lines. These plots show that there is an increase in the FRP strain, especially for strips 1 and 3, corresponding to the separation of repair mortar at 55 kN load, which indicates that the majority of the load was carried by FRP strips then onwards.

The high strain values for strip 1 are approaching the 1.1% rupture strain limit of the FRP. In addition, the lower levels of strain for strip 2 suggest the strip is less effective than the other two strips.

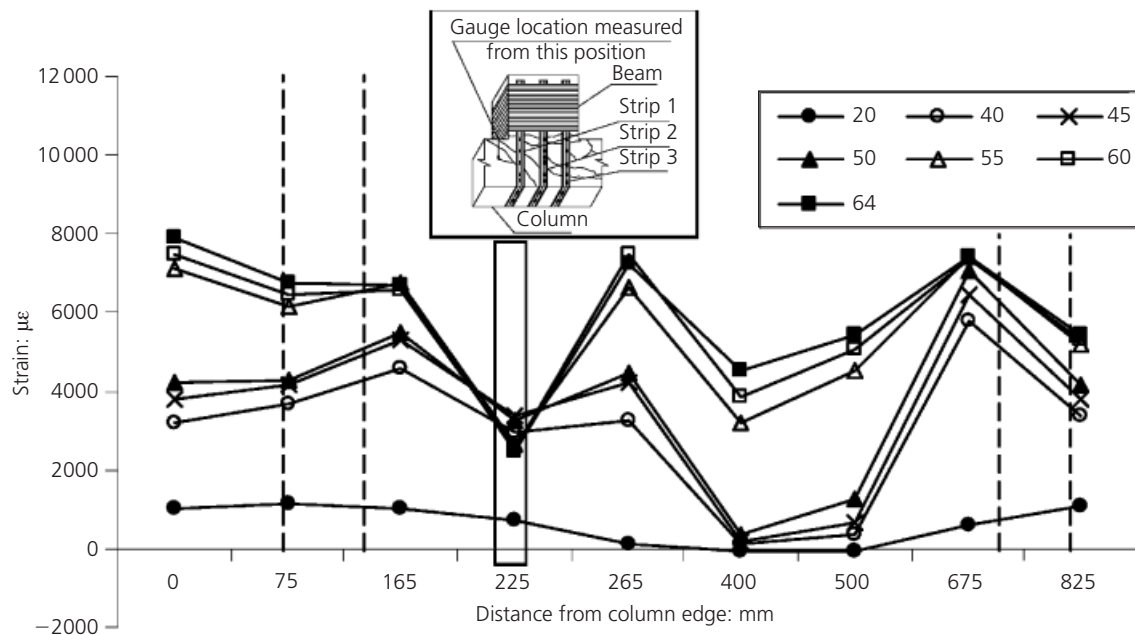
Figure 17. FRP strain distribution along strip 3: RM2
