Faecal contamination of groundwater in rural Vanuatu: prevalence and predictors

Tim Foster, Juliet Willetts and Krishna Kumar Kotra

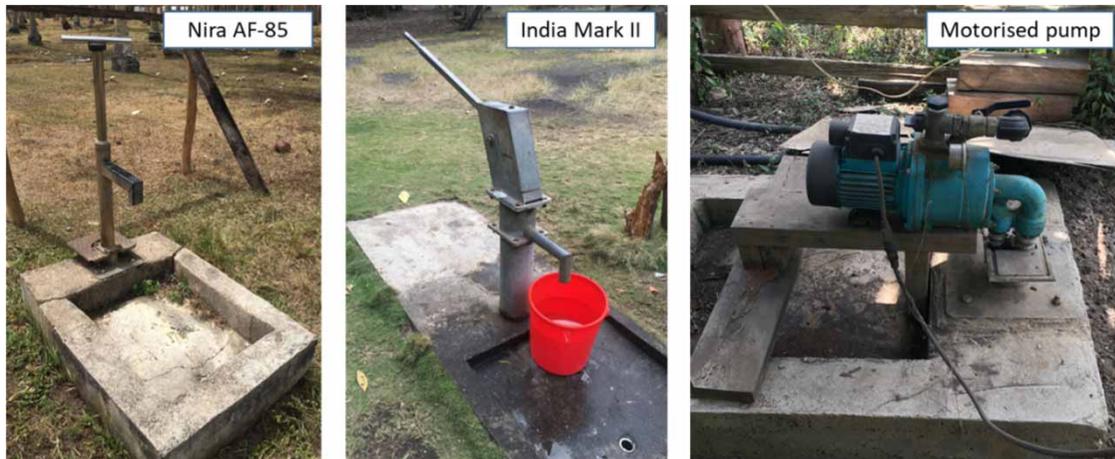
Figure 2 | Pump types included in the assessment.

This included 124 Nira AF-85 handpumps, seven India Mark II handpumps and 18 motorised pumps (Figure 2). The data collection took place across 11 islands during August and September 2017, which are typically the driest months of the year in Vanuatu. Data from the country's rural water supply inventory were used as the basis for locating the groundwater sources to be included in the study.

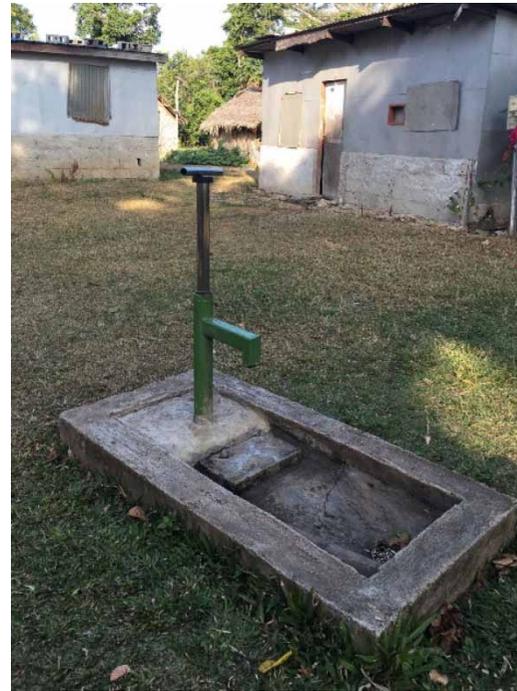
Figure 7 | Example of a Nira AF-85 pump stand encased in concrete.
