An Experimental Investigation of Pressure Loss in Canvas Fire Hose

Aaron Doull and Phuoc Huynh

Faculty of Engineering and IT
University of Technology, Sydney, NSW 2007, Australia

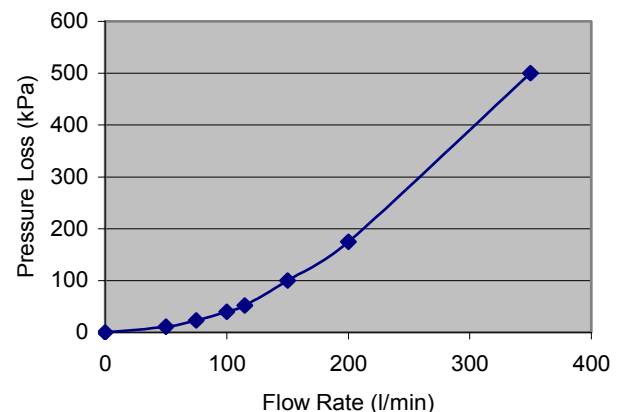
Figure 1. Pressure drop over a “length” of hose (30m) versus flow rate for a representative case of 38-mm-diameter unlined hose. Data from hose manufacturer from tests complying with Australian Standard AS-2792.

There has not been much work done on canvas fire hose. The pressure loss data used by the NSW RFS are from tests conducted by hose manufacturer according to AS-2792 [3,5]. Figure 1 shows a representative set of such data (for 38-mm-diameter unlined hose). Related to this topic is reference 6 on losses in pipe flow, while reference 4 explains how nozzle manufacturers make their hoses to perform at specific nozzle pressures, not pump output pressure. This becomes an issue as a

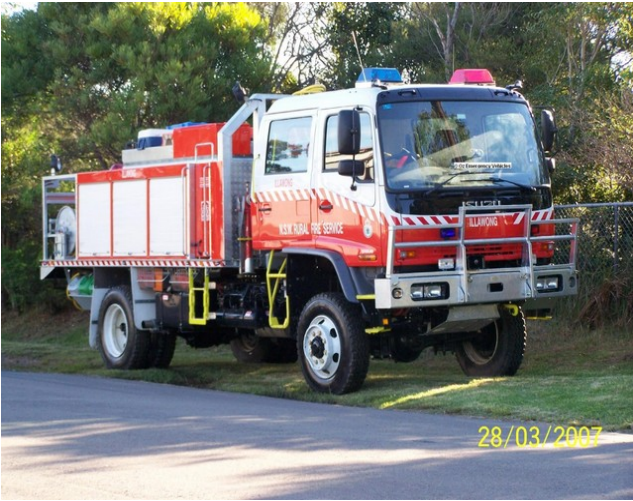
Figure 2. Photo of a Category-1 RFS fire-fighting tanker.

Tests were conducted at a local NSW RFS station in Australia. Measurements of flow rate and pressures (gauge and differential) were done from the back of a Category-1 RFS tanker whose photograph is shown in figure 2. Percolating hose similar to that of figure 3 was used, with 3 sizes: 25-mm diameter, 38-mm, and 65-mm. These are the hose sizes used by the NSW RFS. Two nozzles were used: a 25-mm Dial-A-Jet nozzle [2] for the 25-mm hose, and a 38-mm Akron nozzle [1] for 38-mm and 65-mm hoses (a reducer is also used with 65-mm hose). The experimental set-up is shown in figure 4. A Dobbie Bros pressure gauge is used for measuring nozzle pressure (P2 in figure 4); pressure difference between the tanker pump’s outlet and the nozzle’s inlet (P1 – P2 in the hose set-up’s figure 4) is measured with a Buddenberg differential pressure gauge. Flow rate was measured using a stop watch and a water drum. Figure 5 shows photo of a nozzle with pressure line attached (for pressure P2 in figure 4) and the water drum, and figure 6 is a photo of the back of the tanker showing hose connection and pressure line attached (for pressure P1 in figure 4). Three hose-lay configurations are tested: straight, moderate bends, and severe bends. In straight configuration, the hose was laid as straight as possible on the ground, but it still needs to curve from the back of the tanker down to ground level. Figure 7 shows the hose configuration for moderate bends and severe bends, respectively. Figure 8 is photo of the whole set-up for a severe-bend case.

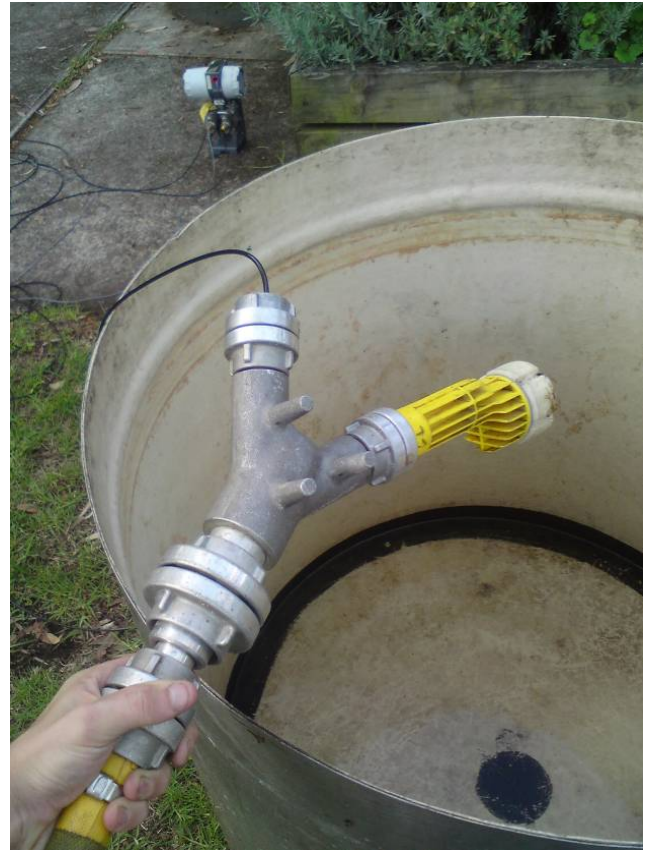
Figure 5. Photo of a nozzle with pressure line attached (for pressure P2 in figure 4) and the water drum.

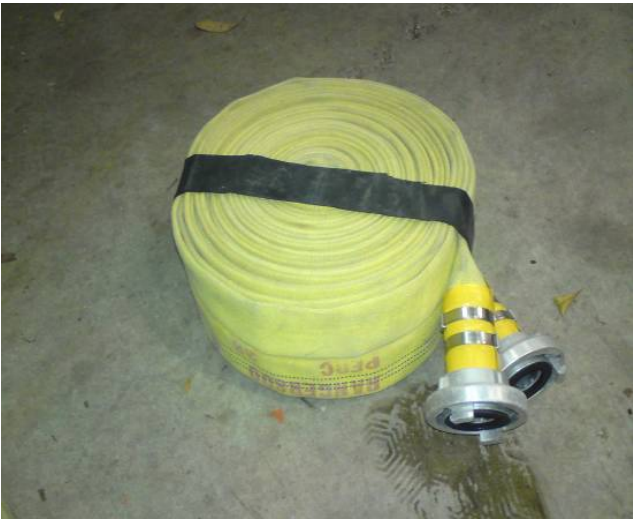
Figure 3. Percolating hose used to deliver water for fire-fighting.

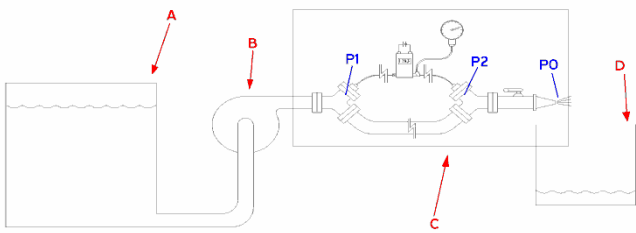
Figure 4. Hose-test set-up. **A** – Supply water reservoir (on tanker), **B** – Pump (on tanker), **C** – System (hose configuration, couplings, nozzle, pressure lines and gauges [upper branch between P1 and P2]), **D** – Water tank (for flow rate measurement), **P1** – Pump outlet pressure, **P2** – Nozzle pressure (kept at 700 kPa gauge), **P0** – Atmospheric pressure (0 kPa gauge).

Pressure P2 at nozzle inlet (see figure 4) is always maintained at 700 kPa (gauge). This keeps the flow rate constant for each hose as its bends become more severe. However, flow rate does vary with hose size, because two different nozzles (plus a reducer) were used to suit the hoses. Using different nozzles to suit the hoses is in keeping with the common practice. Thus, flow rate is 75.2 l/min for the 25-mm hose, 117.3 l/min for 38-mm hose, and 124.4 l/min for 65-mm hose.

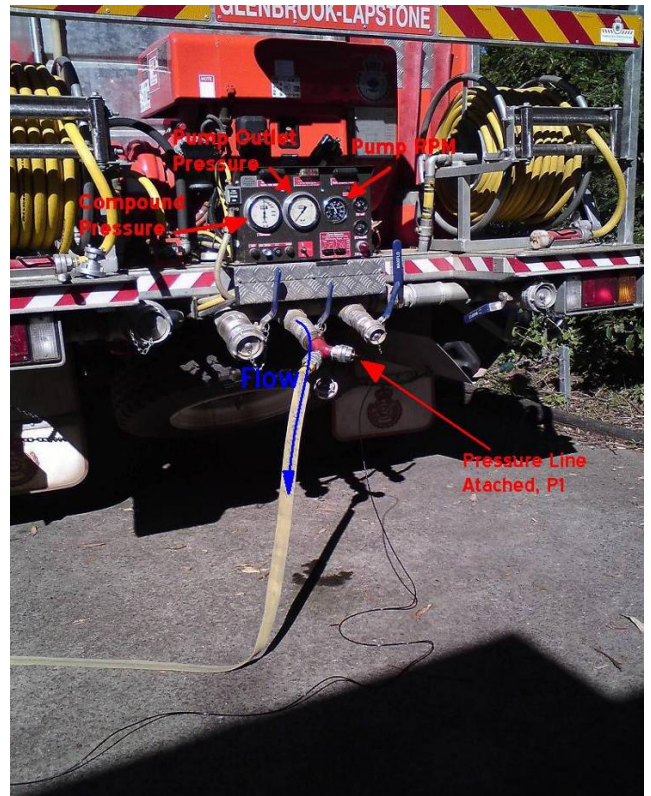
Figure 6. Photo of the back of the tanker showing hose connection and pressure line attached (for pressure P1 in figure 4).

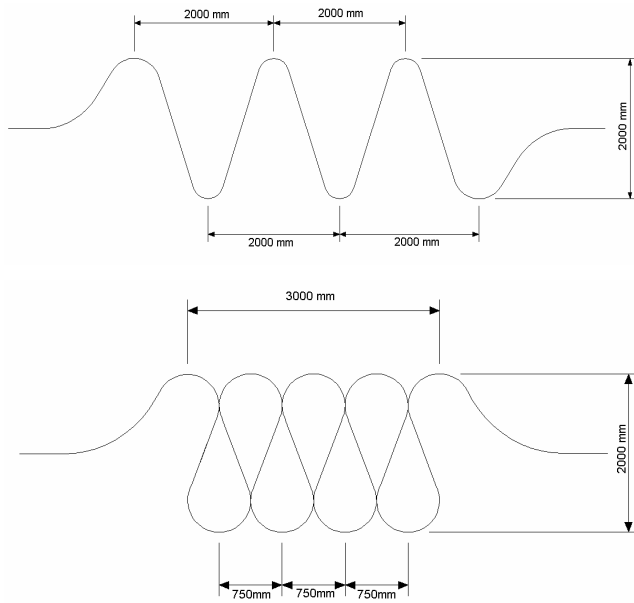
Figure 7. Hose-lay configuration for moderate bends (above) and severe bends (below).

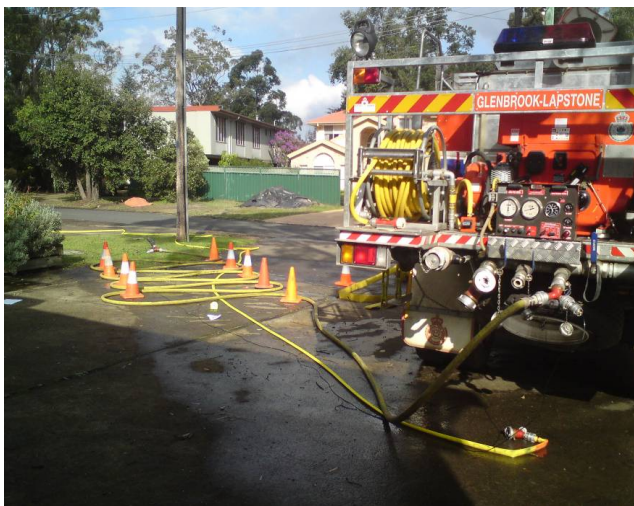
Figure 8. Photo of a test set-up with hose having severe bends.

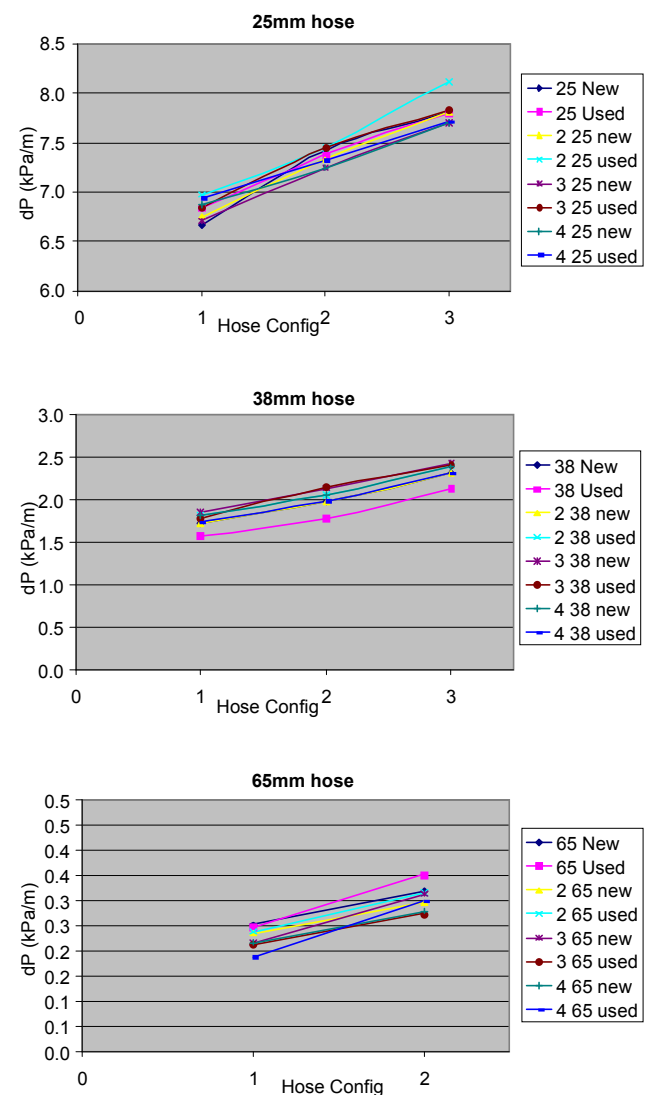
Figure 9. Pressure drop dP versus hose configuration and hose diameter; flow rate was 75.2 l/min with 25-mm hose (top), 117.3 l/min with 38-mm hose (middle), 124.4 l/min with 65-mm hose (bottom). Hose configuration: 1 – straight, 2 – with moderate bends, 3 – with severe bends. 38 used, 2 38 used, 3 38 used, etc. refer to run 1, 2, 3 with 38-mm used (old) hose, etc.

Figure 9 shows results for the above conditions. From this figure, the following points are seen

- Pressure increases significantly as hose bends become more severe, especially with smaller-diameter hoses
- Age does not seem to play a significant role
- Rule-of-thumb figure of 3.33 kPa/m is significantly lower than the pressure drop in 25-mm hose, but larger than that in 38-mm and 65-mm hose

The measurements in figure 9 are also averaged and shown in figure 10.

In similarity with flow in rigid pipes, the averaged pressure-drop values in figure 9 are non-dimensionalised in the form of a friction coefficient f defined as

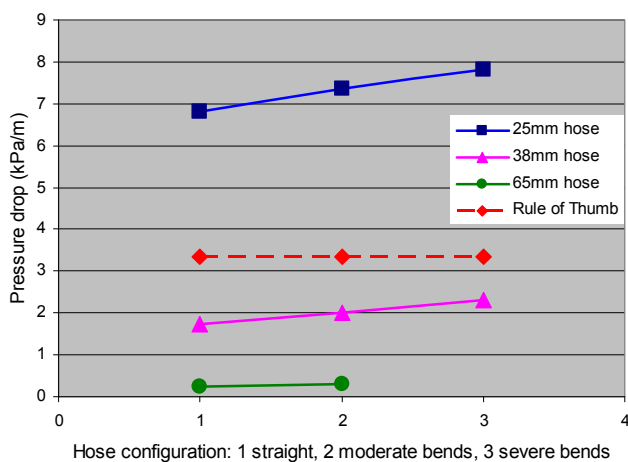
Figure 10. Average pressure drop versus hose configuration and hose diameter.

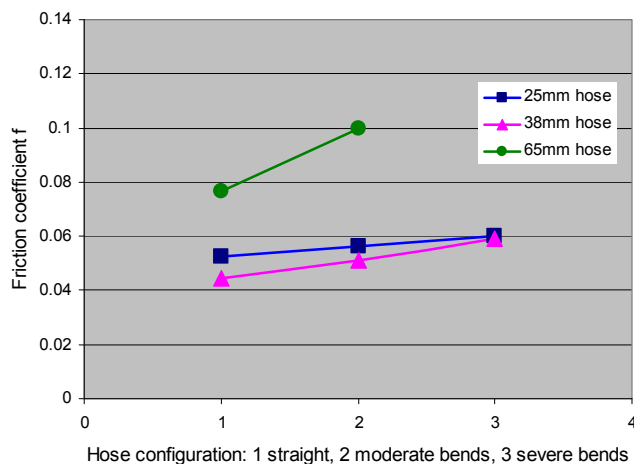
Figure 11. Friction coefficient versus hose configuration and hose diameter.

Figure 11 shows values of f in terms of hose configuration and hose diameter. It is interesting to see that while f values for smaller hoses are comparable to those of very rough rigid pipes (about 0.05), values belonging to the large hose (65-mm diameter) are much larger as well as showing a stiff rise with more bends.
